**Aransas Creek
Recreational Use Attainability Analysis**

**Texas State Soil and Water Conservation Board
Project 11-52**

**Nueces River Authority – Coastal Bend Division
Corpus Christi, Texas**

May 2013

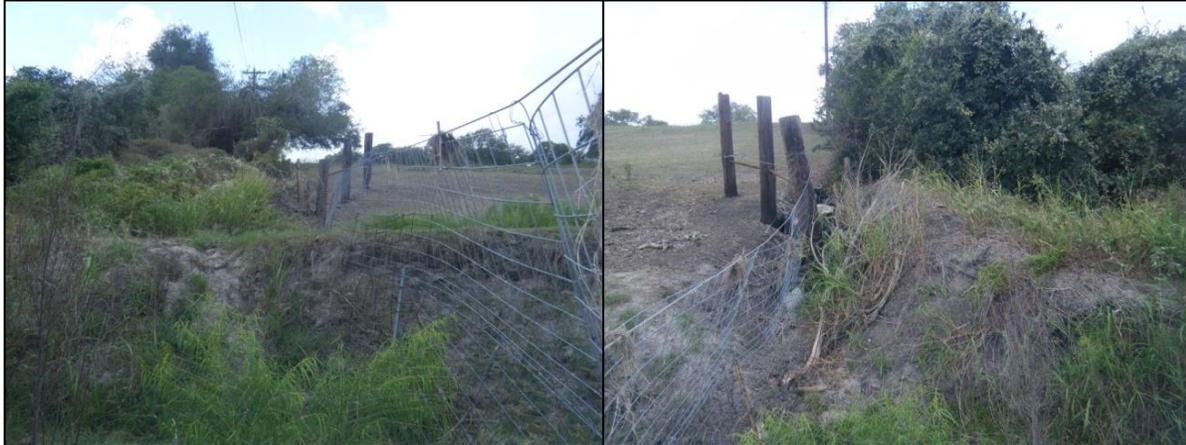
Figure 4-1. Photographs of the fence line upstream at Site ACk02

Accessibility upstream (west) of the bridge crossing was restricted by a large fence (Figure 4-1). All information gathered at site ACk02 occurred at the bridge and to a point 300 m downstream. Once on the river bank, access was achieved from a moderately steep bank approximately 2 m in elevation. At the creek, the left bank (facing downstream) and right bank are heavily vegetated while the streambed itself was dry sand. This section of creek was noted to have significant tree cover blocking out direct sunlight to the streambed. Streamflow has been observed on numerous occasions but was absent during the site surveys. Field staff did not report any pools present in the 300 m reach. Table 4-2 describes the stream channel and corridor assessment at the site. Photogroups 4-1 through 4-4 depict the general appearance of the stream at site ACk02.

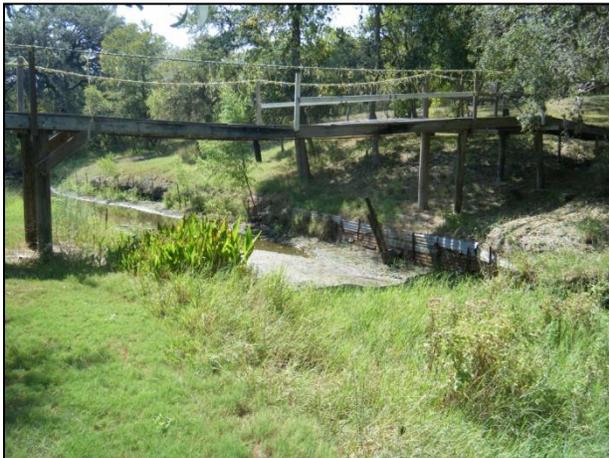
Figure 4-2 Footbridge at ACk04

Aransas Creek at site ACk04 was visited on August 31st, and September 28th, 2012. This site was accessible only through private lands located at a residence on Tammy Lynn Trail just off FM 888 approximately 8 km south/southwest of Beeville in Bee County. Once on the property, the site is approximately 70 m from the residential dwelling and easily accessible throughout the 300 m reach. At the creek, the leftbank (looking downstream) and rightbank are moderately vegetated with trees providing sporadic cover. A dominant structure present at the site is a footbridge connecting the right and left banks (Figure 4-2). The rightbank has also been reinforced with corrugated metal to help control erosion near the base of the footbridge (Figure 4-3). The landowner told the NRA field crew that the creek was modified by a previous landowner to hold water for fishing purposes. The landowner also mentioned some accidental primary contact recreational activities occurring while using the bridge by a family member.

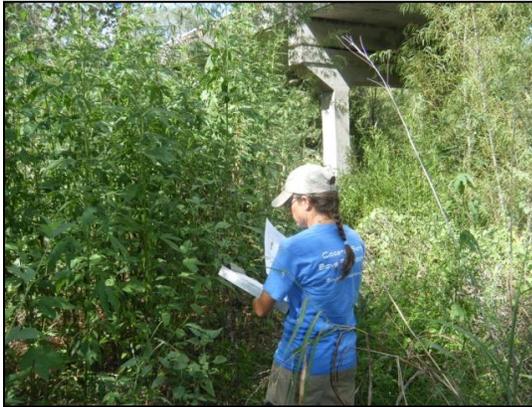
Figure 4-4 Tall vegetation at ACk05

thick making it difficult to travel up and down the 300 m reach (Figure 4-4). A small concrete bridge was present near the 270 m mark allowing for residents to safely traverse the creek (Figure 4-5). Portions of site had wooden structures constructed in the old oak trees that lined the creek bed (Figure 4-6). The structures resembled tree houses or possibly structures to use for fishing since they were located directly over the streambed.

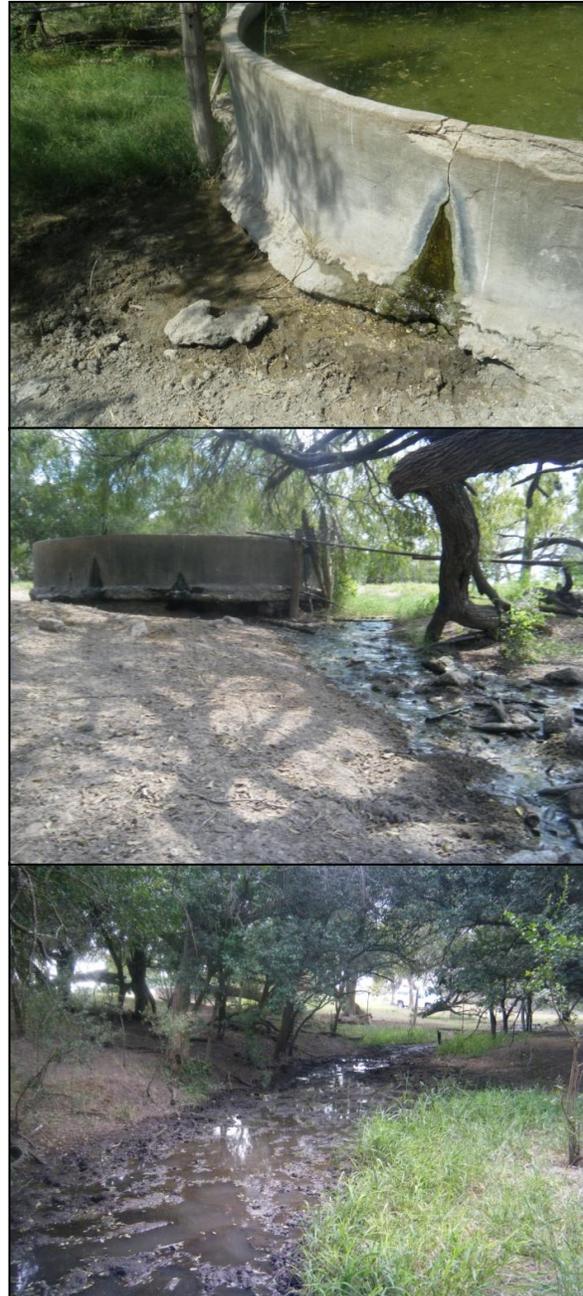
Figure 4-7. Leaking water trough at ACk07

The streambed was completely dry during the first site survey except for the area just downstream of a leaky water trough (Figure 4-7). Water pooled at the 30 m transect was approximately 0.22 m deep and the pool was approximately 32 m long. At the time of the second survey, the leak had been repaired and the pool was slowly drying back up. Cattle were present at the time of both field surveys. No other animals were observed at this location.

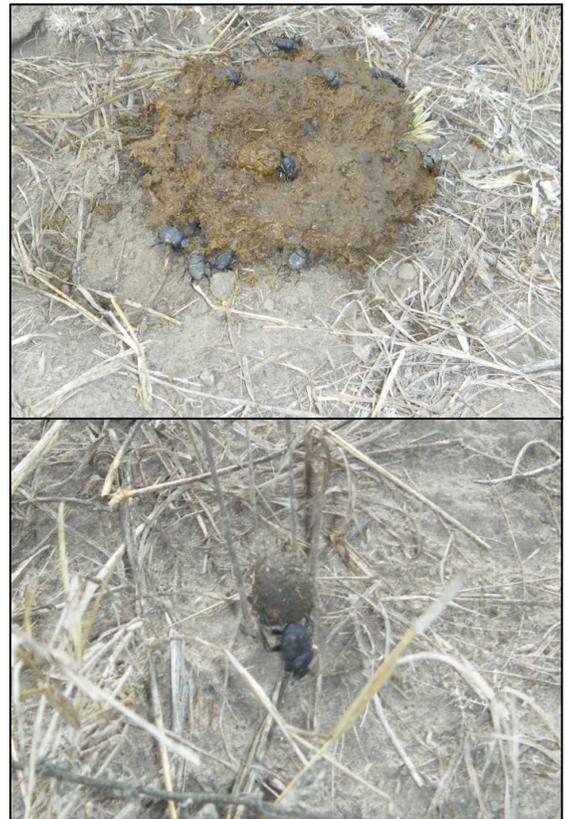
Figure 4-9. Dung beetles at ACk08.

The streambed at ACk08 was completely dry during both of the site surveys. The landowner said that he has owned the property a few years and had not seen any flowing water in that time. The creek banks at site ACk08 were very flat with hardly any riparian vegetation within the 300 m reach. Discussions with the landowner revealed that the creek only flows after a significant rainfall event. The creek can be classified as ephemeral at this location. The landowner uses the ranch to raise livestock (beef cattle) and leases the ranch for game hunting. Although no cattle were seen near the creek bed at the time of the site surveys, fresh cattle feces were observed during both site surveys within the 300 m reach. Dung beetles (*Canthor imitator* most likely) were observed recycling fecal material (Figure 4-9). It is a well known fact that dung beetles such as these are very good at recycling large quantities of fecal material that could otherwise end up in receiving waters (Borror *et al.*, 1989)

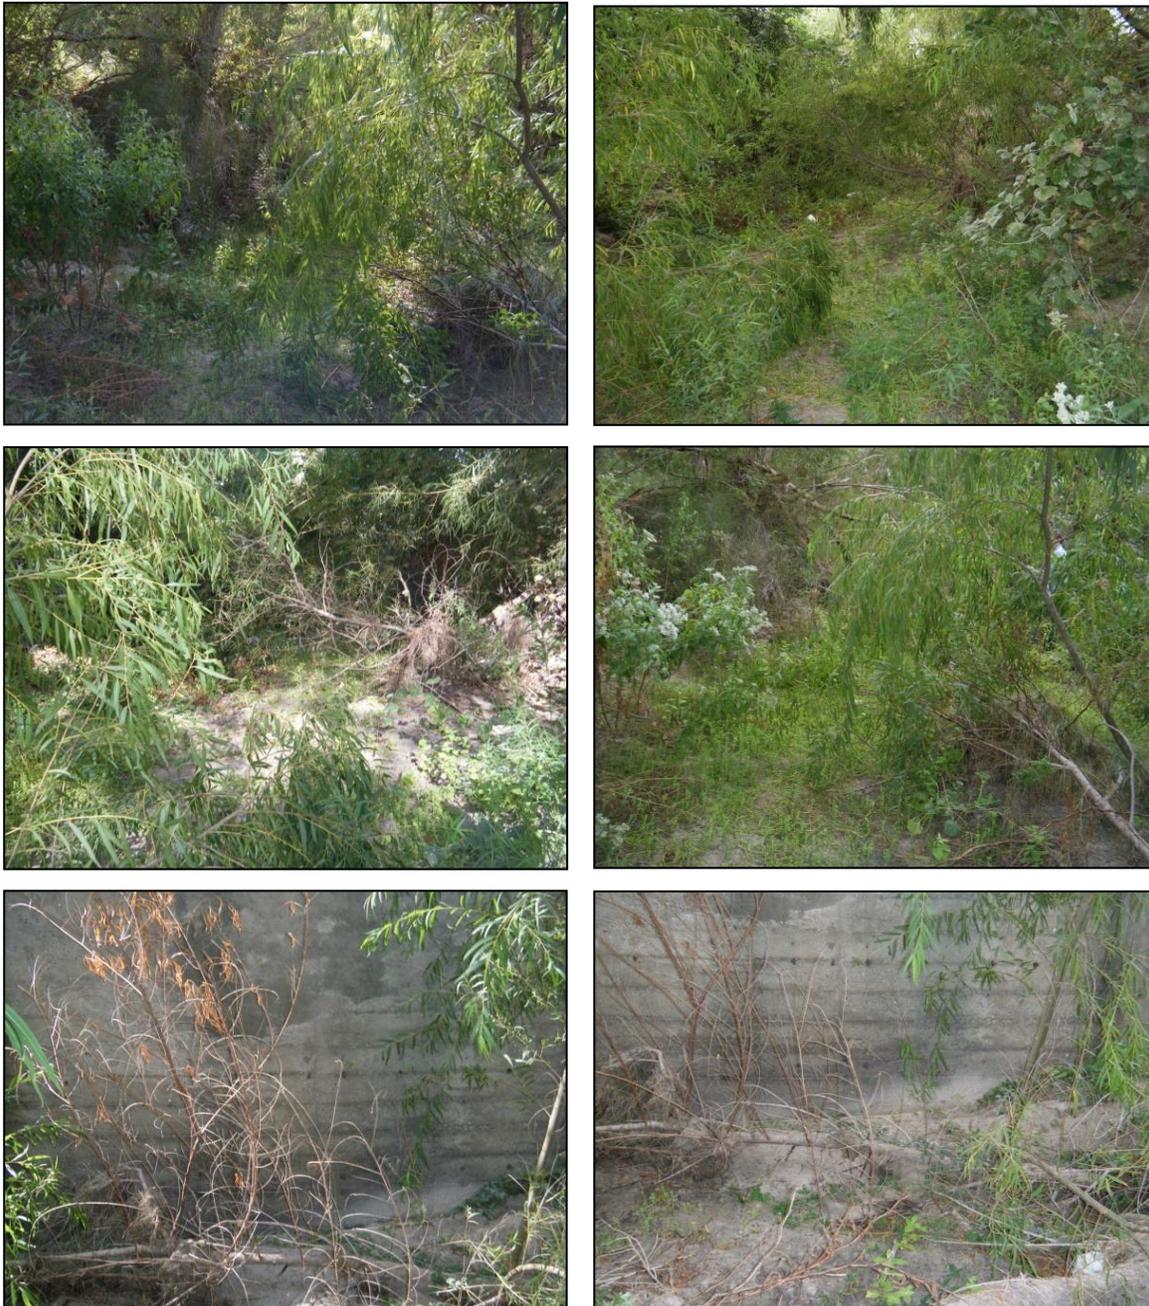
Photogroup 4-1. Aransas Creek site ACK02 depicting general appearance of the site. Top Left – 30 m transect, upstream view, September 1st, 2012; Top Right – 30 m transect, upstream view, September 28th, 2012; Middle Left – 30 m transect, downstream view, September 1st, 2012; Middle Right – 30 m transect, downstream view, September 28th, 2012; Bottom Left – 30 m transect, rightbank view, September 1st, 2012; Bottom Right – 30 m transect, rightbank view, September 28th, 2012.

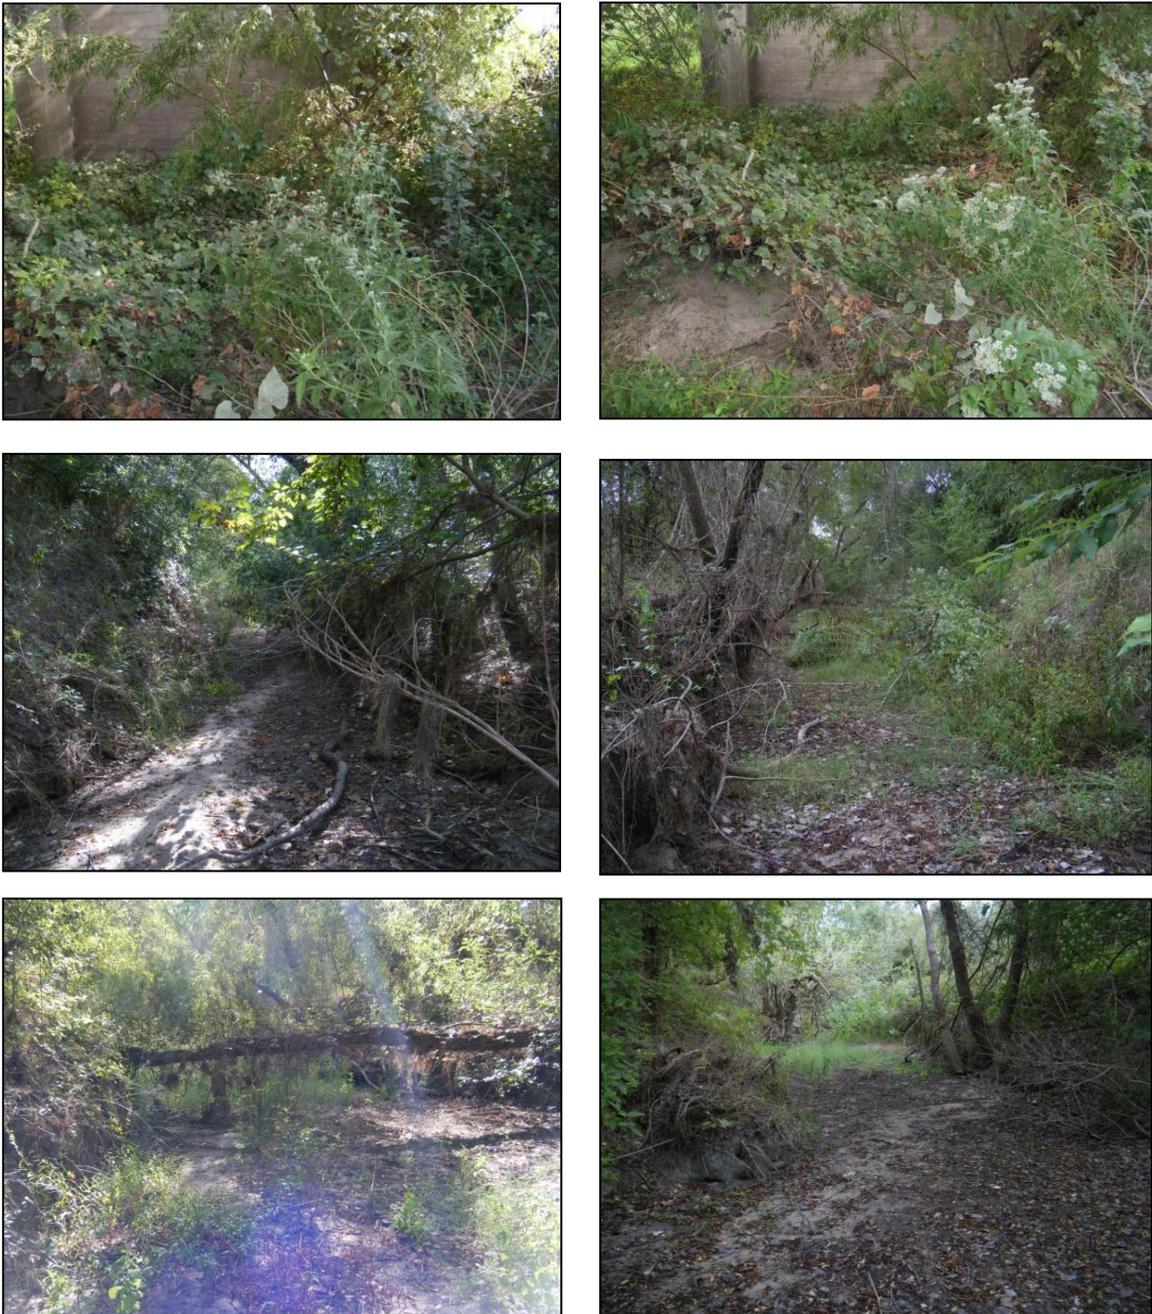
Photogroup 4-2. Aransas Creek site ACl02 depicting general appearance of the site. Top Left – 30 m transect, leftbank view, September 1st, 2012; Top Right – 30 m transect, leftbank view, September 28th, 2012; Middle Left – 150 m transect, upstream view, September 1st, 2012; Middle Right – 150 m transect, upstream view, September 28th, 2012; Bottom Left – 150 m transect, downstream view, September 1st, 2012; Bottom Right – 150 m transect, downstream view, September 28th, 2012.

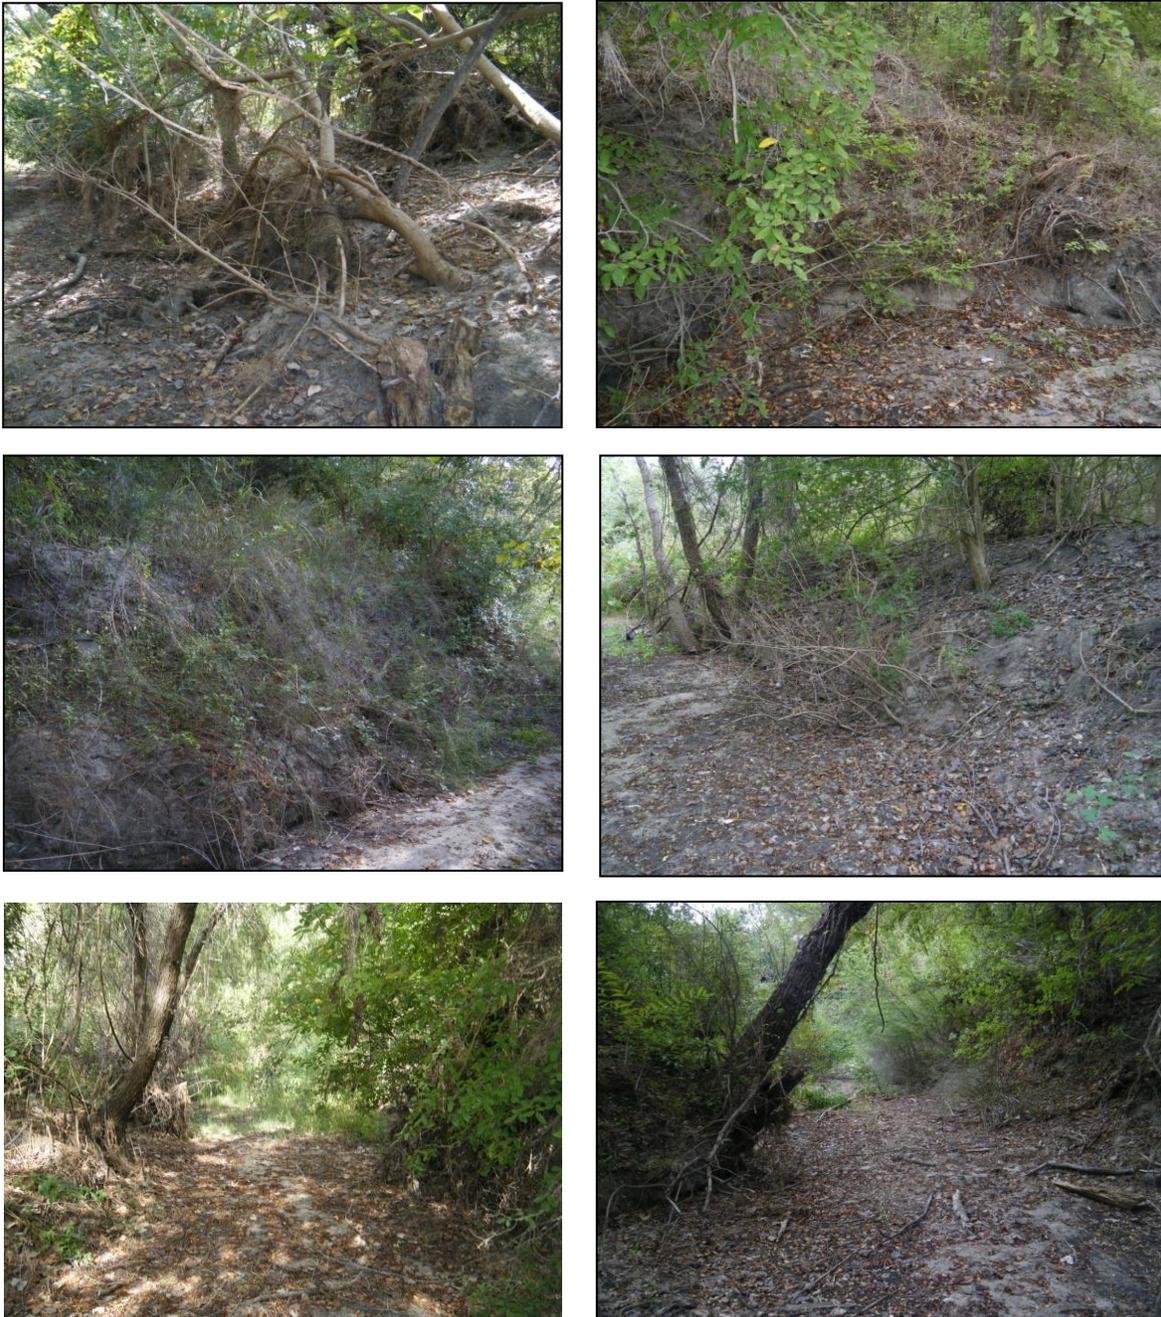
Photogroup 4-3. Aransas Creek site ACk02 depicting general appearance of the site. Top Left – 150 m transect, rightbank view, September 1st, 2012; Top Right – 150 m transect, rightbank view, September 28th, 2012; Middle Left – 150 m transect, leftbank view, September 1st, 2012; Middle Right – 150 m transect, rightbank view, September 28th, 2012; Bottom Left – 300 m transect, upstream view, September 1st, 2012; Bottom Right – 300 m transect, upstream view, September 28th, 2012.

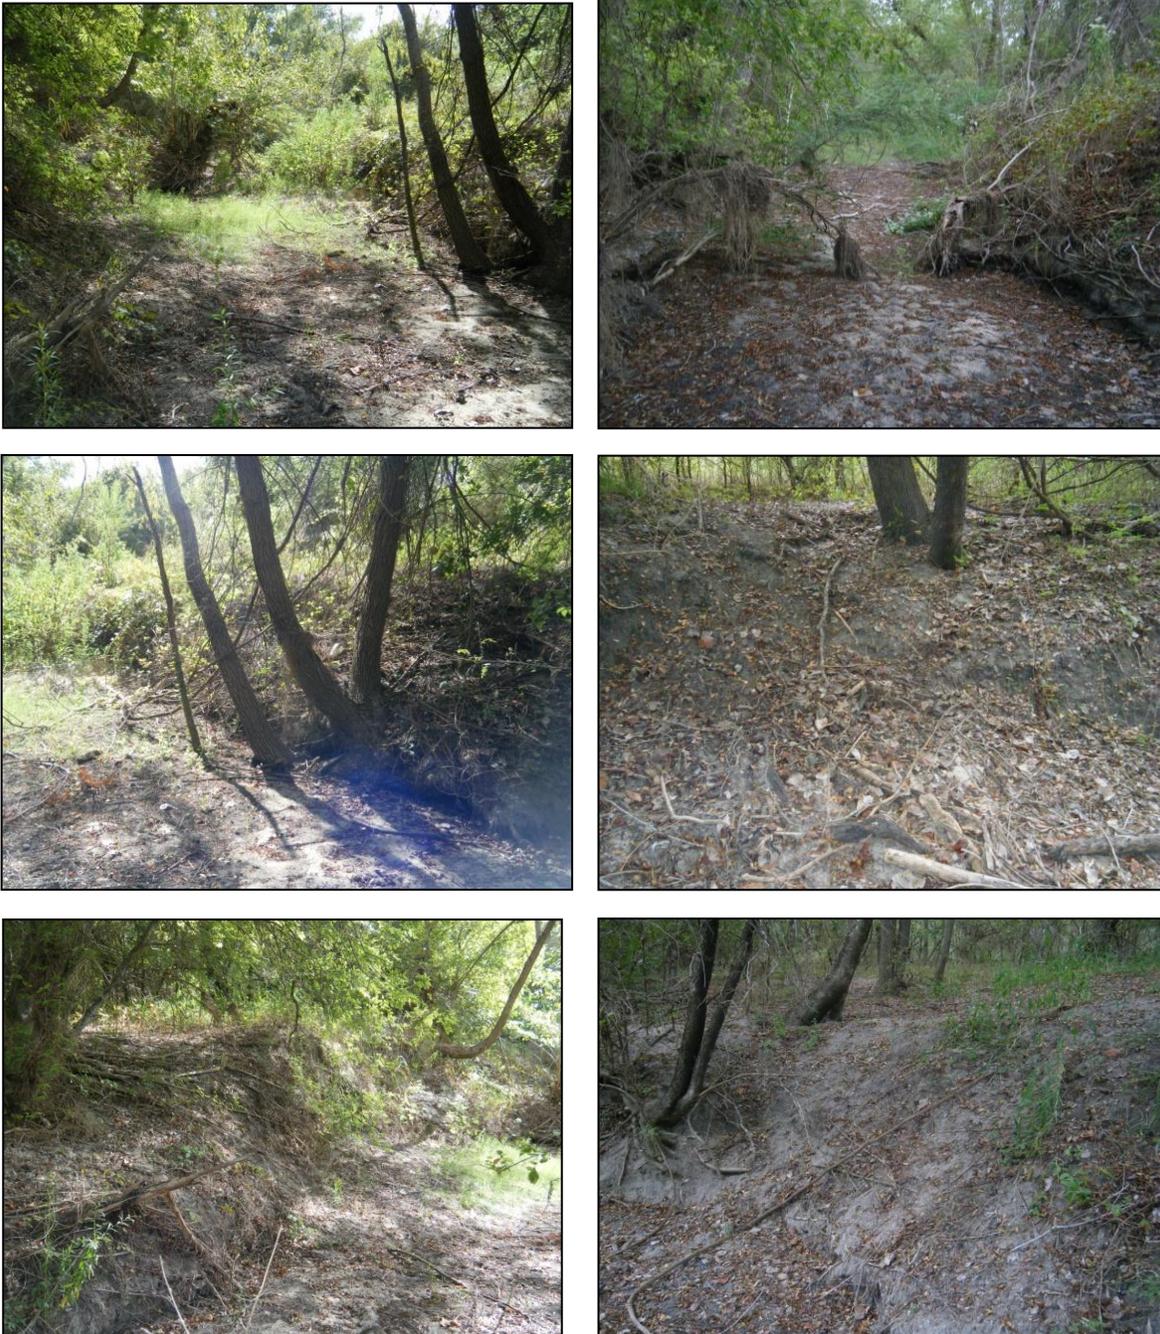
Photogroup 4-4. Aransas Creek site ACK02 depicting general appearance of the site. Top Left – 300 m transect, downstream view, September 1st, 2012; Top Right – 300 m transect, downstream view, September 28th, 2012; Middle Left – 300 m transect, rightbank view, September 1st, 2012; Middle Right – 300 m transect, rightbank view, September 28th, 2012; Bottom Left – 300 m transect, leftbank view, September 1st, 2012; Bottom Right – 300 m transect, leftbank view, September 28th, 2012.

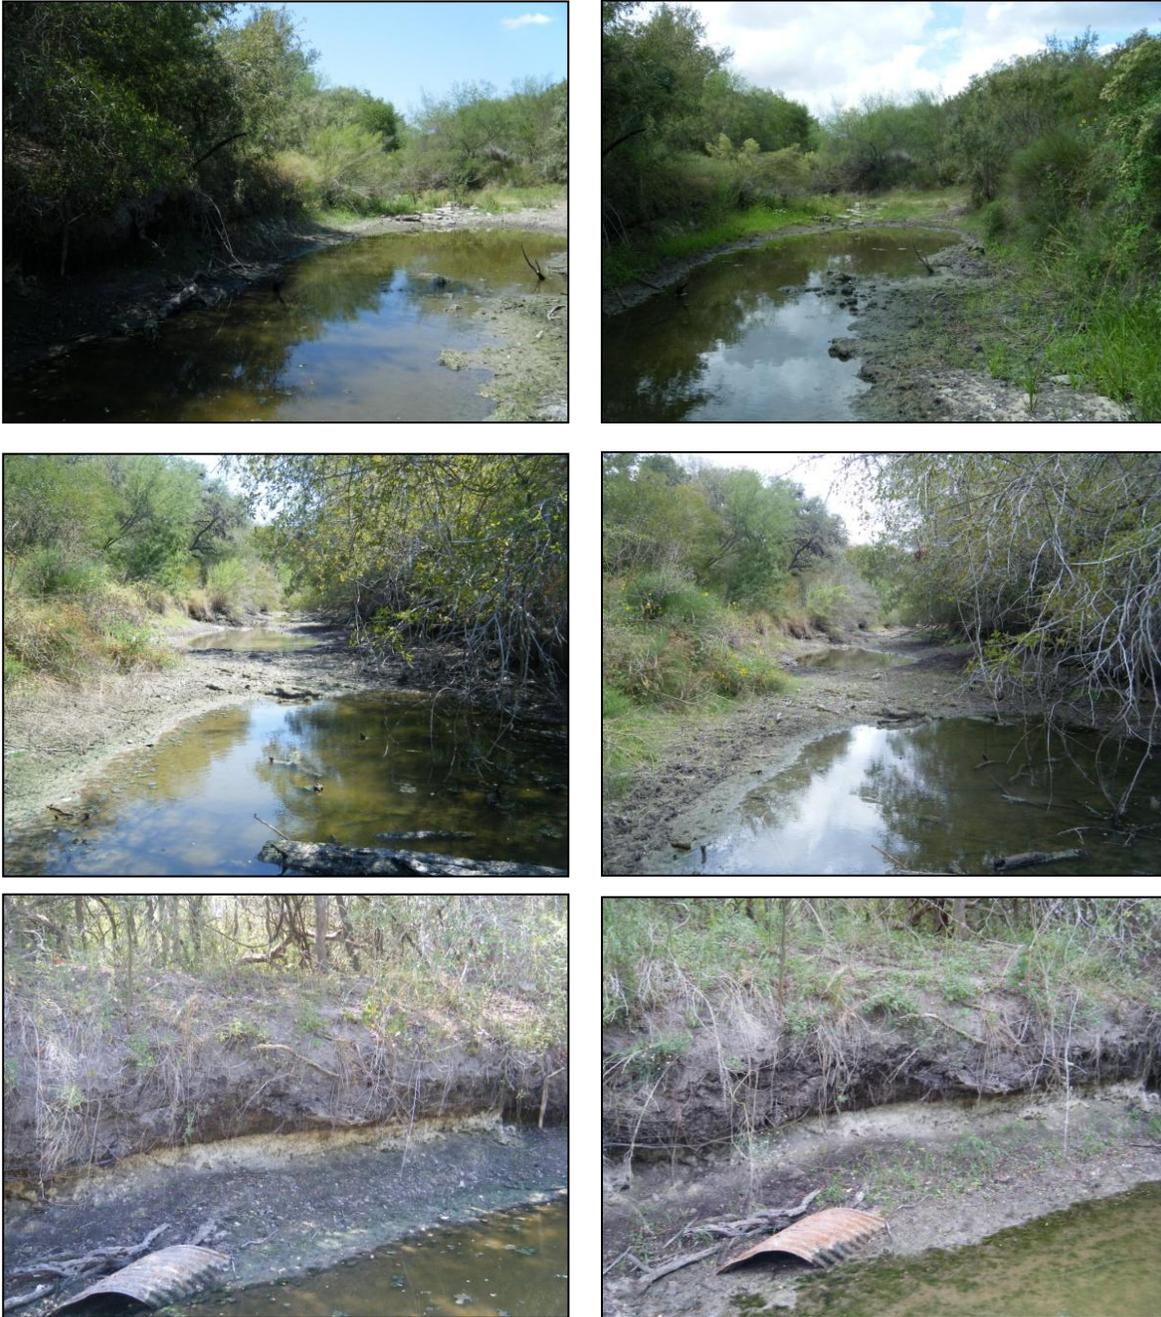
Photogroup 4-5. Aransas Creek site ACk03 depicting general appearance of the site. Top Left – 30 m transect, upstream view, August 31st, 2012; Top Right – 30 m transect, upstream view, September 28th, 2012; Middle Left – 30 m transect, downstream view, August 31st, 2012; Middle Right – 30 m transect, downstream view, September 28th, 2012; Bottom Left – 30 m transect, rightbank view, August 31st, 2012; Bottom Right – 30 m transect, rightbank view, September 28th, 2012.

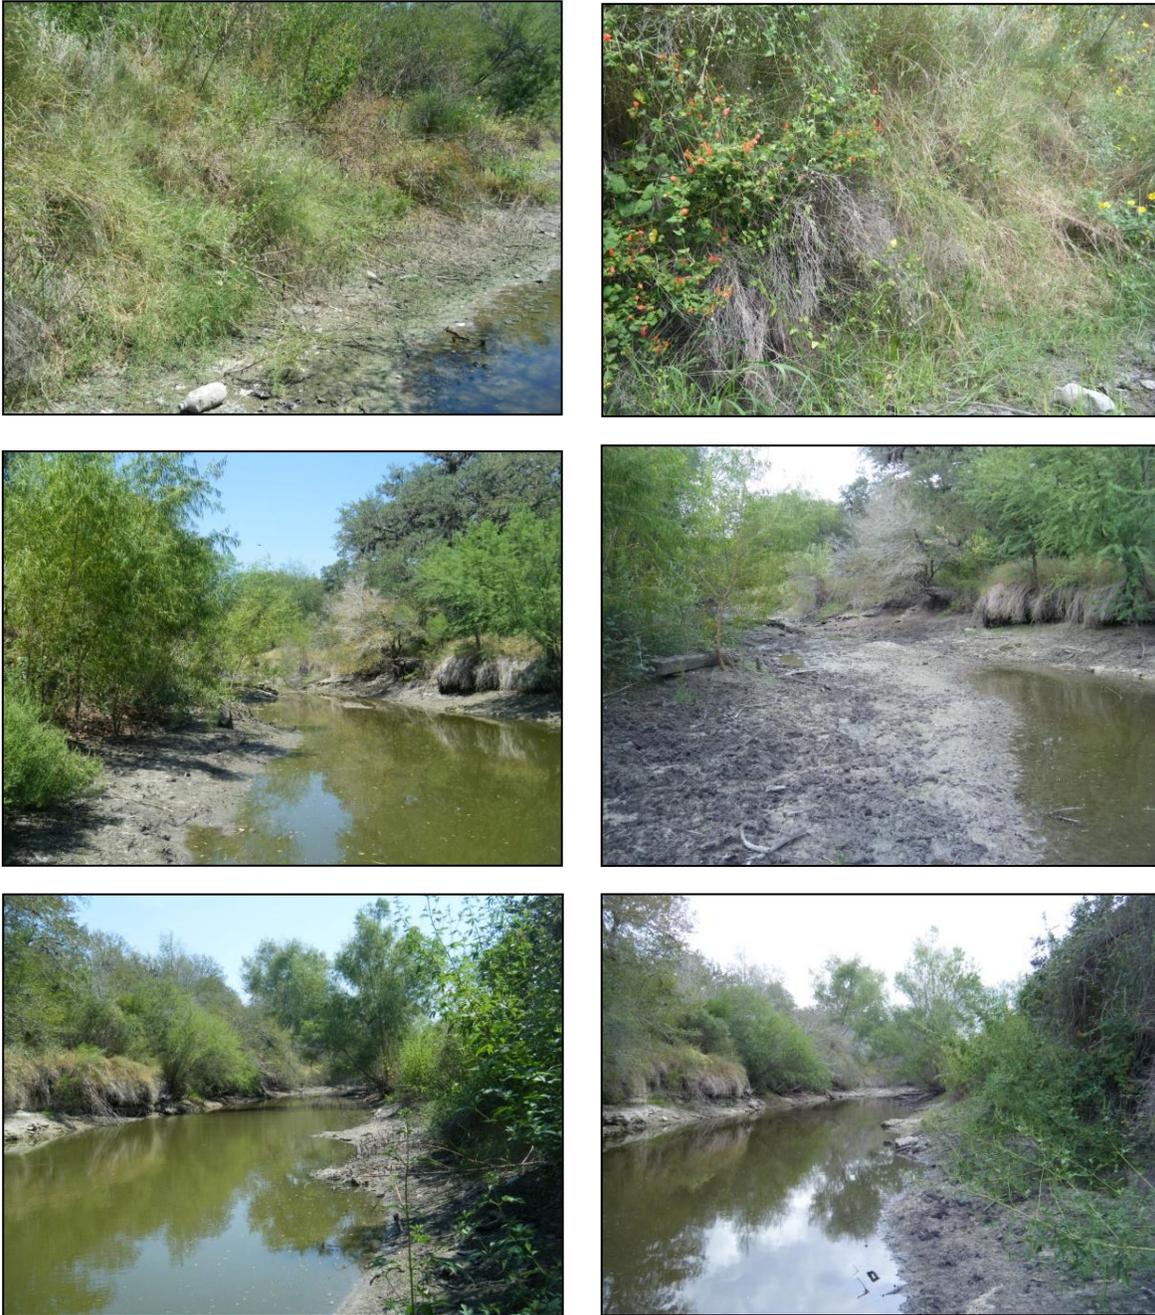
Photogroup 4-6. Aransas Creek site ACk03 depicting general appearance of the site. Top Left – 30 m transect, leftbank view, August 31st, 2012; Top Right – 30 m transect, leftbank view, September 28th, 2012; Middle Left – 150 m transect, upstream view, August 31st, 2012; Middle Right – 150 m transect, upstream view, September 28th, 2012; Bottom Left – 150 m transect, downstream view, August 31st, 2012; Bottom Right – 150 m transect, downstream view, September 28th, 2012.

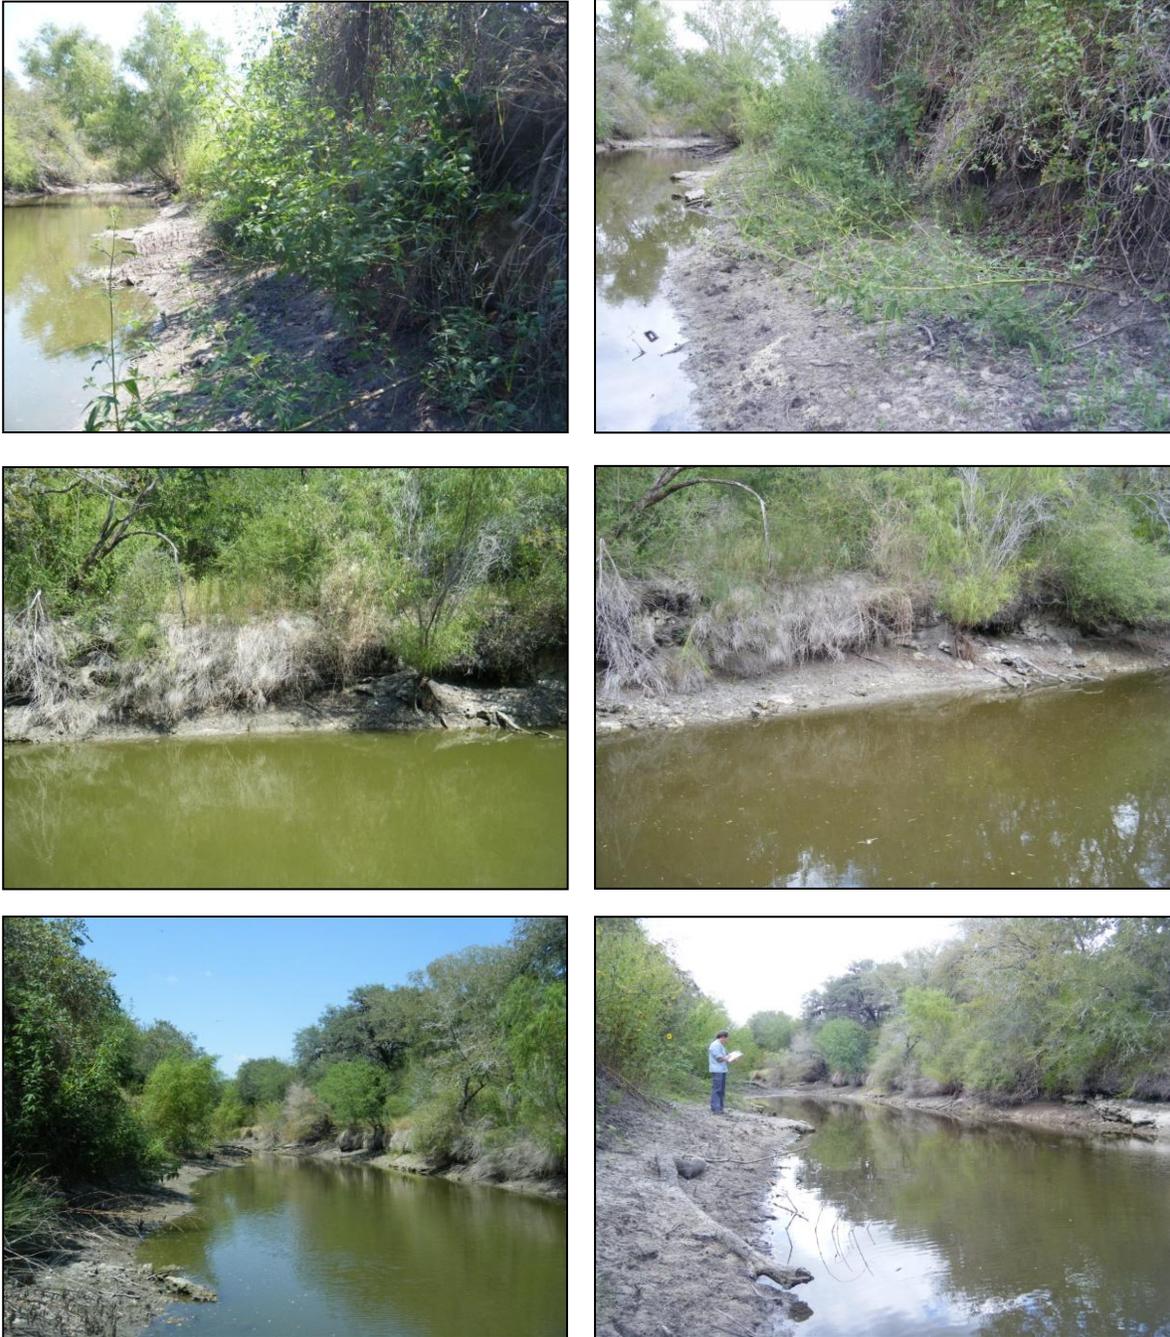
Photogroup 4-7. Aransas Creek site ACk03 depicting general appearance of the site. Top Left – 150 m transect, rightbank view, August 31st, 2012; Top Right – 150 m transect, rightbank view, September 28th, 2012; Middle Left – 150 m transect, leftbank view, August 31st, 2012; Middle Right – 150 m transect, rightbank view, September 28th, 2012; Bottom Left – 300 m transect, upstream view, August 31st, 2012; Bottom Right – 300 m transect, upstream view, September 28th, 2012.

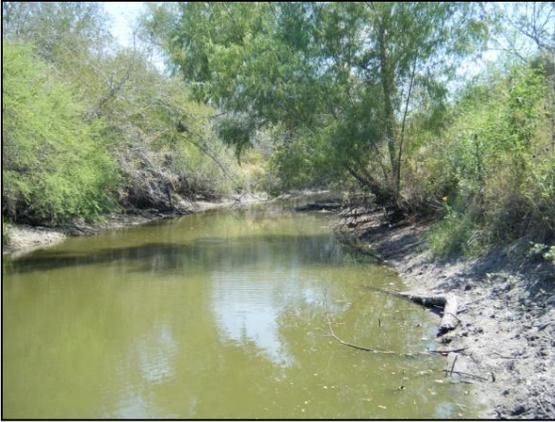
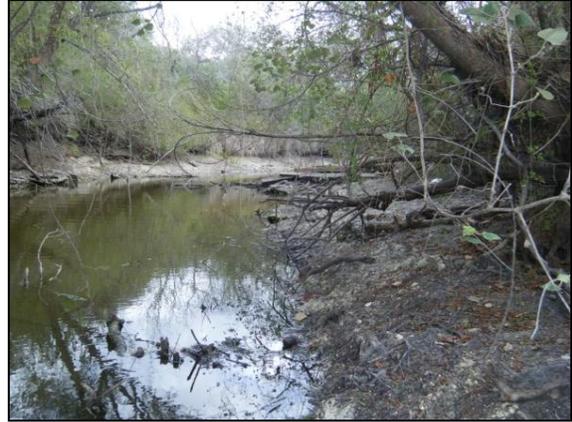
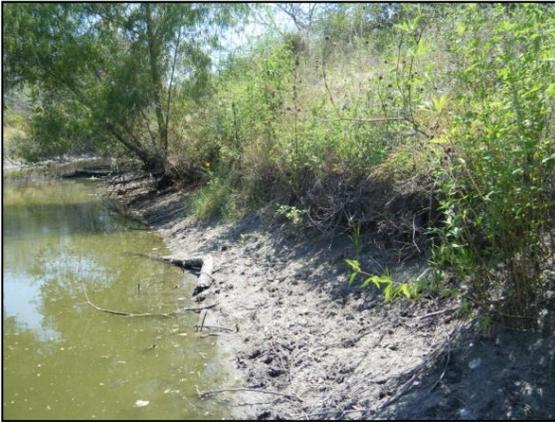
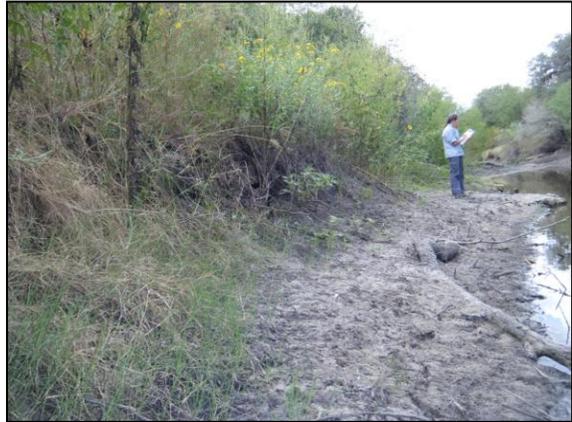
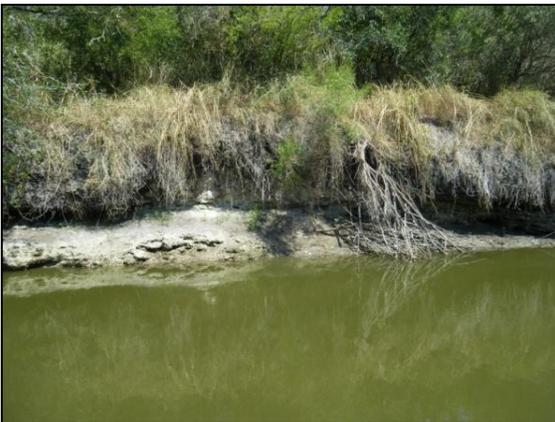
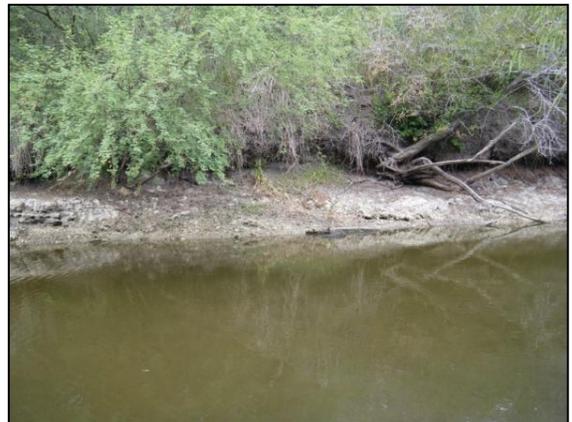
Photogroup 4-8. Aransas Creek site ACk03 depicting general appearance of the site. Top Left – 300 m transect, downstream view, August 31st, 2012; Top Right – 300 m transect, downstream view, September 28th, 2012; Middle Left – 300 m transect, rightbank view, August 31st, 2012; Middle Right – 300 m transect, rightbank view, September 28th, 2012; Bottom Left – 300 m transect, leftbank view, August 31st, 2012; Bottom Right – 300 m transect, leftbank view, September 28th, 2012.

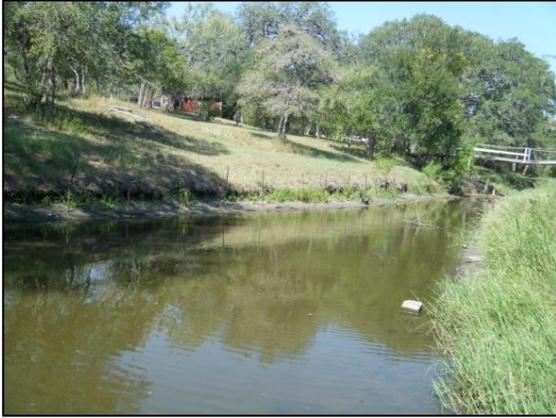
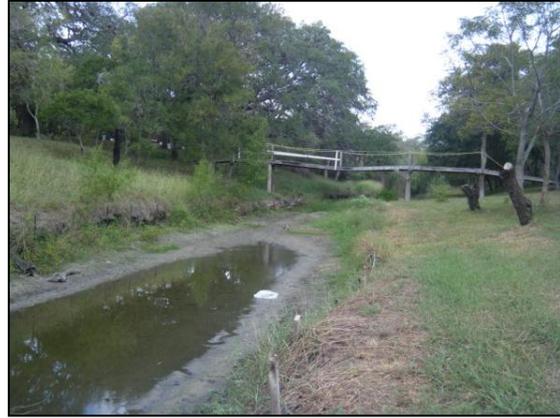
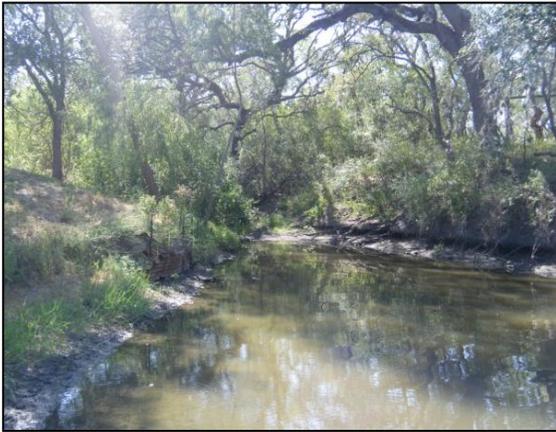
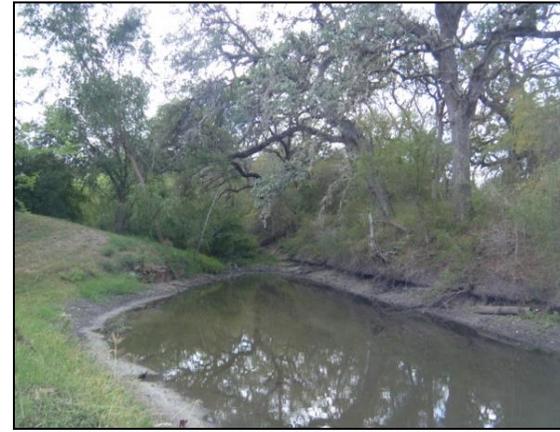
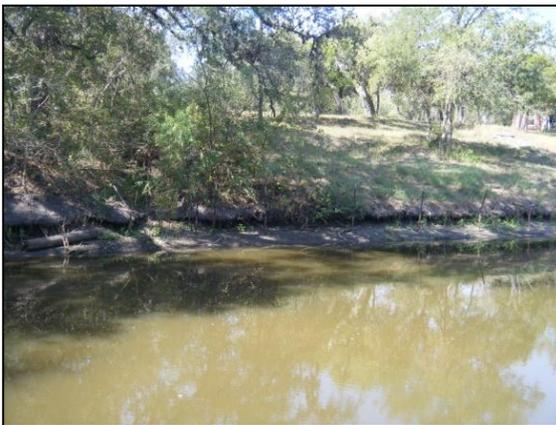
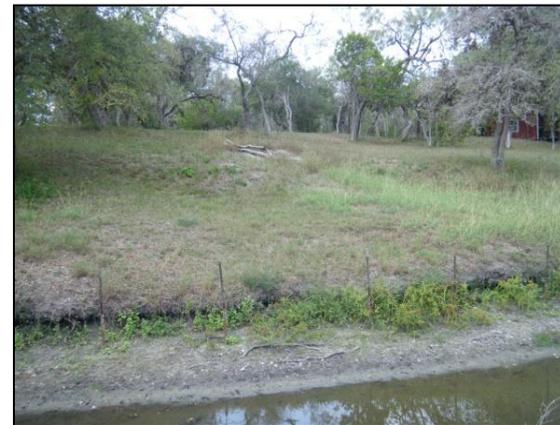
Photogroup 4-9 Aransas Creek site ACh04 depicting general appearance of the site. Top Left – 30 m transect, upstream view, August 31st, 2012; Top Right – 30 m transect, upstream view, September 28th, 2012; Middle Left – 30 m transect, downstream view, August 31st, 2012; Middle Right – 30 m transect, downstream view, September 28th, 2012; Bottom Left – 30 m transect, rightbank view, August 31st, 2012; Bottom Right – 30 m transect, rightbank view, September 28th, 2012.

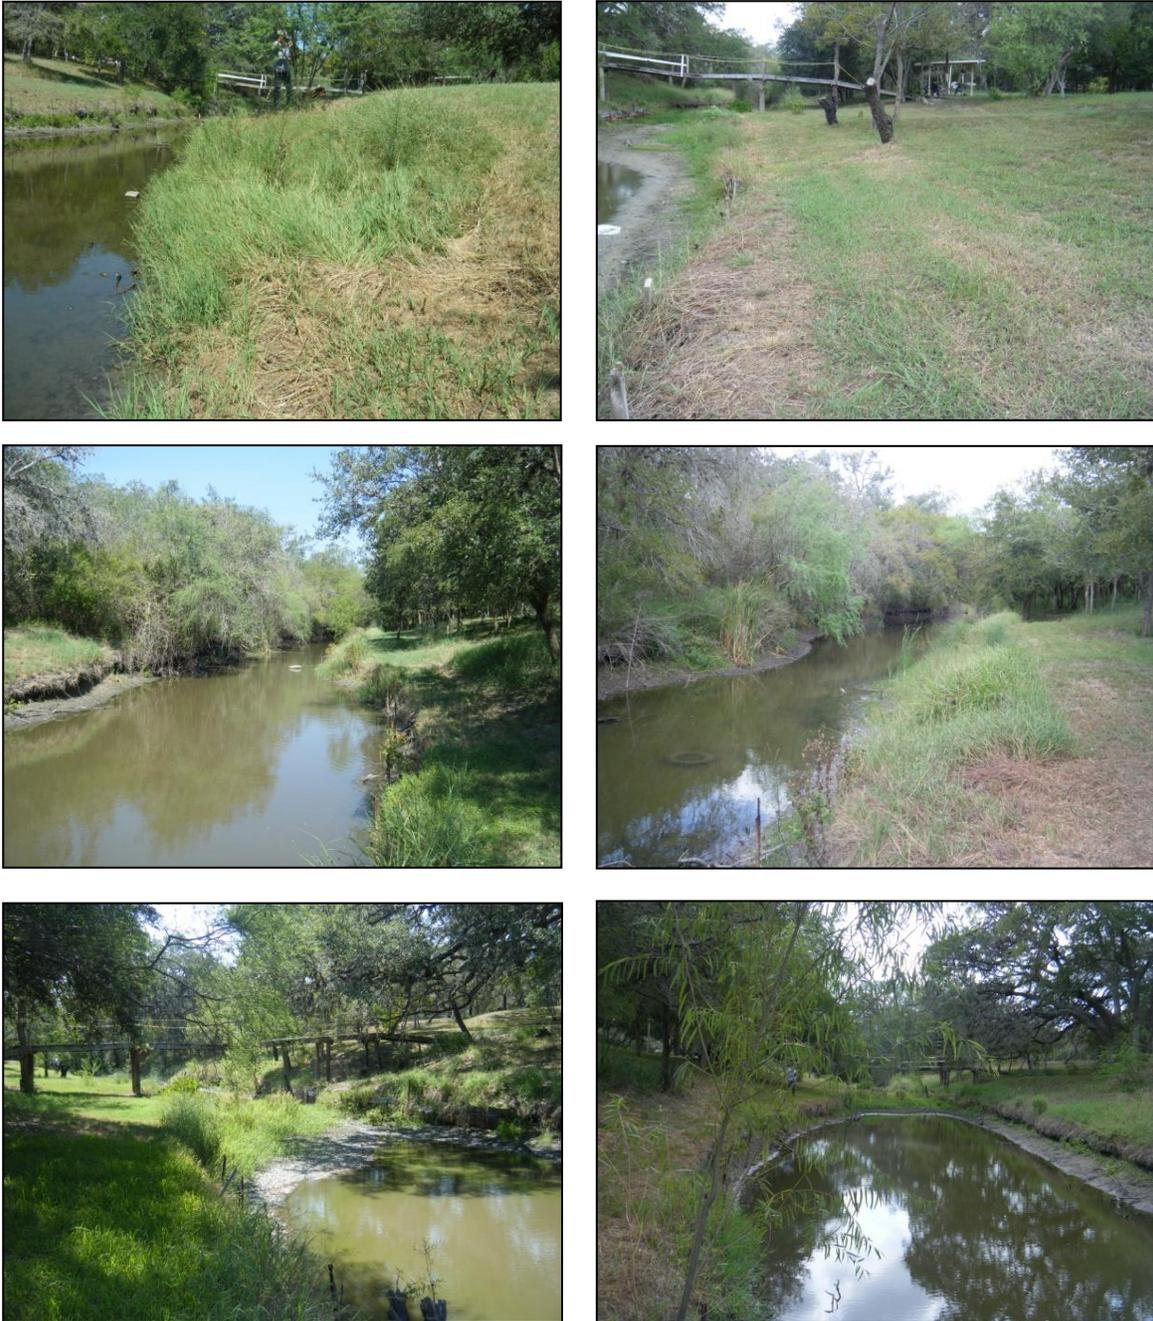
Photogroup 4-10. Aransas Creek site ACk04 depicting general appearance of the site. Top Left – 30 m transect, leftbank view, September 1st, 2012; Top Right – 30 m transect, leftbank view, September 28th 2012; Middle Left – 150 m transect, upstream view, September 1st, 2012; Middle Right – 150 m transect, upstream view, September 28th, 2012; Bottom Left – 150 m transect, downstream view, September 1st, 2012; Bottom Right – 150 m transect, downstream view, September 28th, 2012.

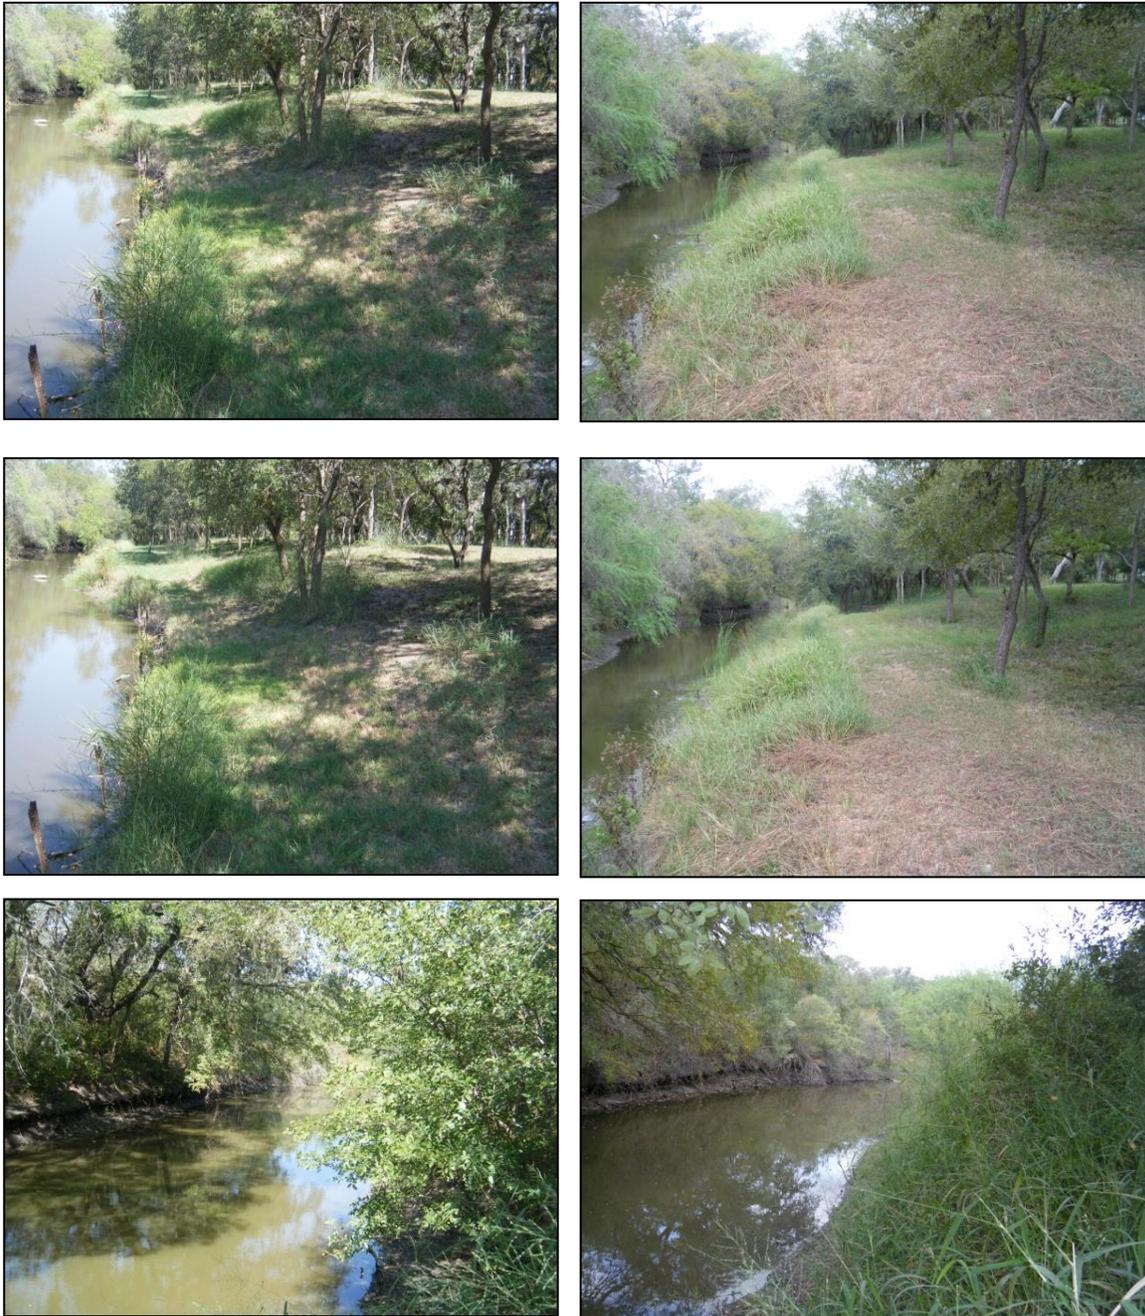
Photogroup 4-11. Aransas Creek site ACh04 depicting general appearance of the site. Top Left – 150 m transect, rightbank view, August 31st, 2012; Top Right – 150 m transect, rightbank view, September 28th, 2012; Middle Left – 150 m transect, leftbank view, August 31st, 2012; Middle Right – 150 m transect, rightbank view, September 28th, 2012; Bottom Left – 300 m transect, upstream view, August 31st, 2012; Bottom Right – 300 m transect, upstream view, September 28th, 2012.

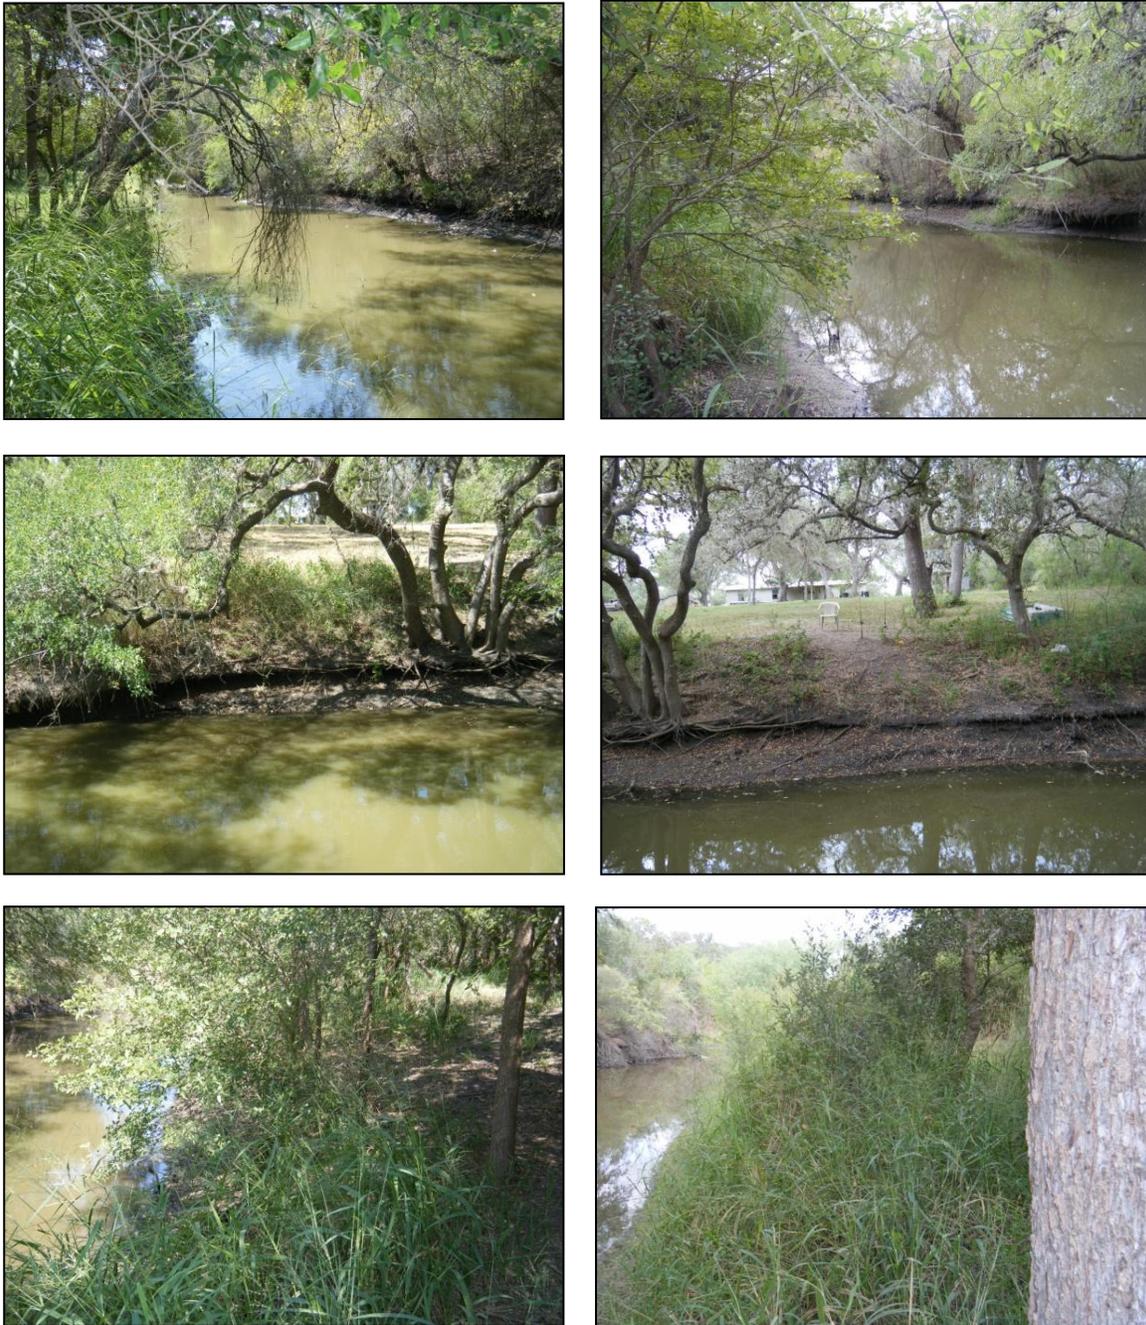
Photogroup 4-12. Aransas Creek site ACK04 depicting general appearance of the site. Top Left – 300 m transect, downstream view, August 31st, 2012; Top Right – 300 m transect, downstream view, September 28th, 2012; Middle Left – 300 m transect, rightbank view, August 31st, 2012; Middle Right – 300 m transect, rightbank view, September 28th, 2012; Bottom Left – 300 m transect, leftbank view, August 31st, 2012; Bottom Right – 300 m transect, leftbank view, September 28th, 2012.
