**Aransas Creek
Recreational Use Attainability Analysis**

**Texas State Soil and Water Conservation Board
Project 11-52**

**Nueces River Authority – Coastal Bend Division
Corpus Christi, Texas**

May 2013

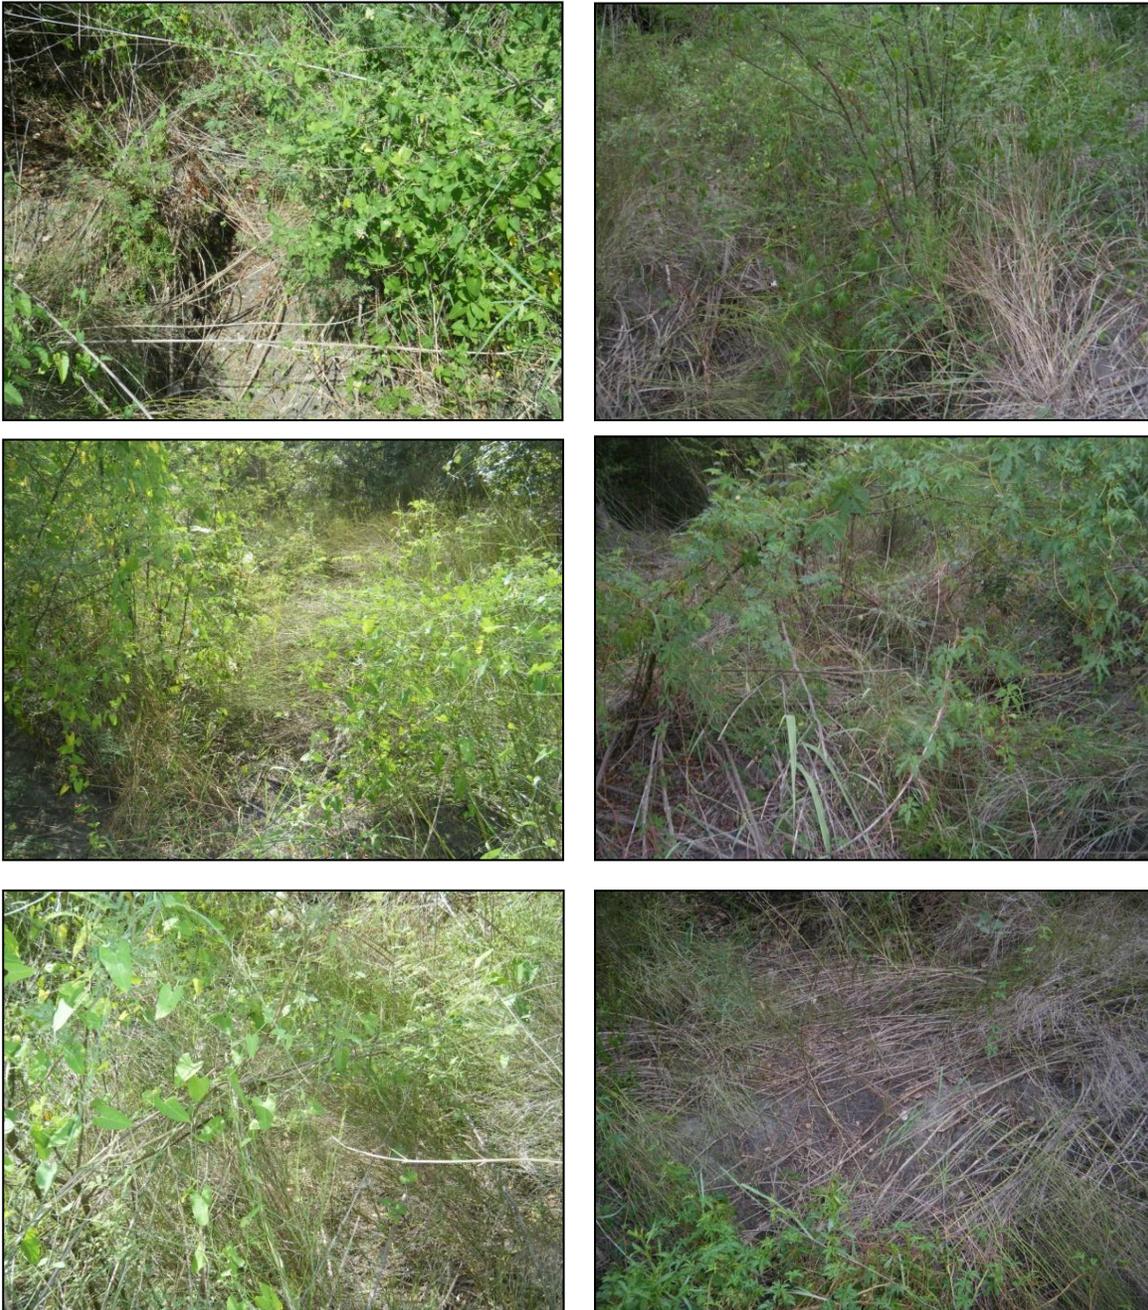
Photogroup 4-13. Aransas Creek site ACk05 depicting general appearance of the site. Top Left – 30 m transect, upstream view, September 1st, 2012; Top Right – 30 m transect, upstream view, September 28th, 2012; Middle Left – 30 m transect, downstream view, September 1st, 2012; Middle Right – 30 m transect, downstream view, September 28th, 2012; Bottom Left – 30 m transect, rightbank view, September 1st, 2012; Bottom Right – 30 m transect, rightbank view, September 28th, 2012

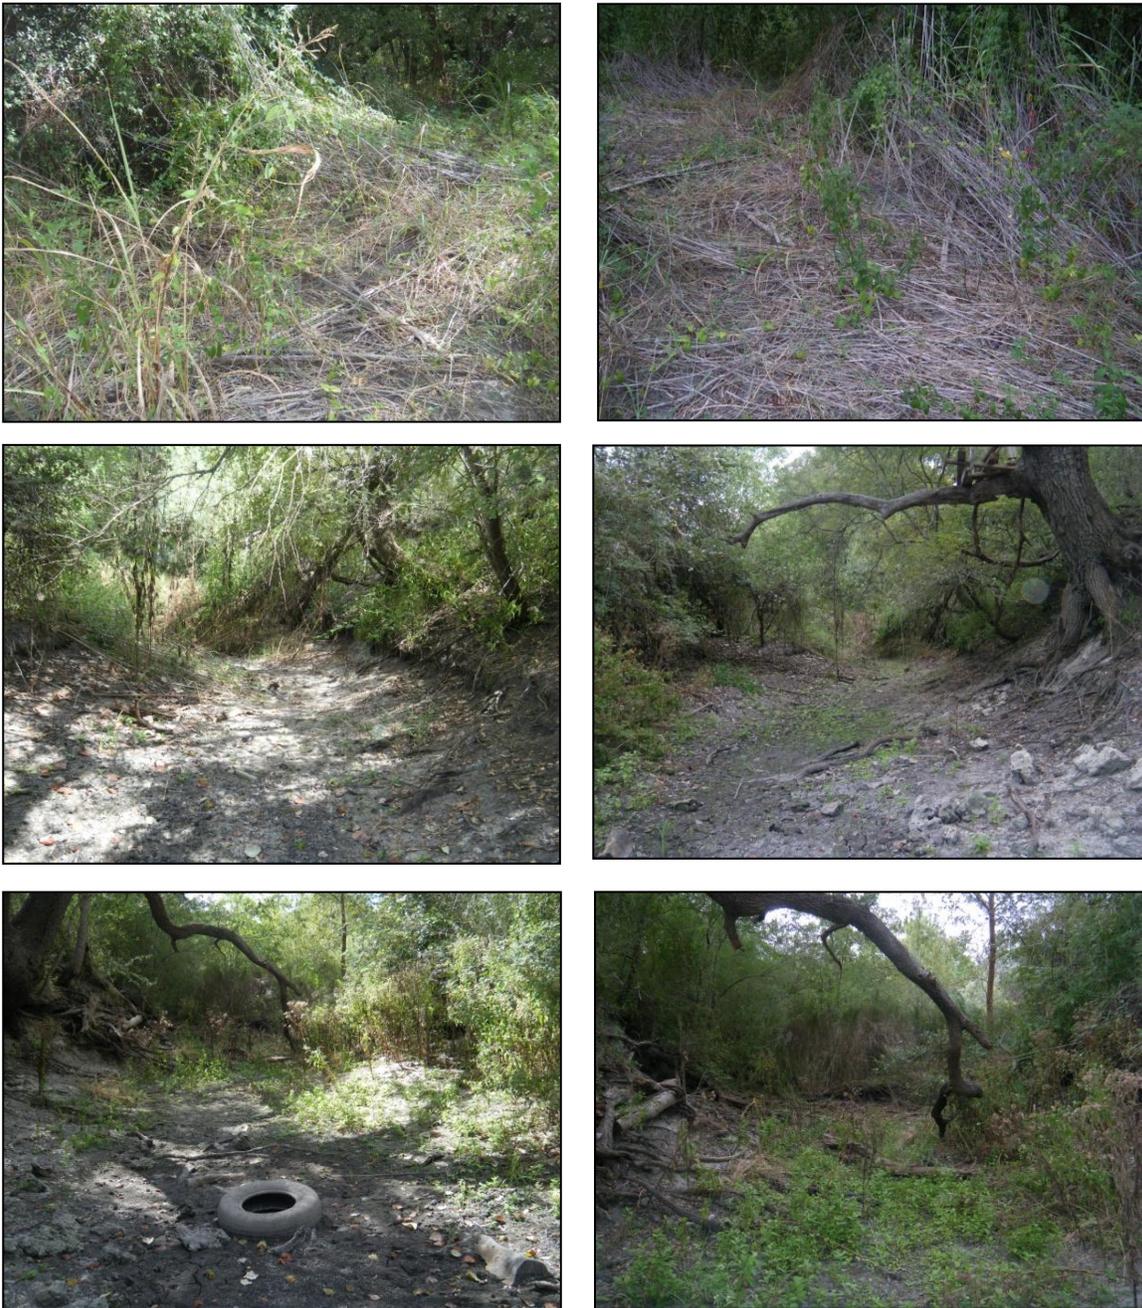
Photogroup 4-14. Aransas Creek site ACk05 depicting general appearance of the site. Top Left – 30 m transect, leftbank view, September 1st, 2012; Top Right – 30 m transect, leftbank view, September 28th, 2012; Middle Left – 150 m transect, upstream view, September 1st, 2012; Middle Right – 150 m transect, upstream view, September 28th, 2012; Bottom Left – 150 m transect, downstream view, September 1st, 2012; Bottom Right – 150 m transect, downstream view, September 28th, 2012.

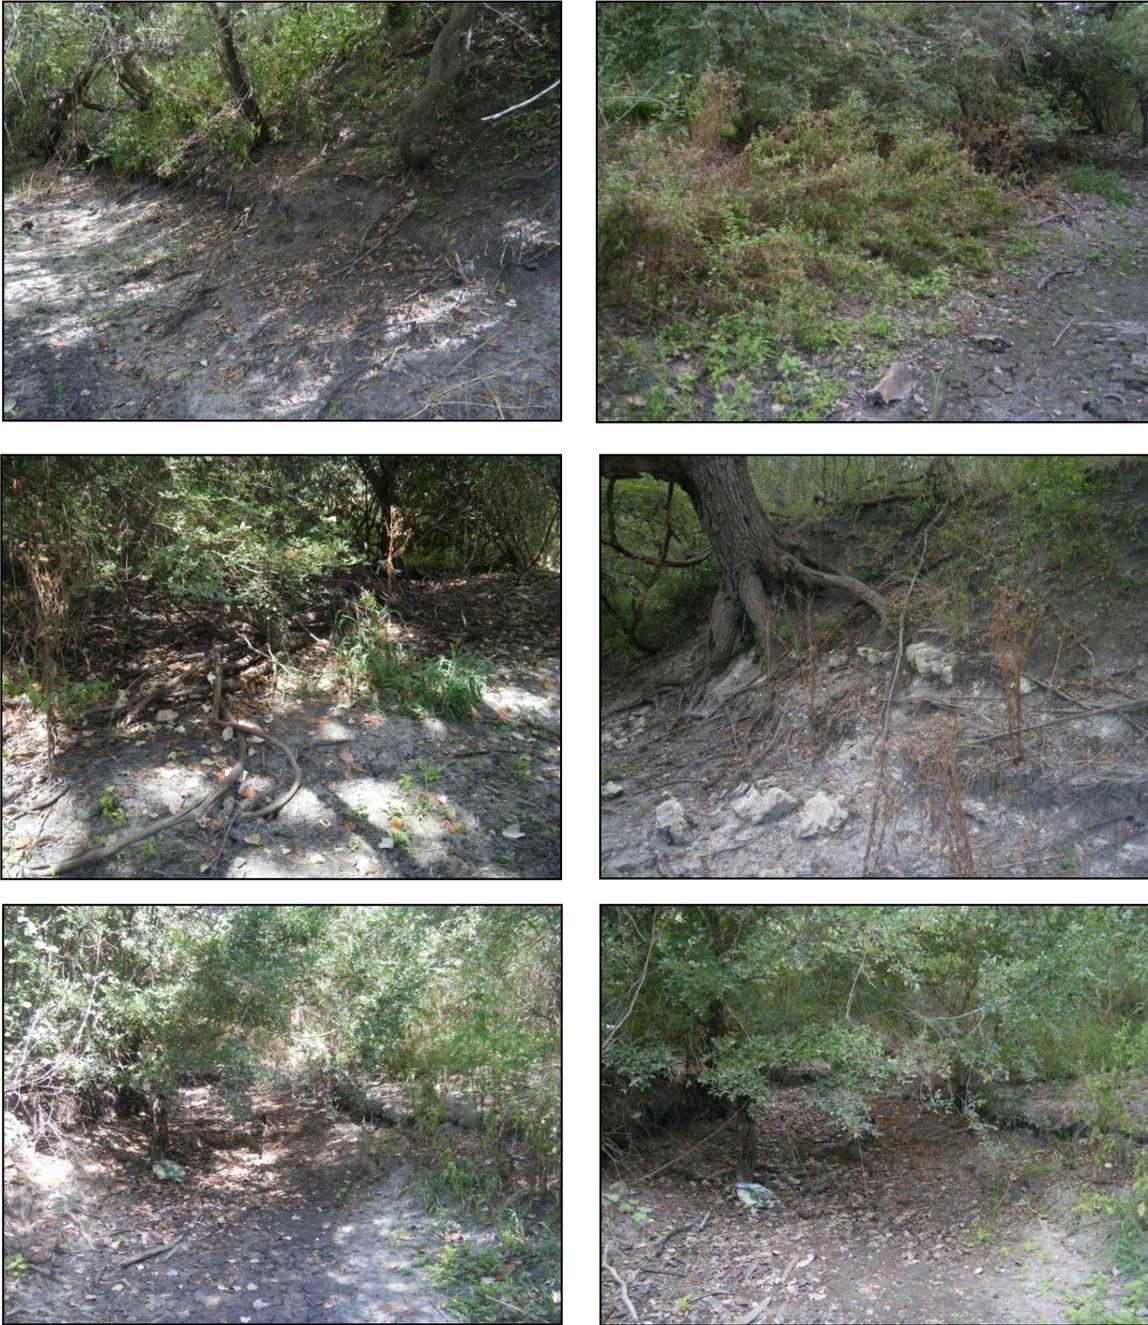
Photogroup 4-15. Aransas Creek site ACh05 depicting general appearance of the site. Top Left – 150 m transect, rightbank view, September 1st, 2012; Top Right – 150 m transect, rightbank view, September 28th, 2012; Middle Left – 150 m transect, leftbank view, September 1st, 2012; Middle Right – 150 m transect, rightbank view, September 28th, 2012; Bottom Left – 300 m transect, upstream view, September 1st, 2012; Bottom Right – 300 m transect, upstream view, September 28th, 2012.

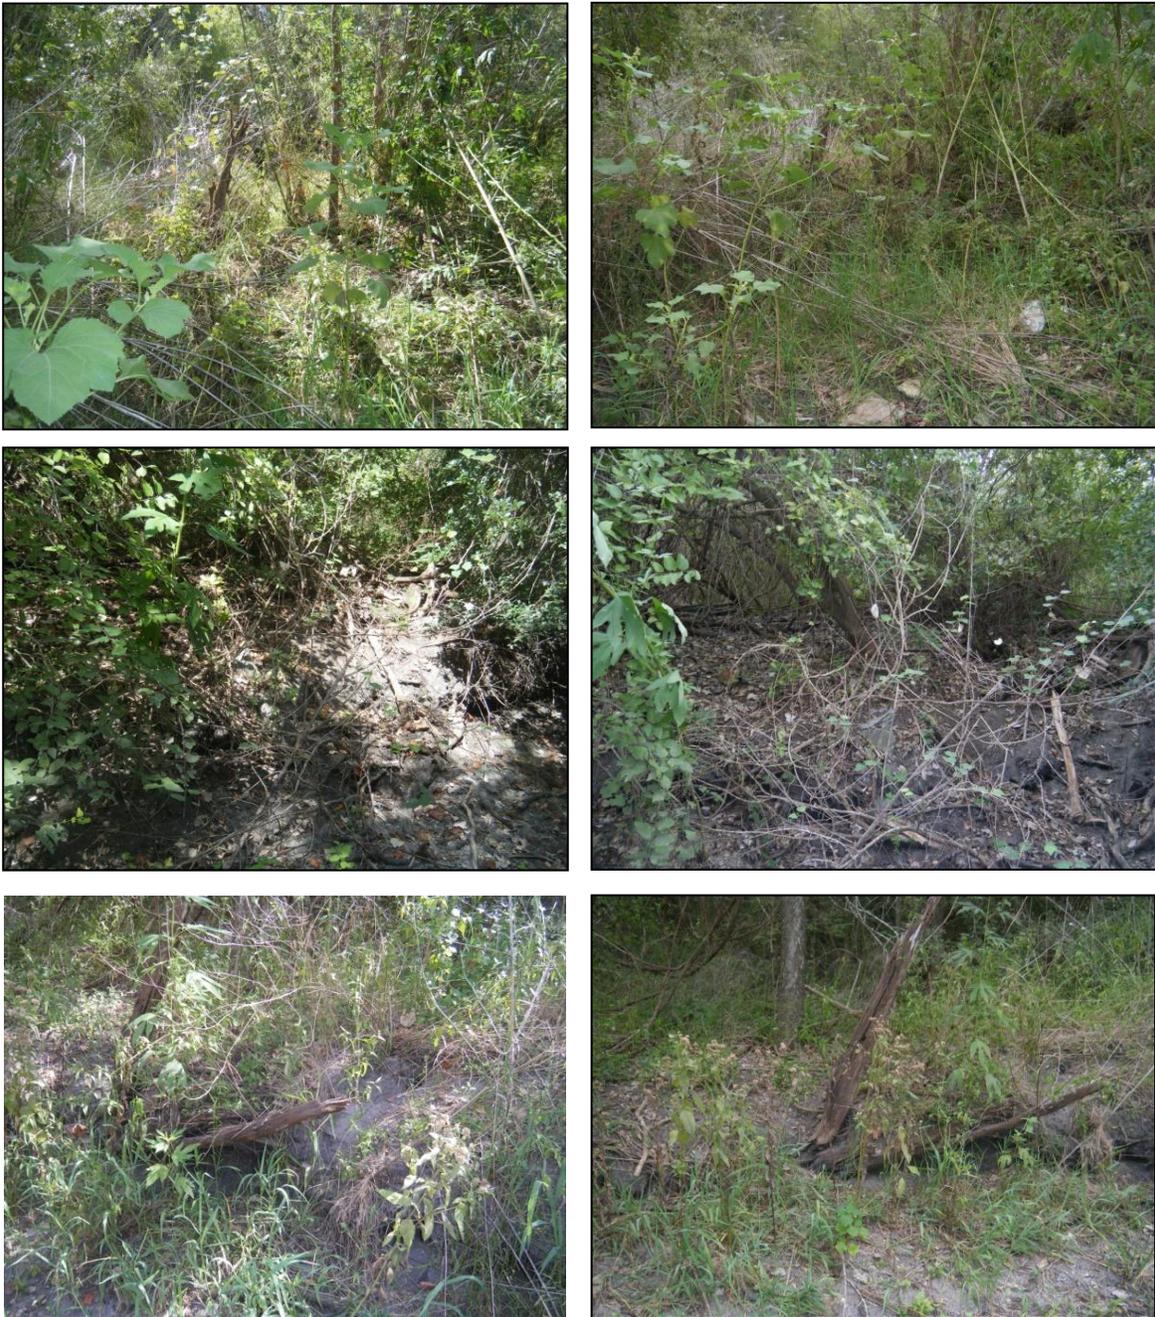
Photogroup 4-16. Aransas Creek site ACh05 depicting general appearance of the site. Top Left – 300 m transect, downstream view, September 1st, 2012; Top Right – 300 m transect, downstream view, September 28th, 2012; Middle Left – 300 m transect, rightbank view, September 1st, 2012; Middle Right – 300 m transect, rightbank view, September 28th, 2012; Bottom Left – 300 m transect, leftbank view, September 1st, 2012; Bottom Right – 300 m transect, leftbank view, September 28th, 2012.

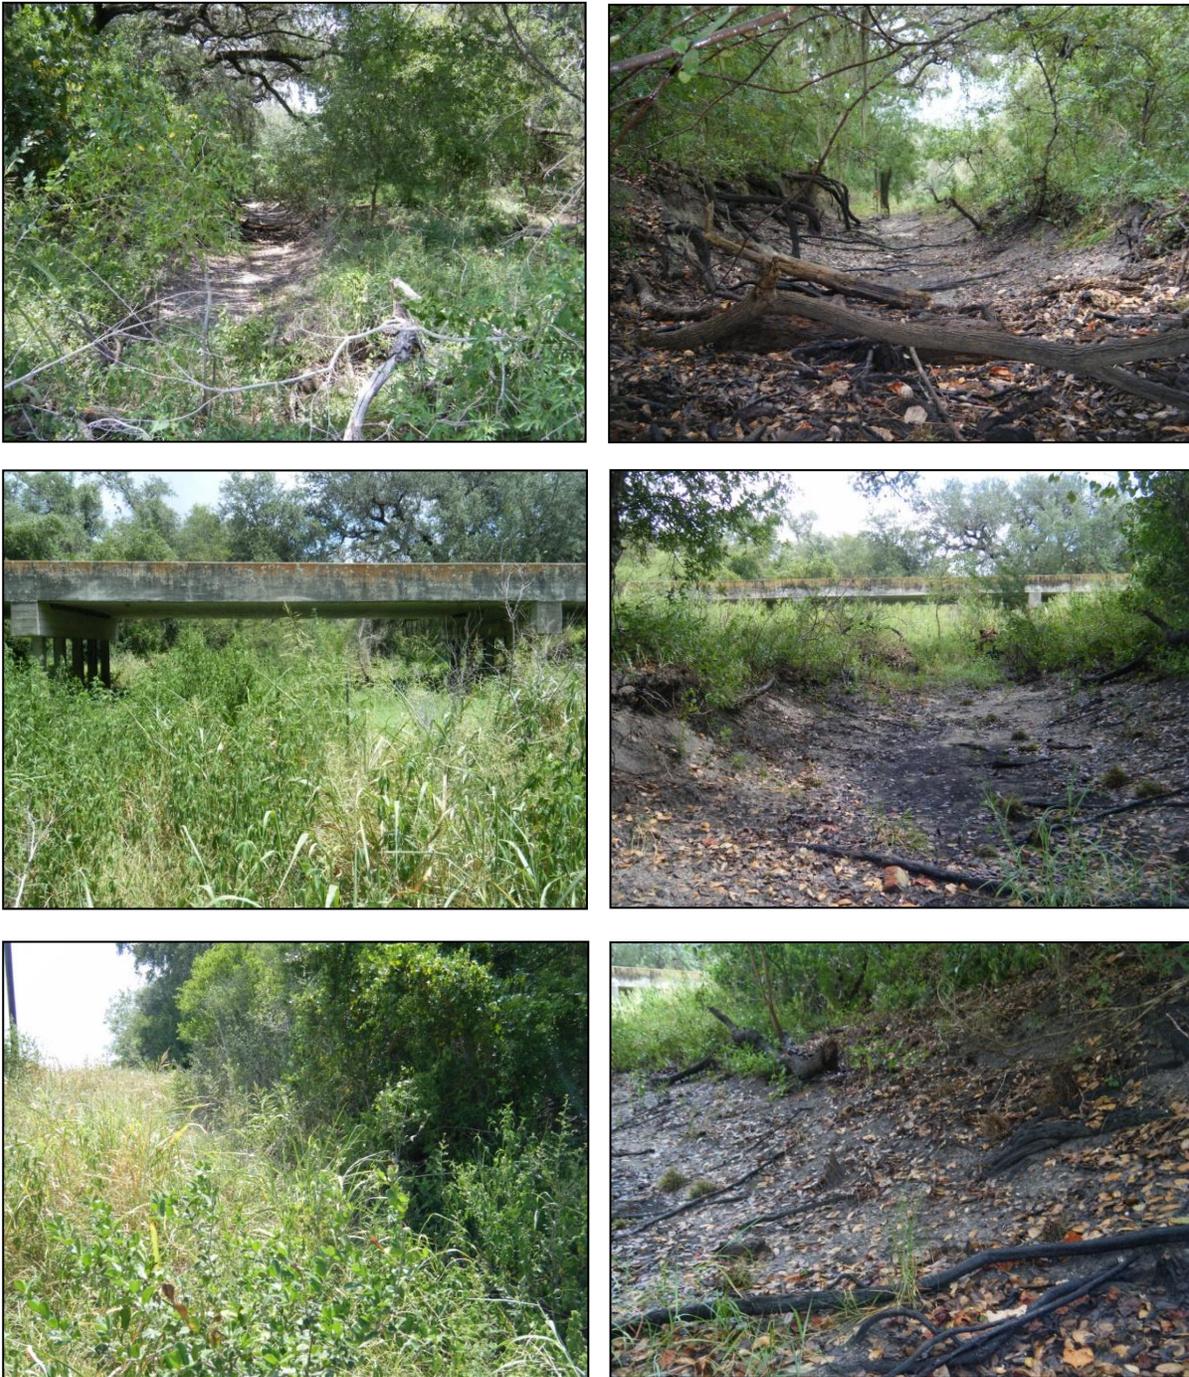
Photogroup 4-17. Aransas Creek site ACk06 depicting general appearance of the site. Top Left – 30 m transect, upstream view, August 31st, 2012; Top Right – 30 m transect, upstream view, September 28th, 2012; Middle Left – 30 m transect, downstream view, August 31st, 2012; Middle Right – 30 m transect, downstream view, September 28th, 2012; Bottom Left – 30 m transect, rightbank view, August 31st, 2012; Bottom Right – 30 m transect, rightbank view, September 28th, 2012.

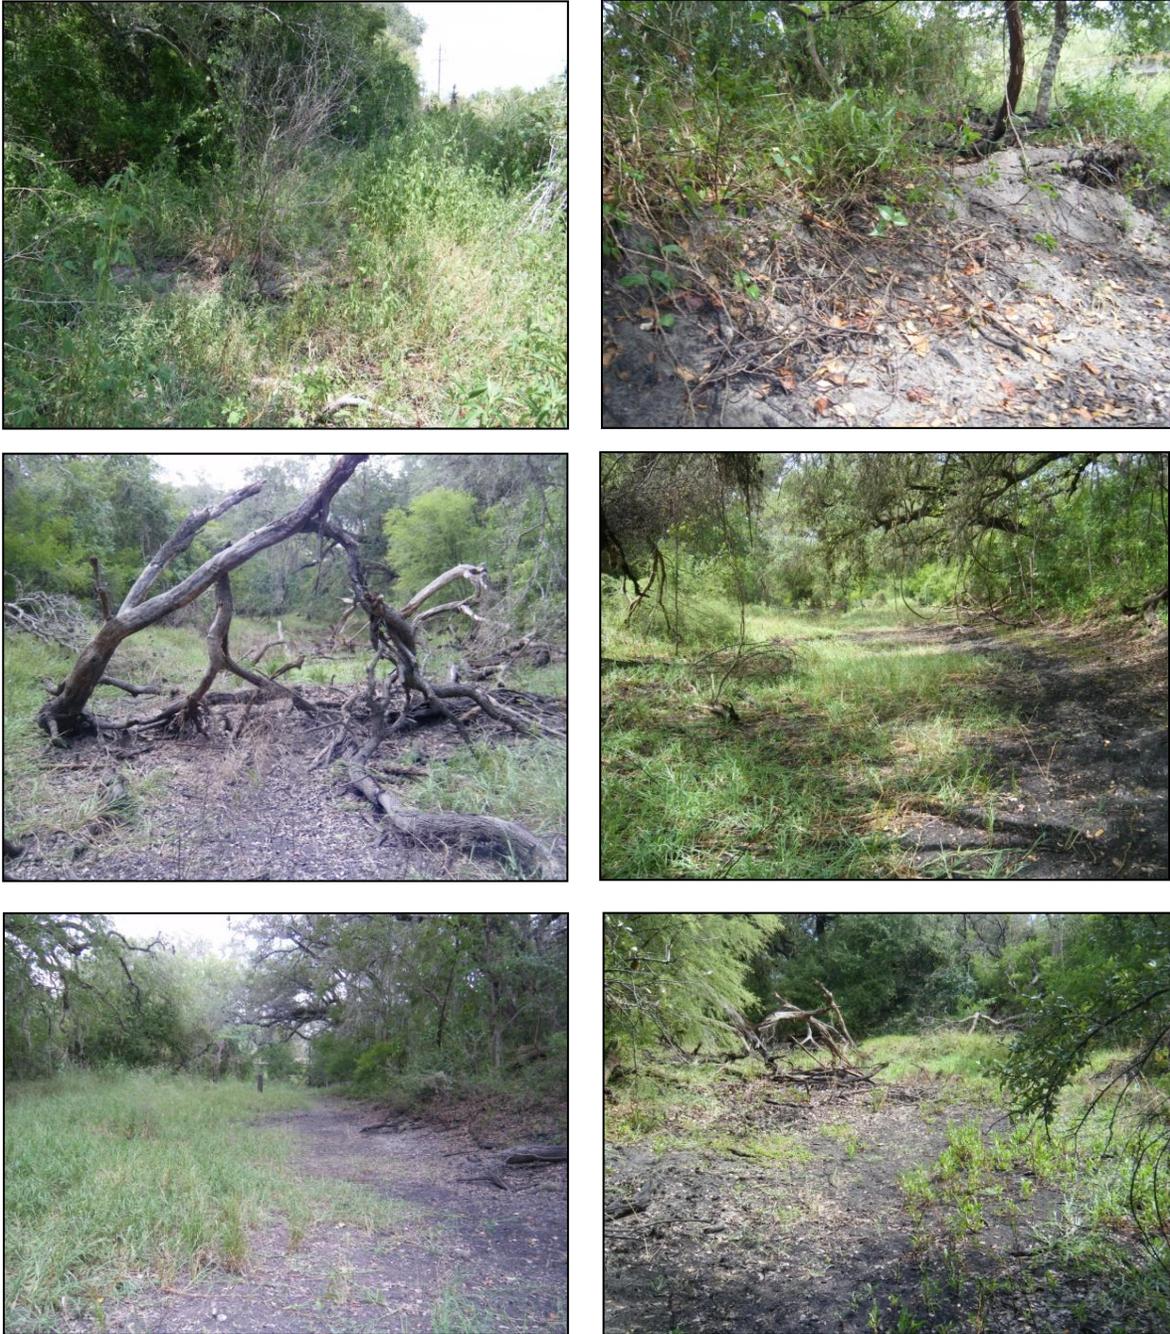
Photogroup 4-18. Aransas Creek site ACk06 depicting general appearance of the site. Top Left – 30 m transect, leftbank view, August 31st, 2012; Top Right – 30 m transect, leftbank view, September 28th, 2012; Middle Left – 150 m transect, upstream view, August 31st, 2012; Middle Right – 150 m transect, upstream view, September 28th, 2012; Bottom Left – 150 m transect, downstream view, August 31st, 2012; Bottom Right – 150 m transect, downstream view, September 28th, 2012.

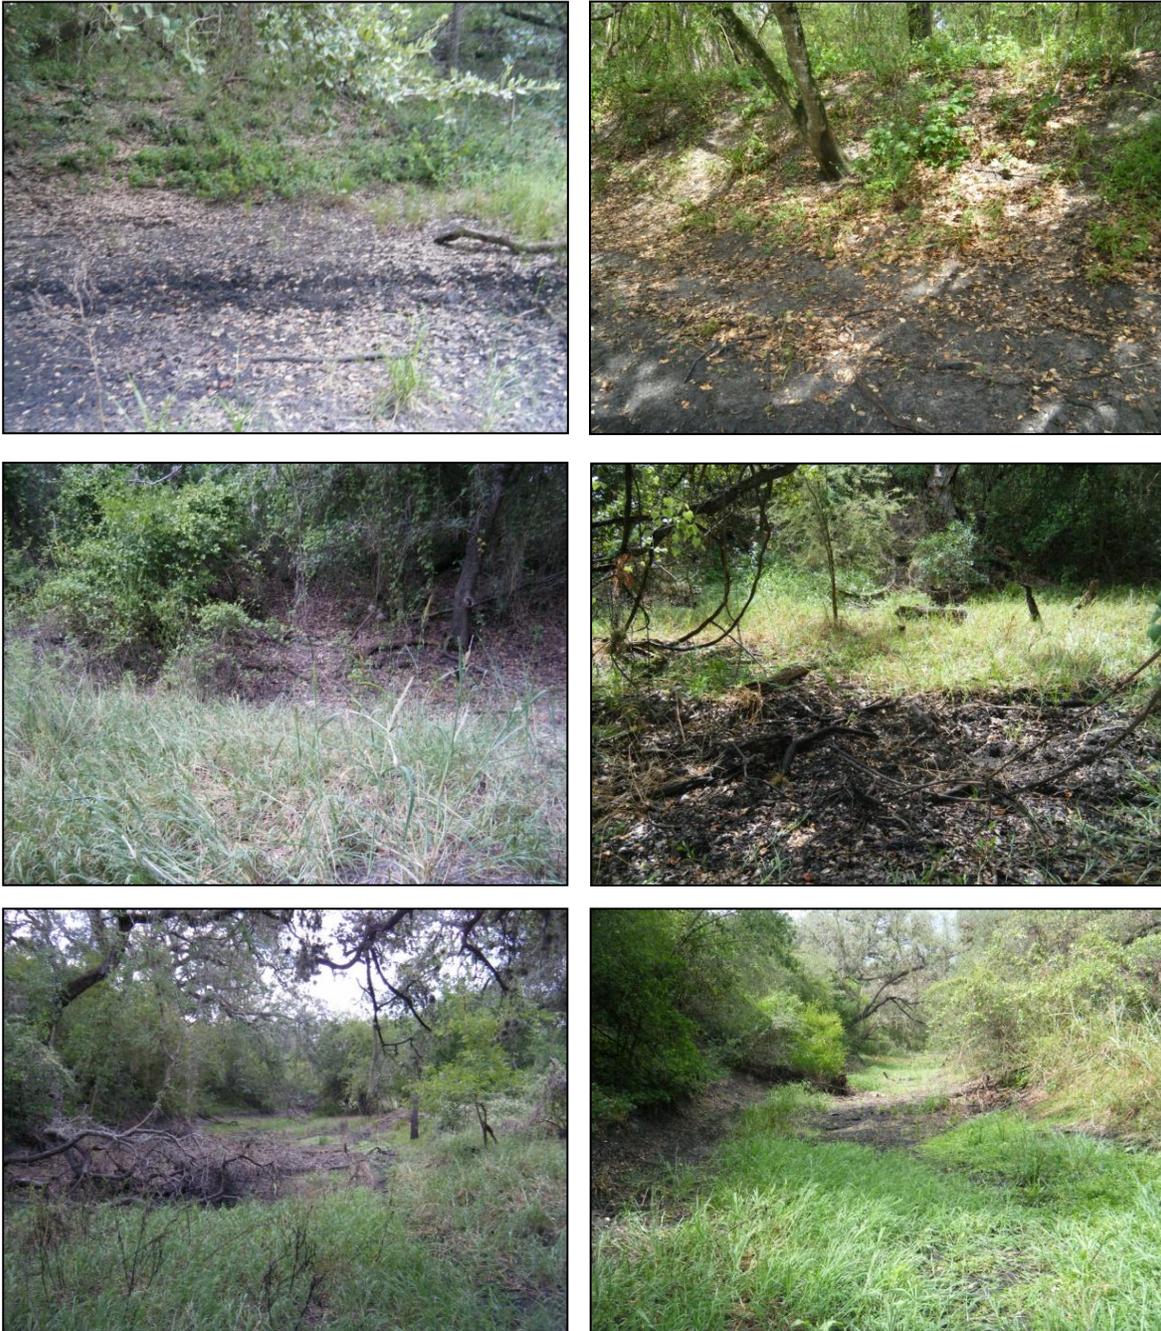
Photogroup 4-19. Aransas Creek site ACk06 depicting general appearance of the site. Top Left – 150 m transect, rightbank view, August 31st, 2012; Top Right – 150 m transect, rightbank view, September 28th, 2012; Middle Left – 150 m transect, leftbank view, August 31st, 2012; Middle Right – 150 m transect, rightbank view, September 28th, 2012; Bottom Left – 300 m transect, upstream view, August 31st, 2012; Bottom Right – 300 m transect, upstream view, September 28th, 2012.

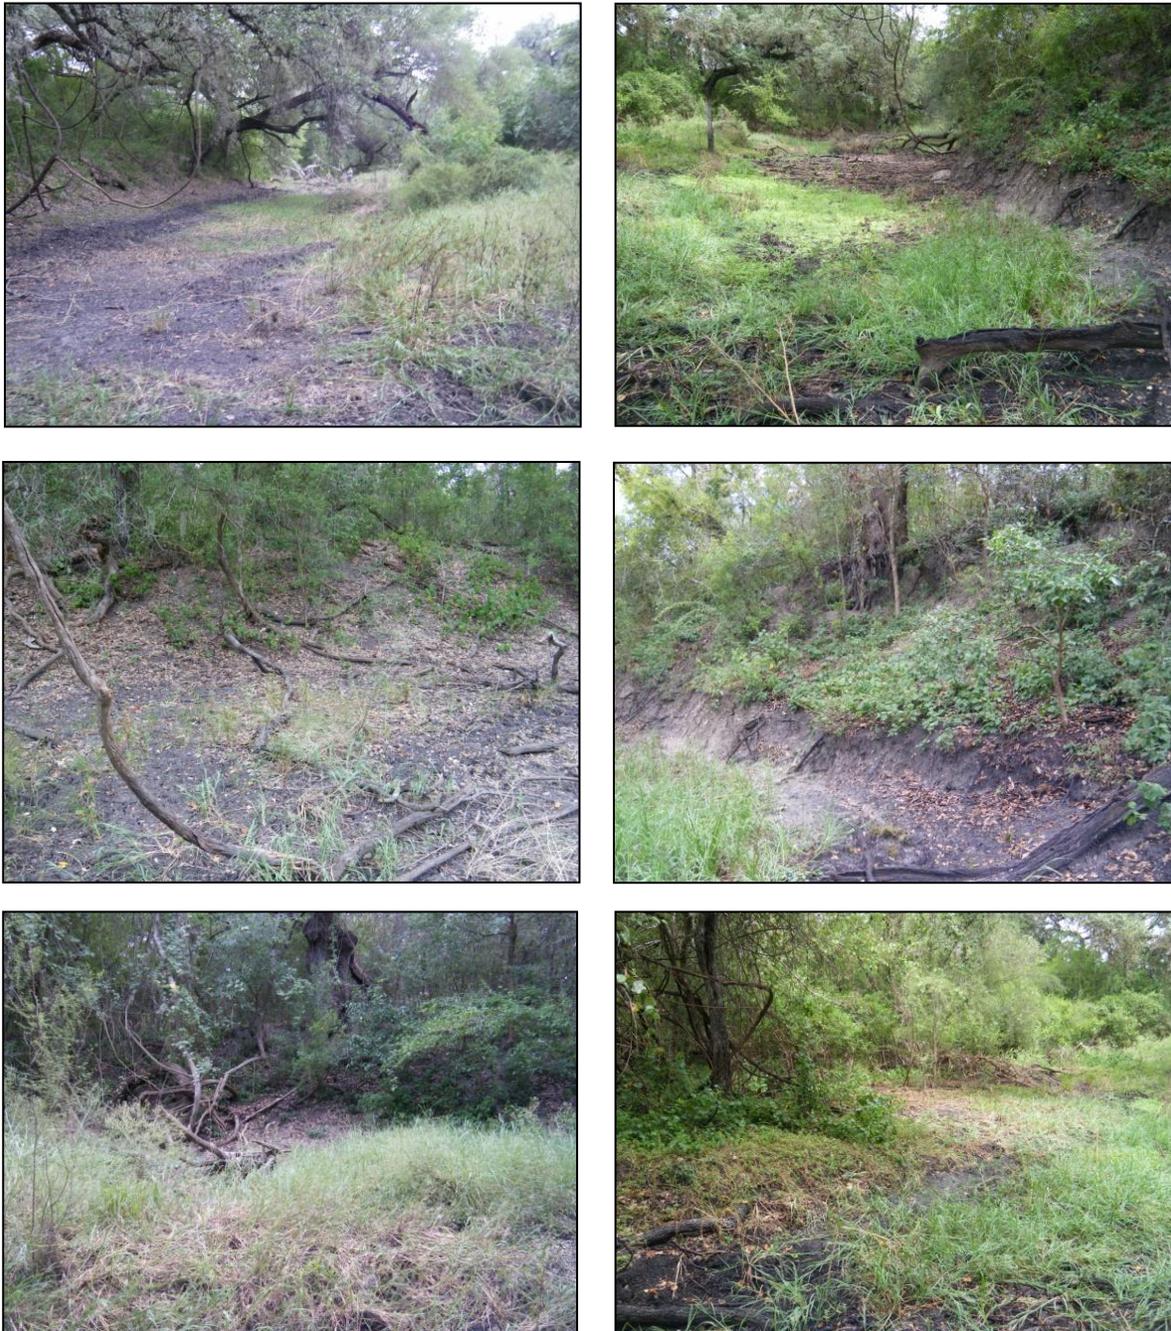
Photogroup 4-20. Aransas Creek site ACl06 depicting general appearance of the site. Top Left – 300 m transect, downstream view, August 31st, 2012; Top Right – 300 m transect, downstream view, September 28th, 2012; Middle Left – 300 m transect, rightbank view, August 31st, 2012; Middle Right – 300 m transect, rightbank view, September 28th, 2012; Bottom Left – 300 m transect, leftbank view, August 31st, 2012; Bottom Right – 300 m transect, leftbank view, September 28th, 2012.

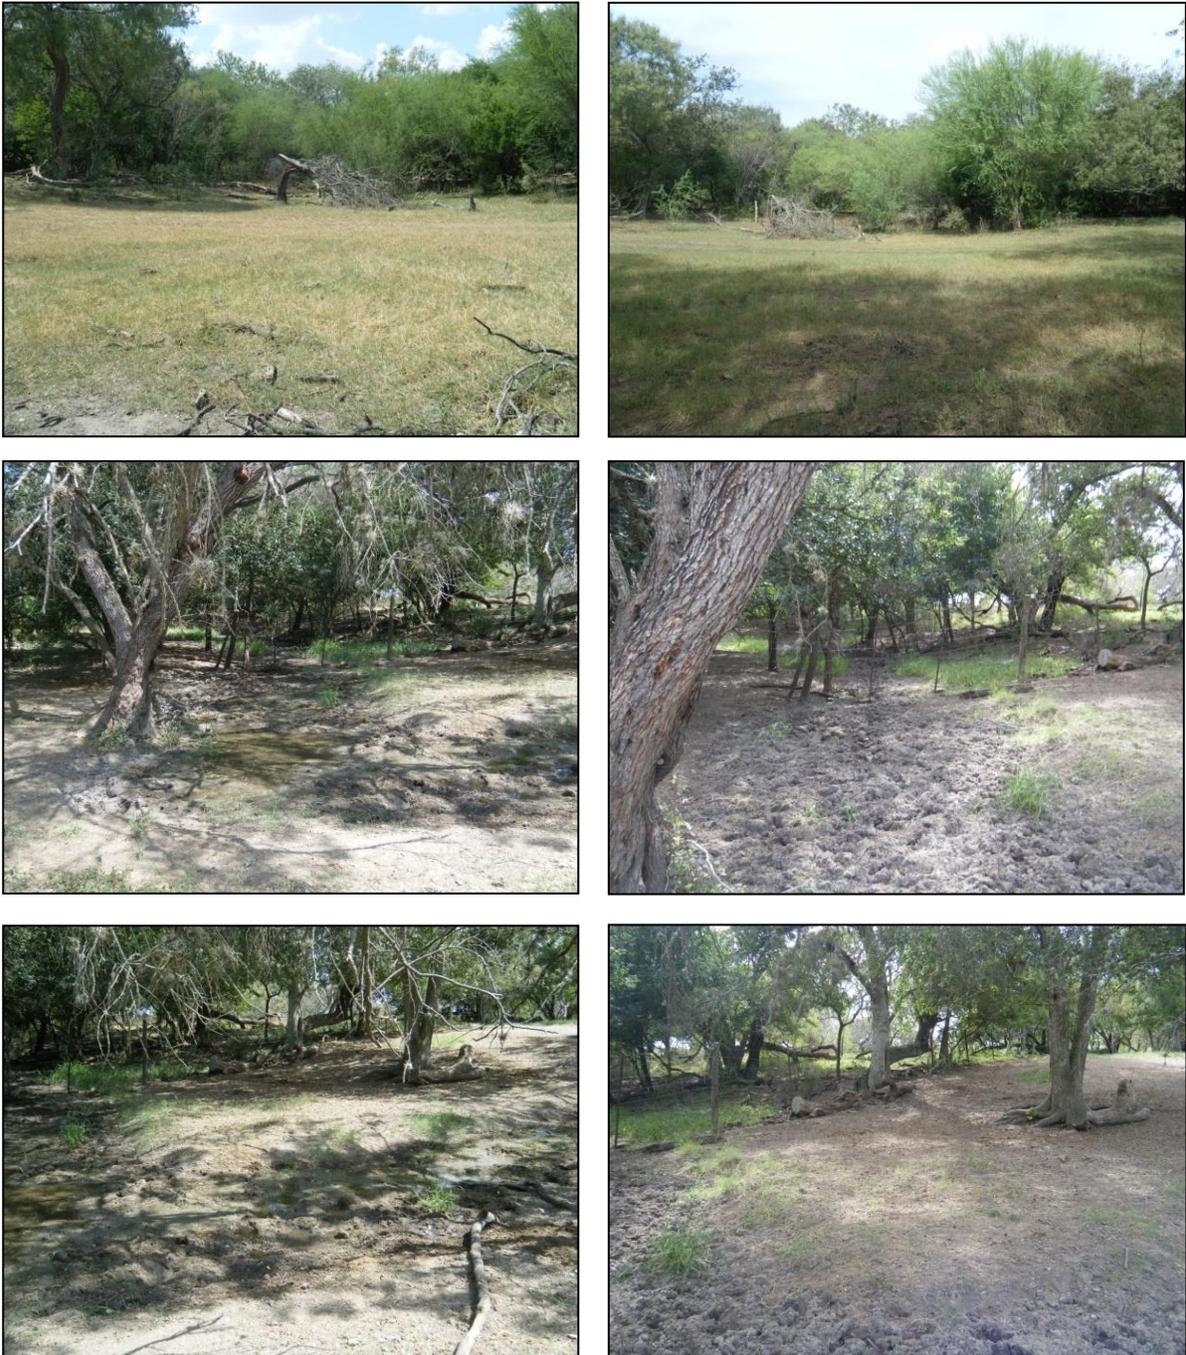
Photogroup 4-21. Aransas Creek site ACk07 depicting general appearance of the site. Top Left – 30 m transect, upstream view, August 31st, 2012; Top Right – 30 m transect, upstream view, September 28th, 2012; Middle Left – 30 m transect, downstream view, August 31st, 2012; Middle Right – 30 m transect, downstream view, September 28th, 2012; Bottom Left – 30 m transect, rightbank view, August 31st, 2012; Bottom Right – 30 m transect, rightbank view, September 28th, 2012.

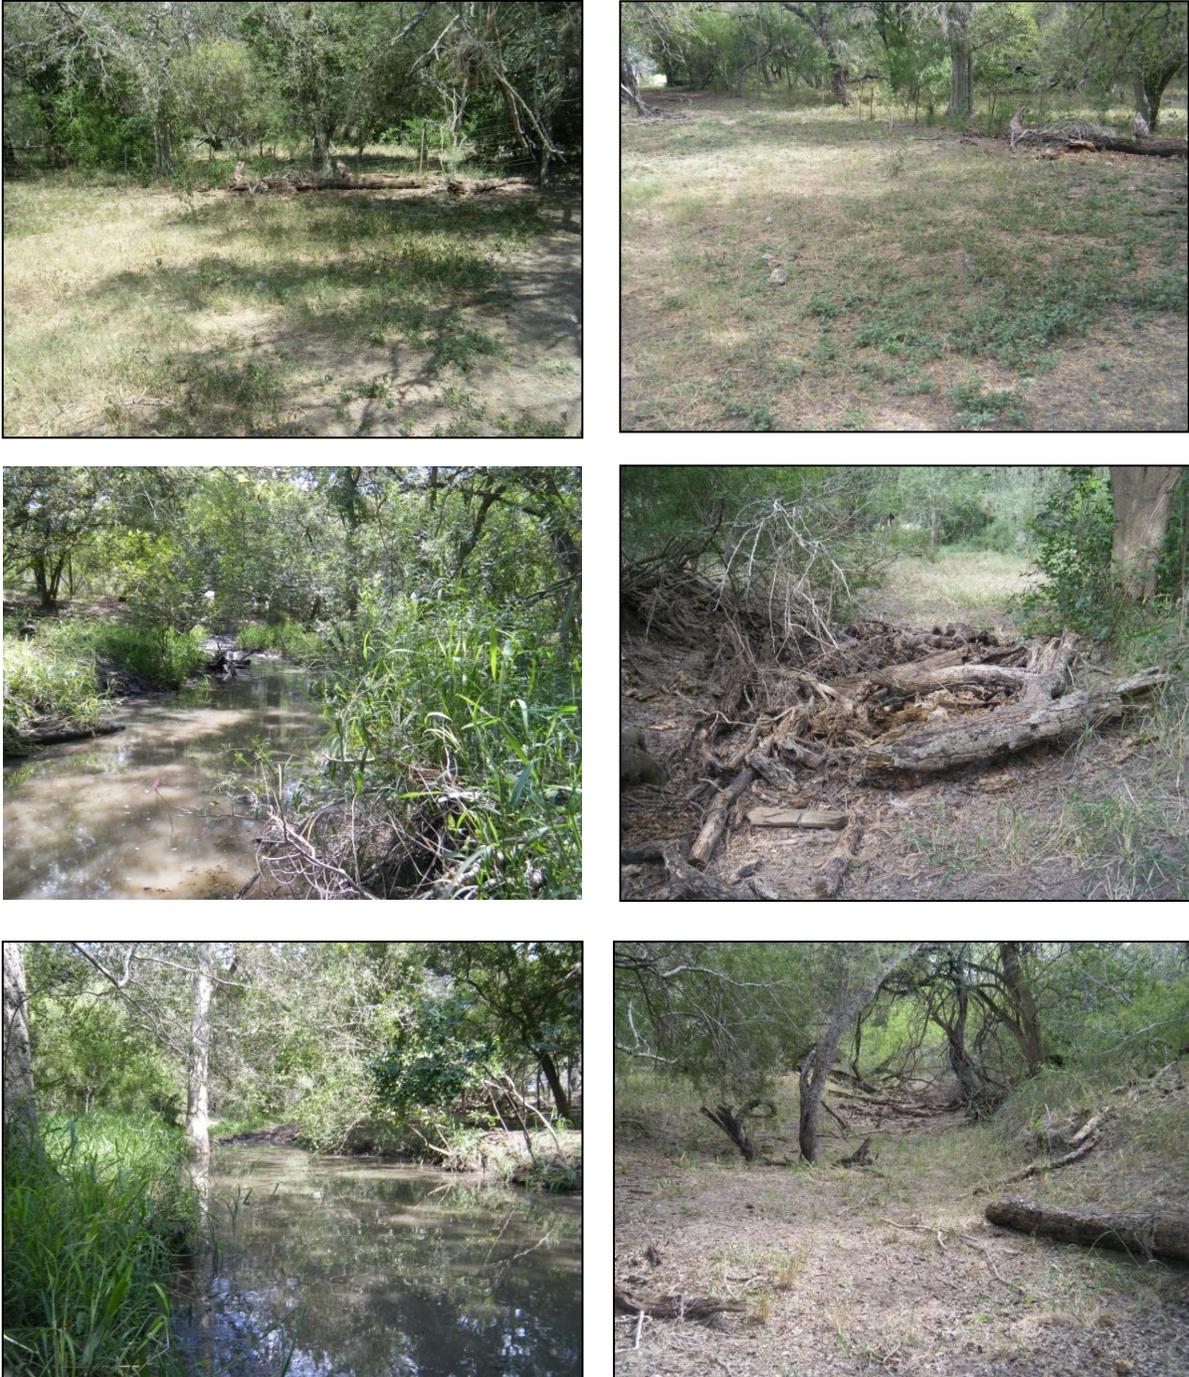
Photogroup 4-22. Aransas Creek site ACk07 depicting general appearance of the site. Top Left – 30 m transect, leftbank view, August 31st, 2012; Top Right – 30 m transect, leftbank view, September 28th, 2012; Middle Left – 150 m transect, upstream view, August 31st, 2012; Middle Right – 150 m transect, upstream view, September 28th, 2012; Bottom Left – 150 m transect, downstream view, August 31st, 2012; Bottom Right – 150 m transect, downstream view, September 28th, 2012.

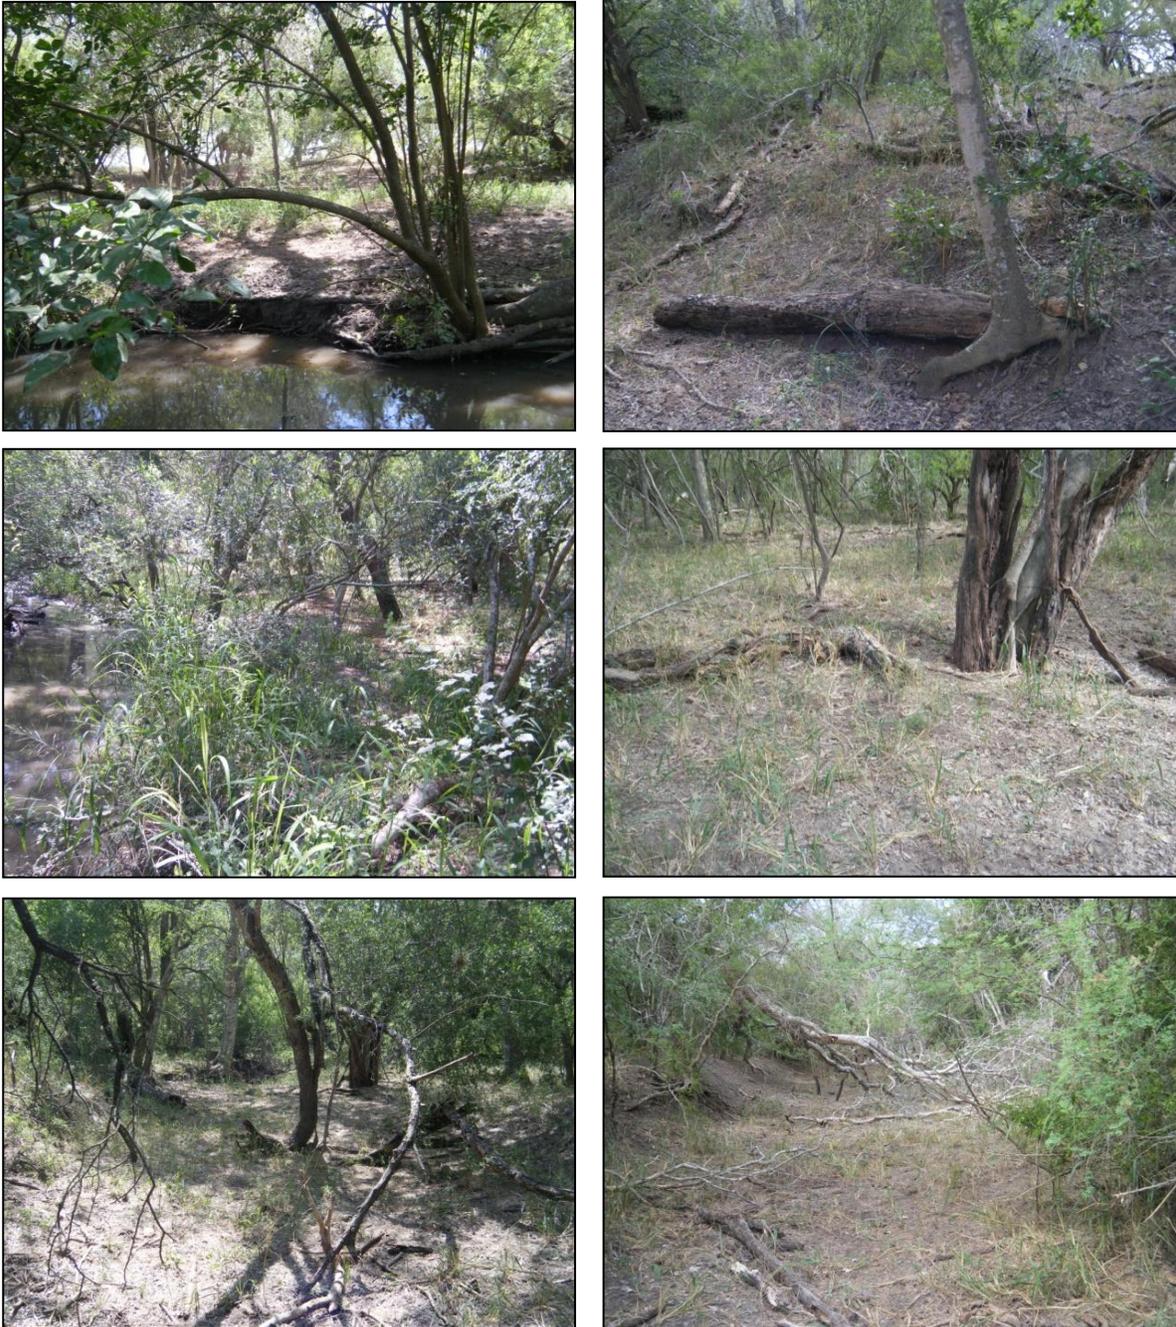
Photogroup 4-23. Aransas Creek site ACk07 depicting general appearance of the site. Top Left – 150 m transect, rightbank view, August 31st, 2012; Top Right – 150 m transect, rightbank view, September 28th, 2012; Middle Left – 150 m transect, leftbank view, August 31st, 2012; Middle Right – 150 m transect, rightbank view, September 28th, 2012; Bottom Left – 300 m transect, upstream view, August 31st, 2012; Bottom Right – 300 m transect, upstream view, September 28th, 2012.

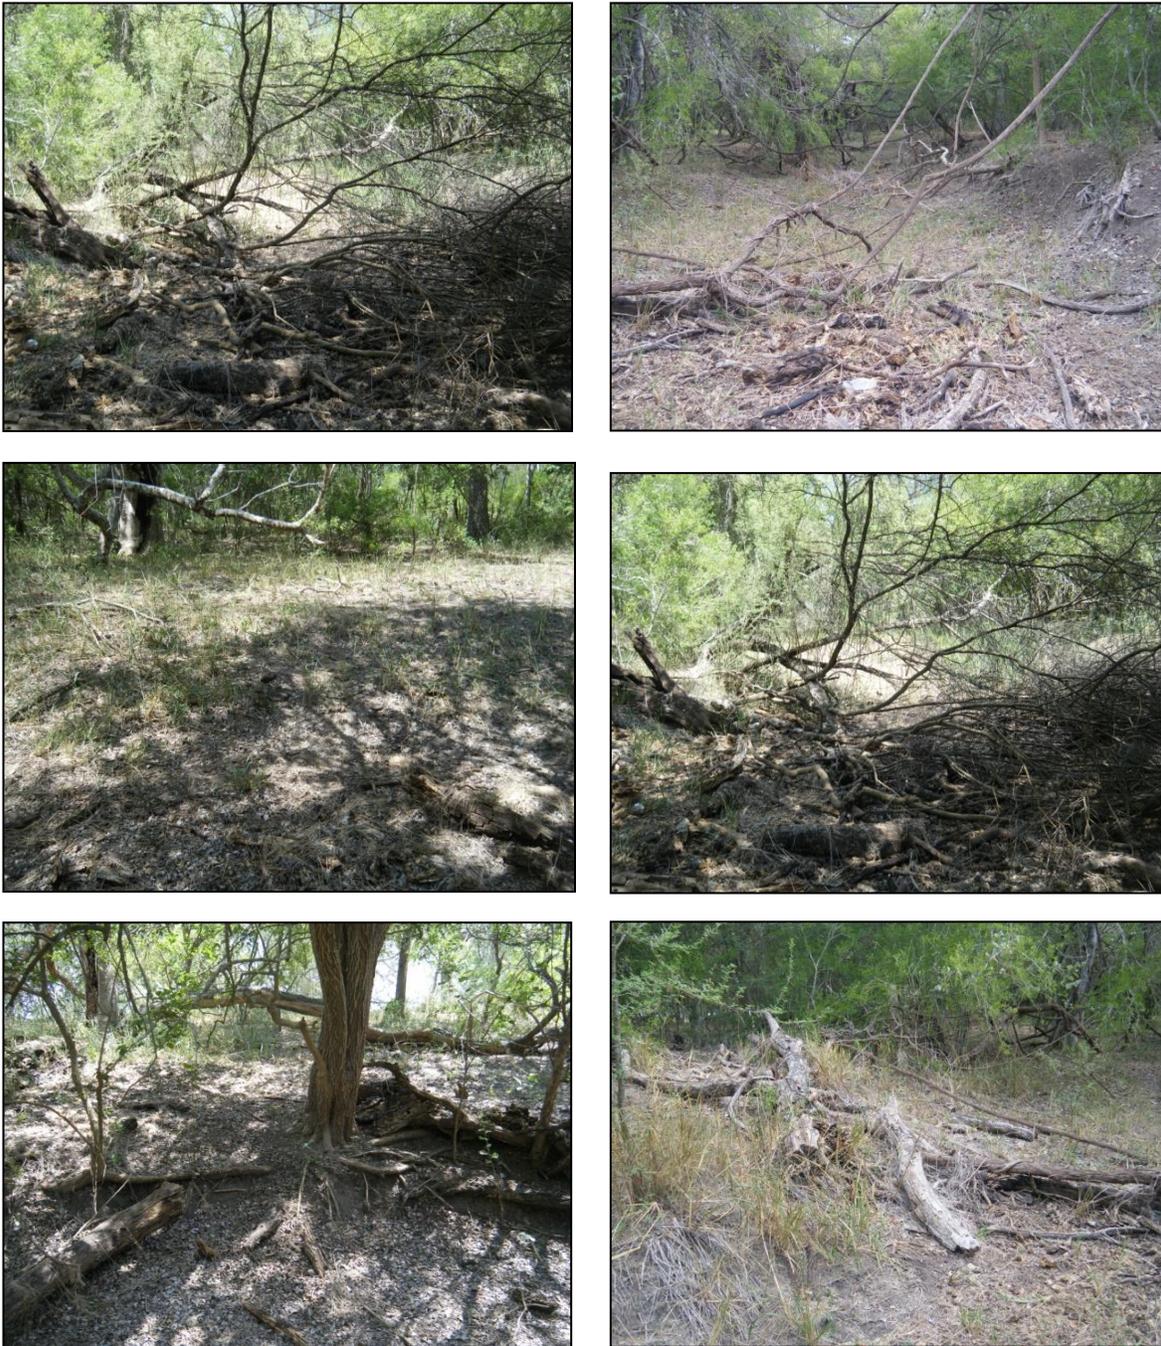
Photogroup 4-24 Aransas Creek site ACh07 depicting general appearance of the site. Top Left – 300 m transect, downstream view, August 31st, 2012; Top Right – 300 m transect, downstream view, September 28th, 2012; Middle Left – 300 m transect, rightbank view, August 31st, 2012; Middle Right – 300 m transect, rightbank view, September 28th, 2012; Bottom Left – 300 m transect, leftbank view, August 31st, 2012; Bottom Right – 300 m transect, leftbank view, September 28th, 2012.

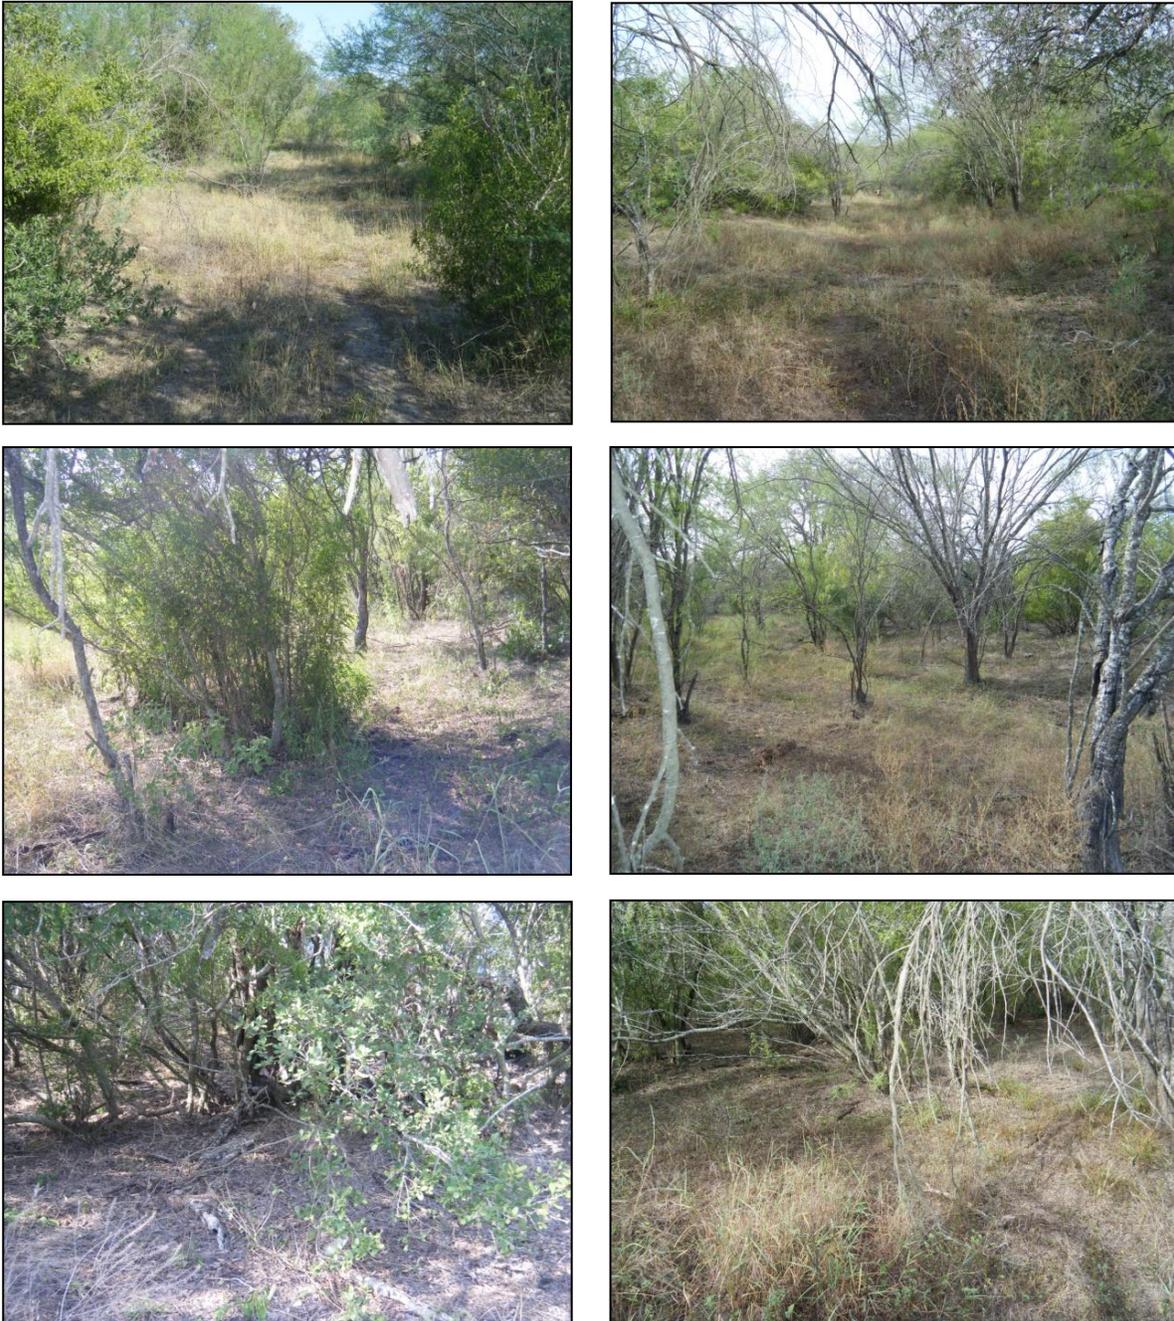
Photogroup 4-25. Aransas Creek site ACK08B depicting general appearance of the site. Top Left – 30 m transect, upstream view, August 31st, 2012; Top Right – 30 m transect, upstream view, September 28th, 2012; Middle Left – 30 m transect, downstream view, August 31st, 2012; Middle Right – 30 m transect, downstream view, September 28th, 2012; Bottom Left – 30 m transect, rightbank view, August 31st, 2012; Bottom Right – 30 m transect, rightbank view, September 28th, 2012.
