**Aransas Creek
Recreational Use Attainability Analysis**

**Texas State Soil and Water Conservation Board
Project 11-52**

**Nueces River Authority – Coastal Bend Division
Corpus Christi, Texas**

May 2013

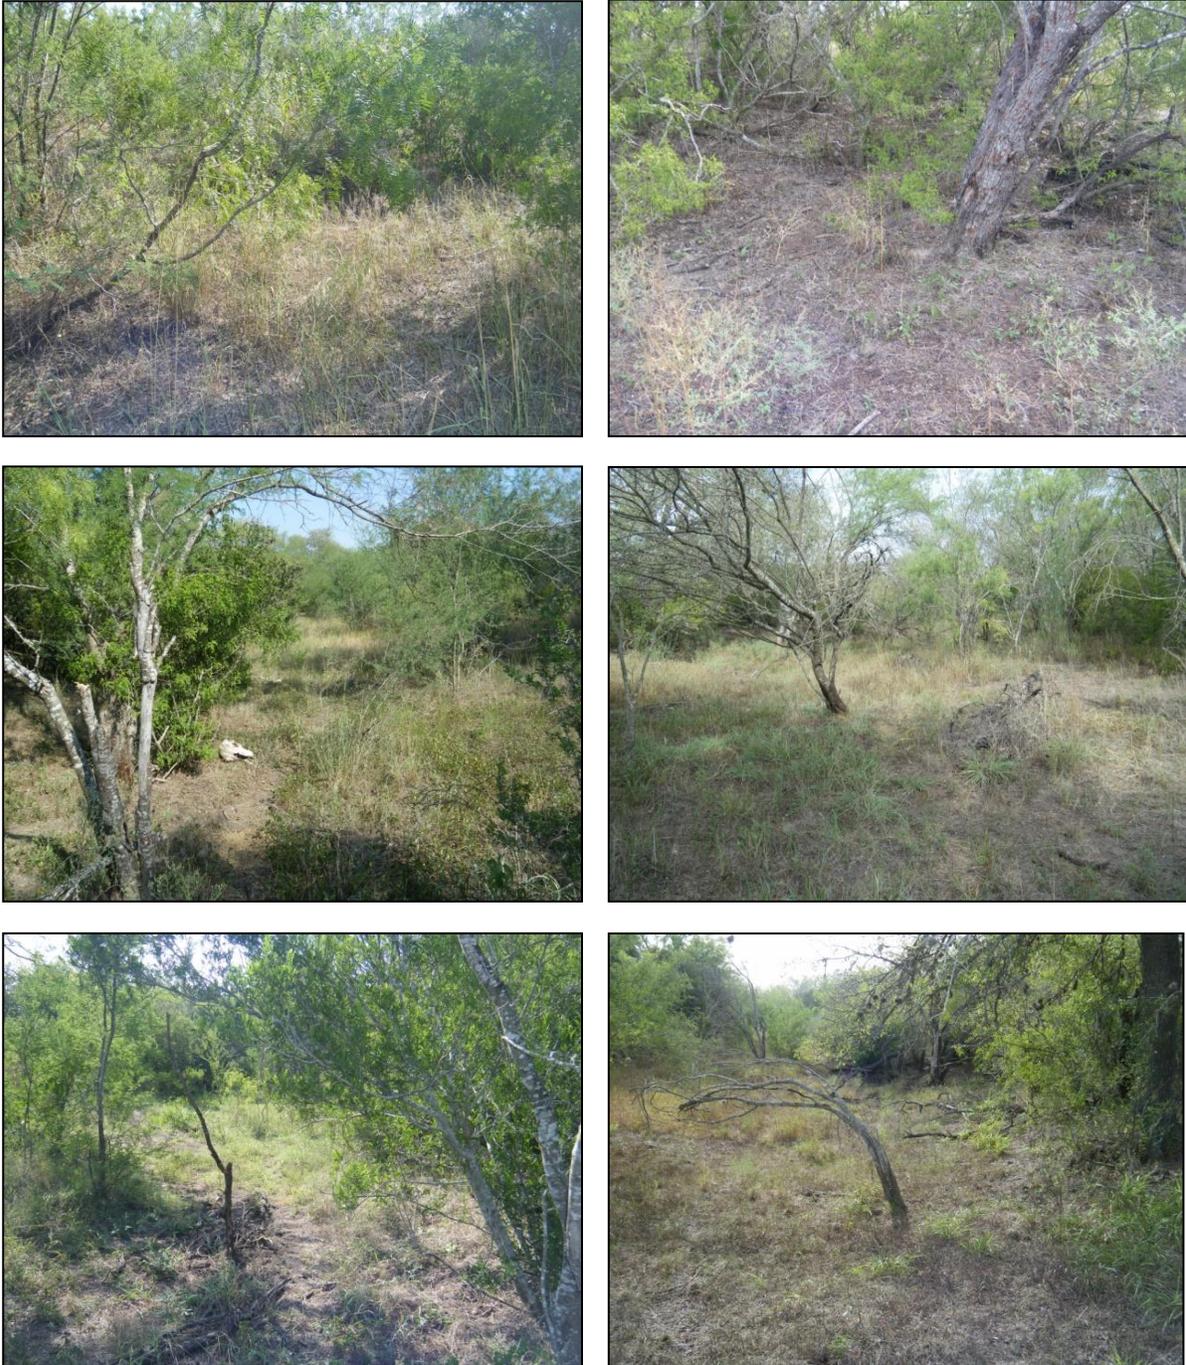
Photogroup 4-26. Aransas Creek site ACK08B depicting general appearance of the site. Top Left – 30 m transect, leftbank view, August 31st, 2012; Top Right – 30 m transect, leftbank view, September 28th, 2012; Middle Left – 150 m transect, upstream view, August 31st, 2012; Middle Right – 150 m transect, upstream view, September 28th, 2012; Bottom Left – 150 m transect, downstream view, August 31st, 2012; Bottom Right – 150 m transect, downstream view, September 28th, 2012.

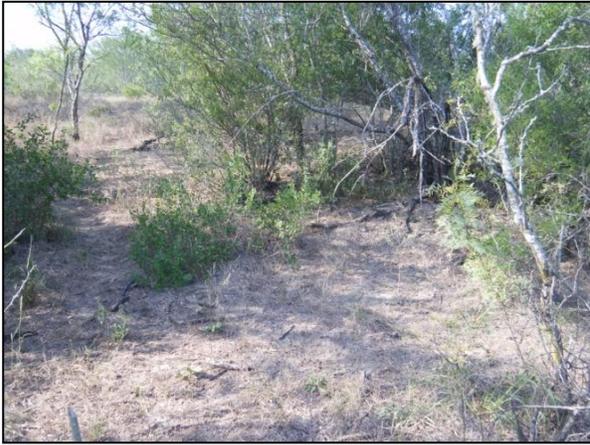
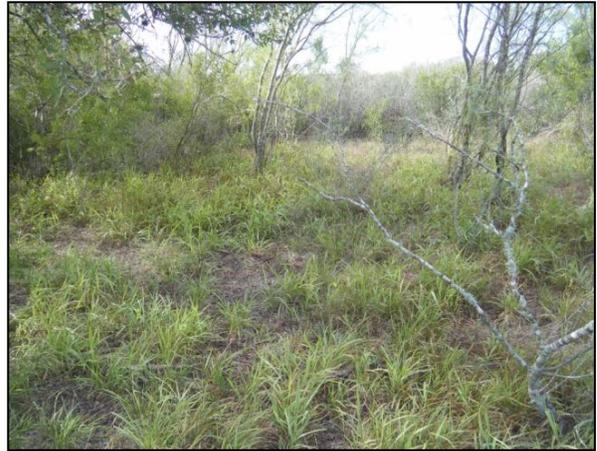
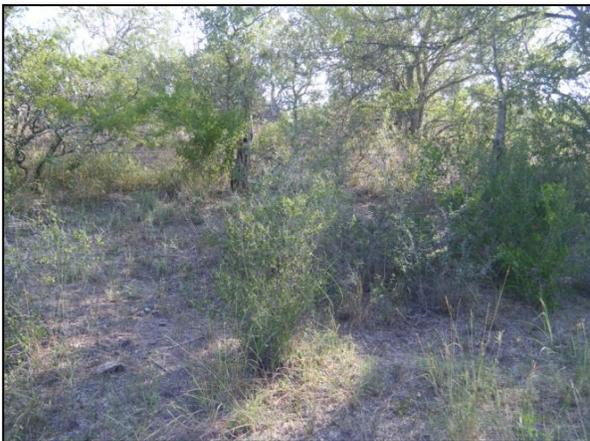
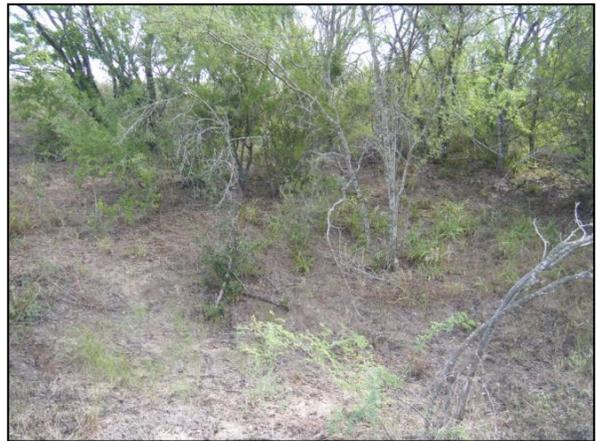
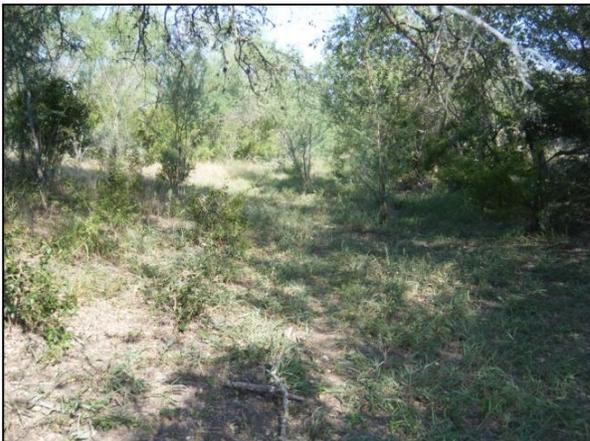
Photogroup 4-27. Aransas Creek site ACk08B depicting general appearance of the site. Top Left – 150 m transect, rightbank view, August 31st, 2012; Top Right – 150 m transect, rightbank view, September 28th, 2012; Middle Left – 150 m transect, leftbank view, August 31st, 2012; Middle Right – 150 m transect, rightbank view, September 28th, 2012; Bottom Left – 300 m transect, upstream view, August 31st, 2012.

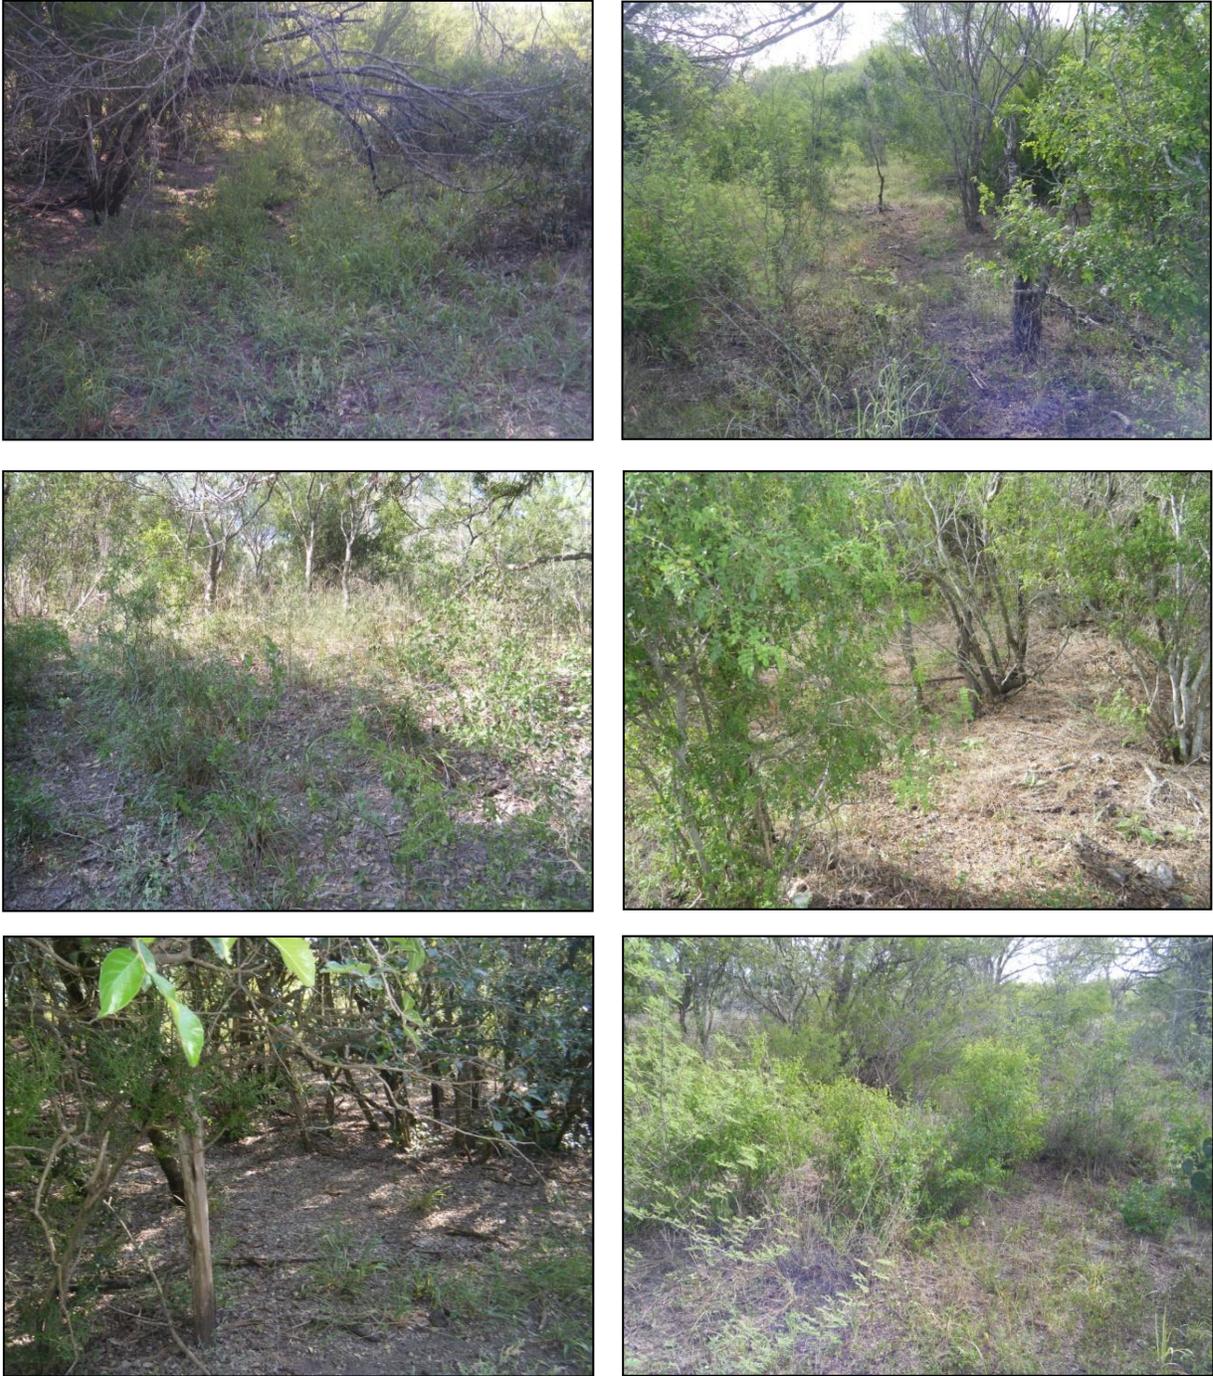
Photogroup 4-28. Aransas Creek site ACh08B depicting general appearance of the site. Top Left – 300 m transect, downstream view, August 31st, 2012; Top Right – 300 m transect, downstream view, September 28th, 2012; Middle Left – 300 m transect, rightbank view, August 31st, 2012; Middle Right – 300m transect, rightbank view, September 28, 2012; Bottom Left – 300 m transect, leftbank view, August 31st, 2012; Bottom Right – 300 m transect, leftbank view, September 28th, 2012.

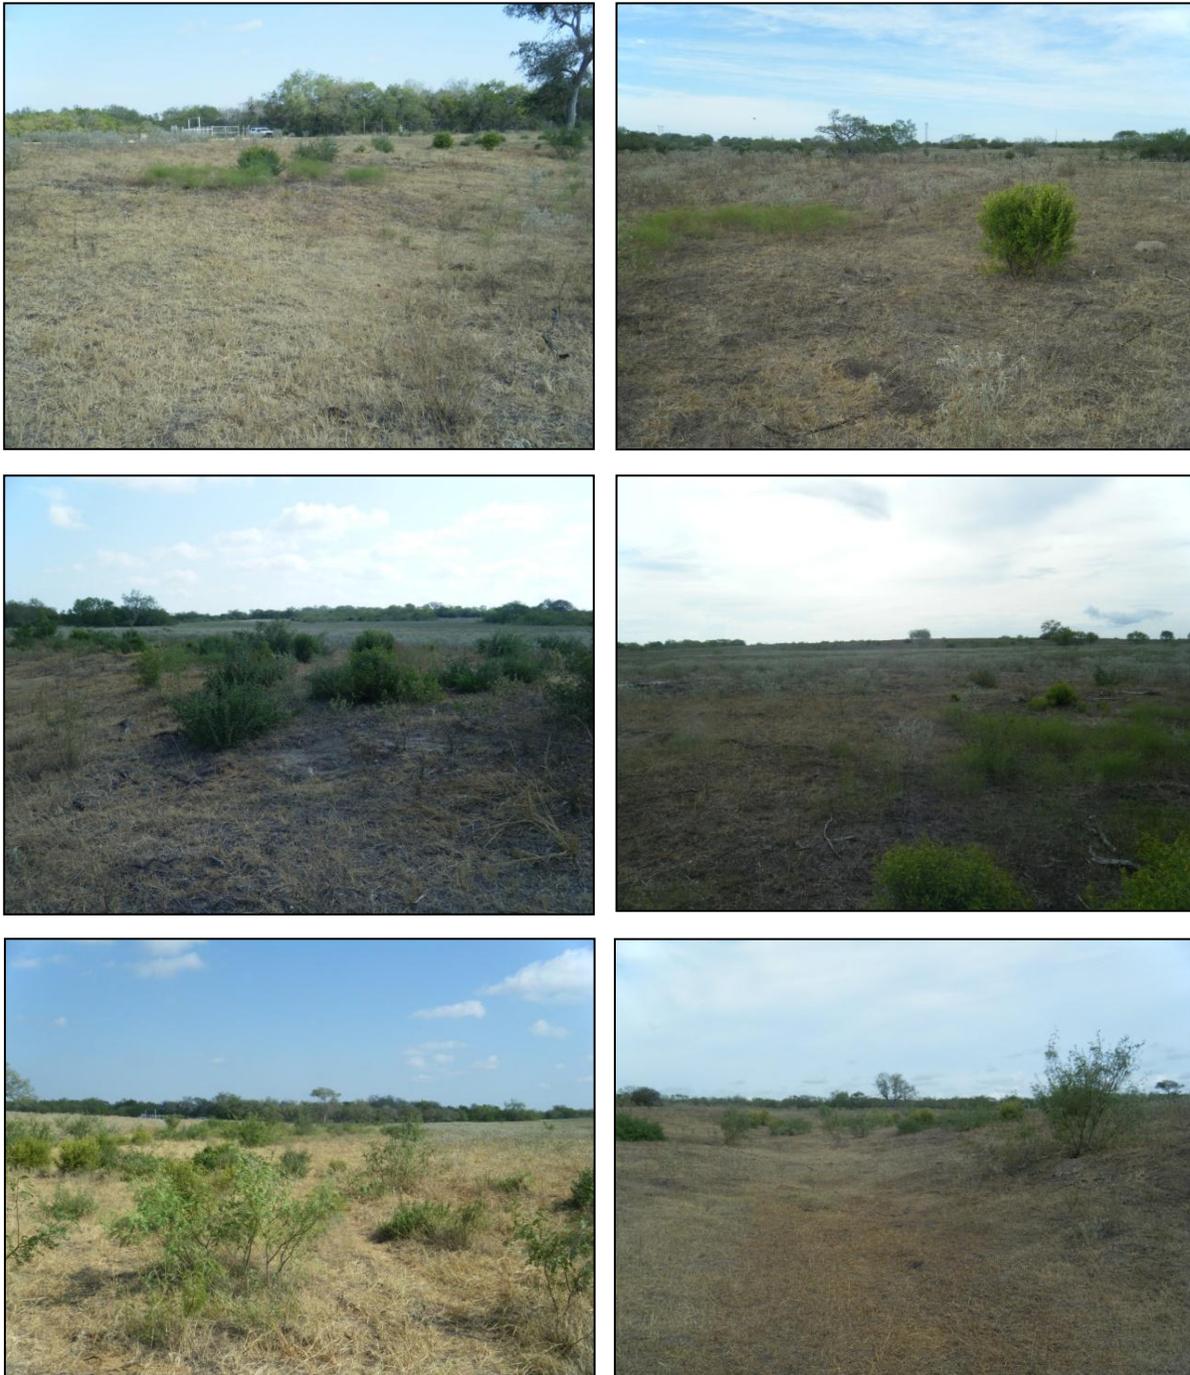
Photogroup 4-31. Aransas Creek site ACh08 depicting general appearance of the site. Top Left – 150 m transect, rightbank view, August 31st, 2012; Top Right – 150 m transect, rightbank view, September 28th, 2012; Middle Left – 150 m transect, leftbank view, August 31st, 2012; Middle Right – 150 m transect, rightbank view, September 28th, 2012; Bottom Left – 300 m transect, upstream view, August 31st, 2012; Bottom Right – 300 m transect, upstream view, September 28th, 2012.

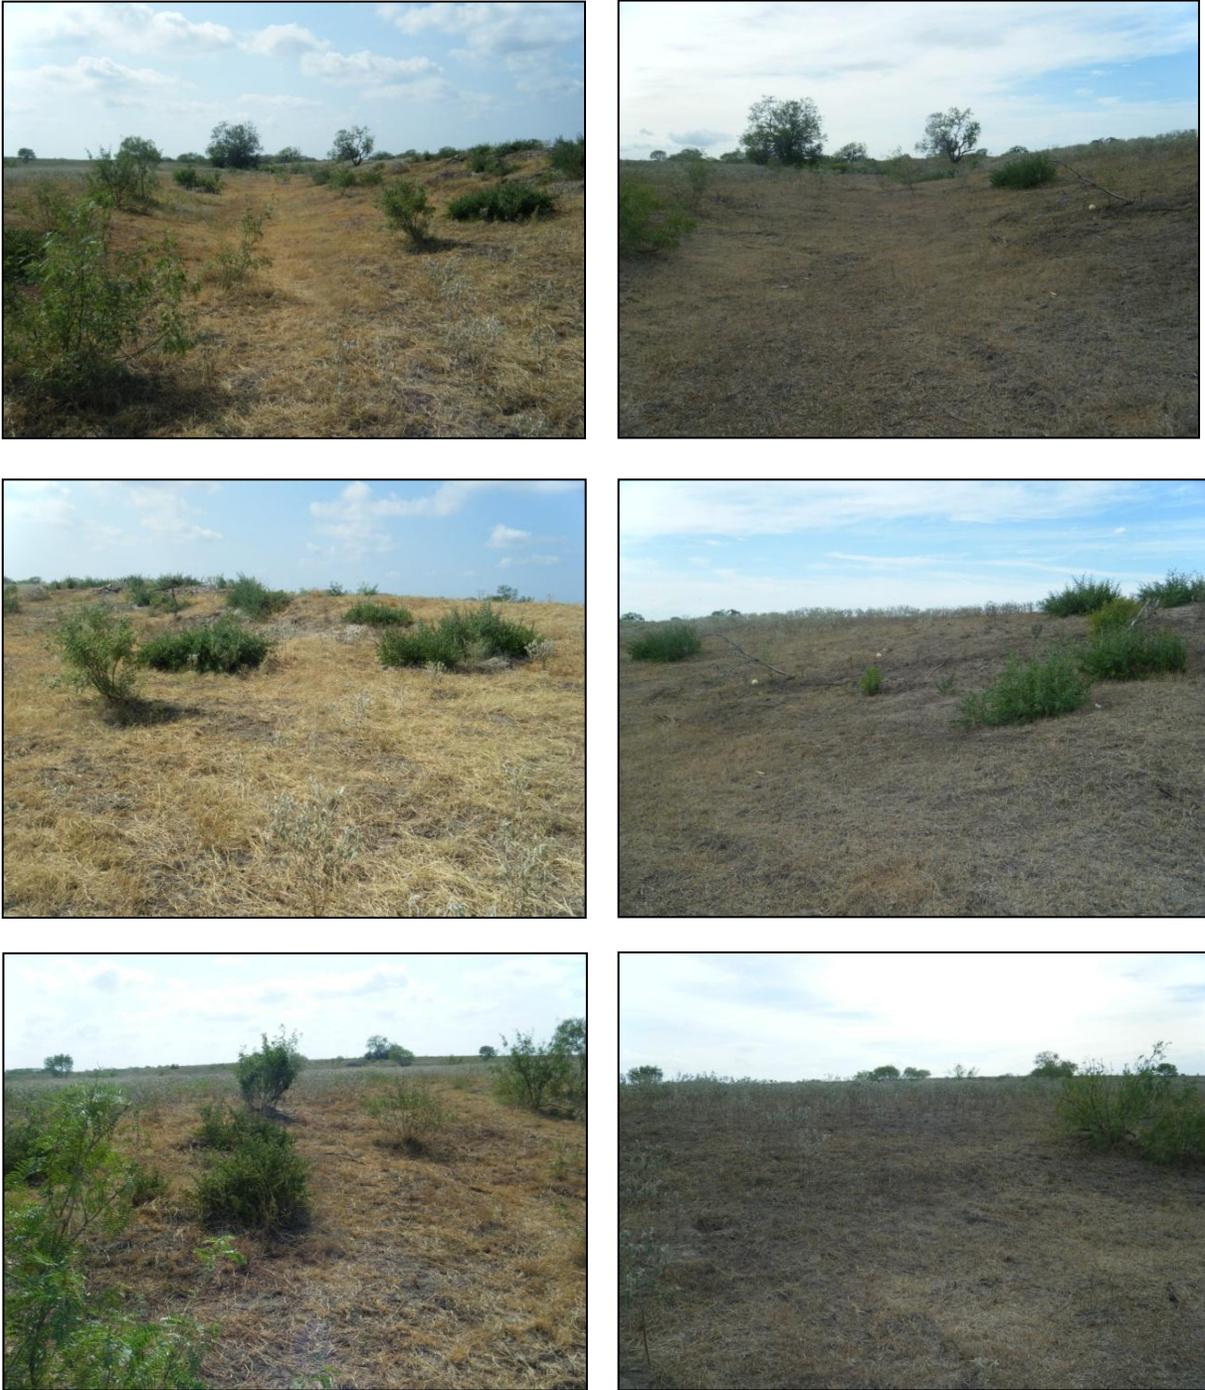
Photogroup 4-32. Aransas Creek site ACh08 depicting general appearance of the site. Top Left – 300 m transect, downstream view, August 31st, 2012; Top Right – 300 m transect, downstream view, September 28th, 2012; Middle Left – 300 m transect, rightbank view, August 31st, 2012; Middle Right – 300 m transect, rightbank view, September 28th, 2012; Bottom Left – 300 m transect, leftbank view, August 31st, 2012; Bottom Right – 300 m transect, leftbank view, September 28th, 2012.

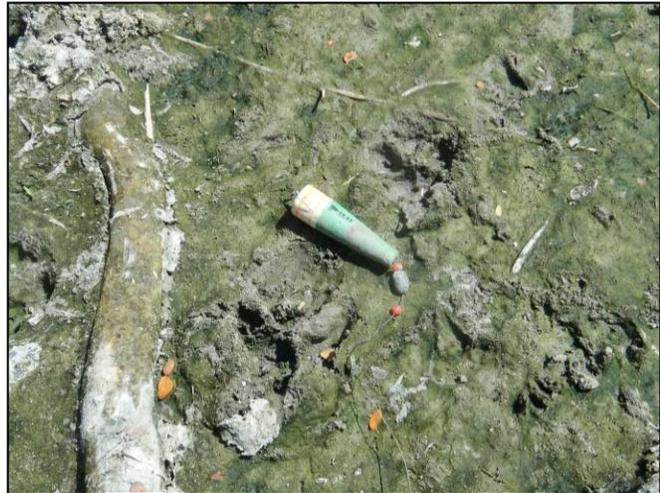
Figure 5-1. Fishing bobber at ACk03

Evidence of secondary contact recreation was observed at site ACk03 during the first field survey on August 31st, 2012. Evidence in the form of a fishing bobber (Figure 5-1) was observed within the 300 m reach associated with site ACk03. The landowner from site ACk03 mentioned that the bobber must have washed downstream from fishing activity that likely occurred upstream from his property. No other evidence of fishing was observed at this site. An interview with the landowner indicated that since the property (228 acres on both sides of the creek) was acquired in 1985, the creek has been used for hunting and fishing in years when sufficient water exists. The landowner said that the family will fish the creek during rain events when the creek has flowing water.

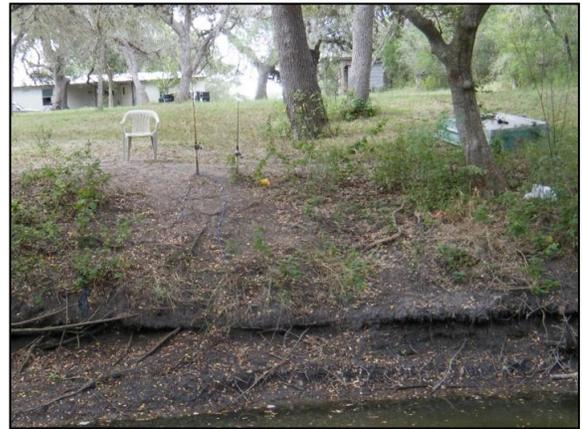
Figure 5-2. Fishing poles, chair and boat

Evidence of secondary contact recreation was observed at site ACk04 at the time both field surveys were completed. Evidence including 2 fishing poles, a chair, a fishing light, and an aluminum boat were observed at a residence located across the creek from the property owner

Although the two fishing poles appeared to be deployed, no fishing activities were observed. The creek bed had been dug out by a family member to hold water during dry times. An interview with the landowner indicated the creek has been used by family and friends for fishing and by children with radio controlled boats. Anecdotal evidence of primary contact recreation occurred when a family member inadvertently fell from the footbridge into the water. No other forms of recreation were mentioned in the interview form.

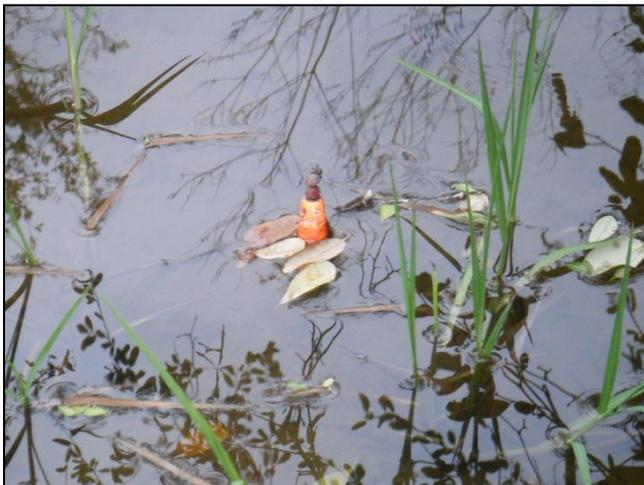
Figure 5-3. Fishing bobber near ACk05

Site ACk05 is one of two sites where Aransas Creek is publically accessible. Evidence of secondary contact recreation (fishing) was found during the bacteria source study near this site in February 2012. At the time the bacteria source study was conducted, Aransas creek was not flowing but contained numerous pools. Access to the creek was moderately difficult due to overgrown riparian vegetation. Once on the creek bed, NRA field staff navigated downstream stopping at each pool to take pictures and to look for bacteria sources. A fishing rod (minus the reel) and a bobber were found adjacent to the creek on private property (Figure 5-3 and 5-4) approximately 450 m downstream of the FM 888 bridge crossing.

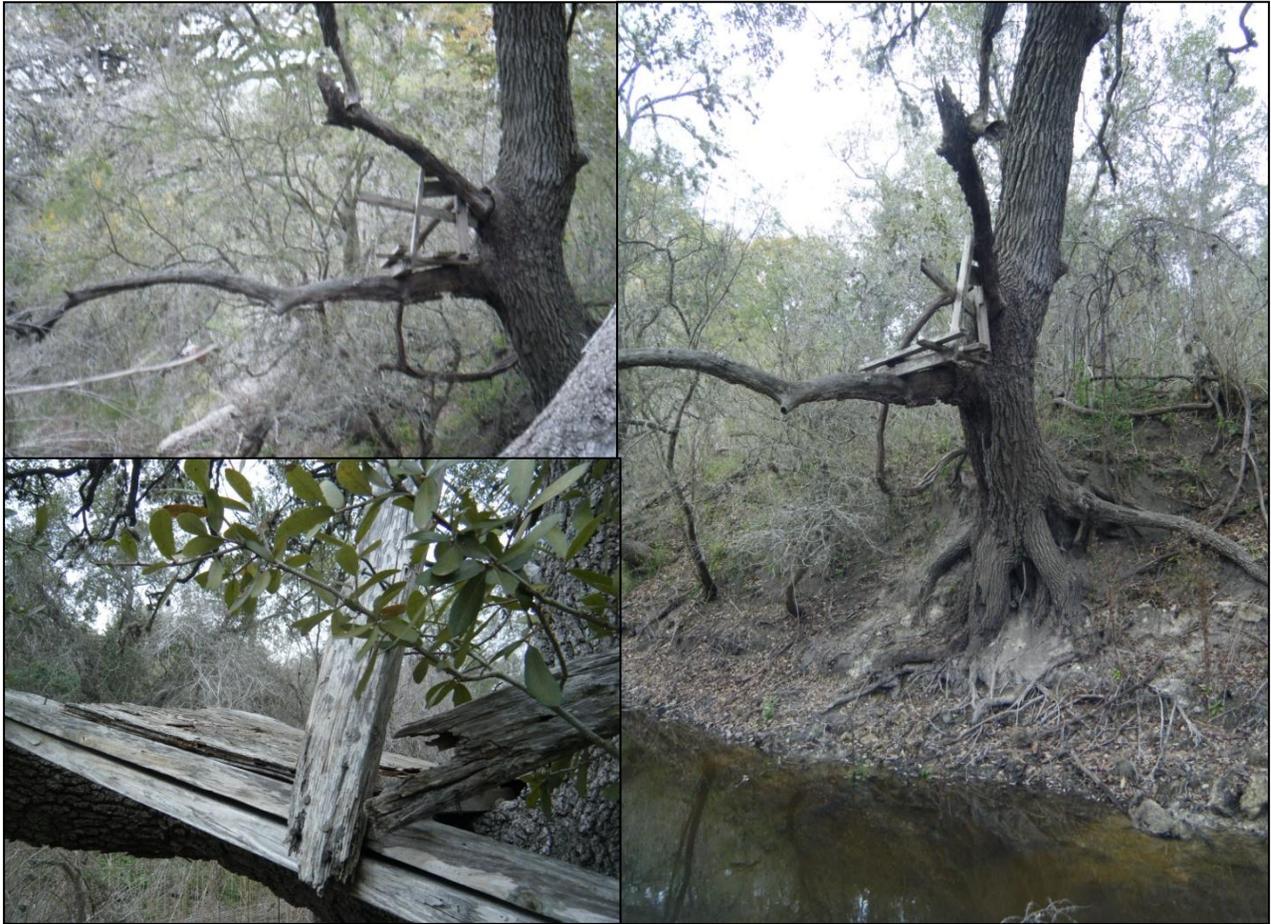
Figure 5-5. Wooden structures built in the oak trees lining Aransas Creek near ACk05

In addition, multiple wooden structures were constructed in the oak trees that lined the creek (Figures 5-5, 5-6). The structures appeared directly over the creek bed at several locations. Due to the proximity of the structures to the water, one can assume a recreational use would likely be associated. NRA field staff also encountered a small pier that might also have a recreational use associated with it (Figure 5-7). Also located nearby was a pool float that was found partially

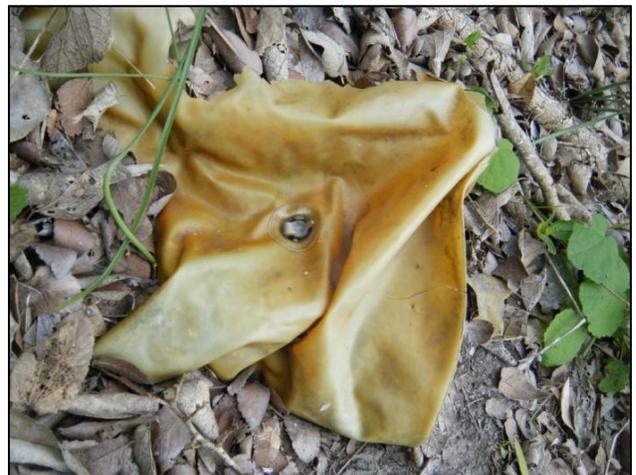
Figure 5-7. Pool float near ACk05

buried in the sediment in the rightbank of the creek (Figure 5-8). No swimming pools were located in the area after a Google Earth search was performed, suggesting the pool float may have possibly been used in the creek.

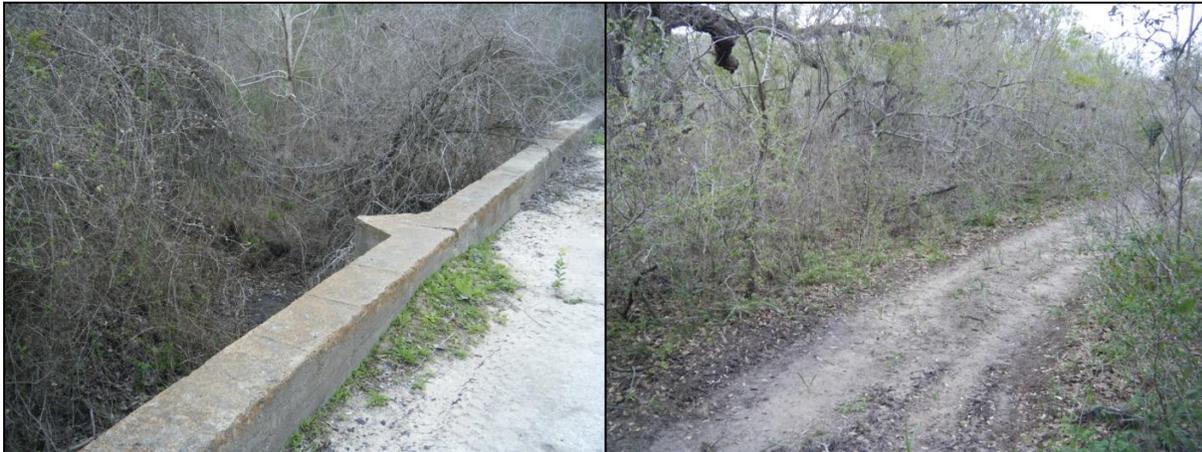
Figure 5-8. ATV tracks and dirt road near ACk05

Numerous trails and paths were observed in the vicinity of site ACk05 suggesting regular use by humans. All Terrain Vehicle (ATV) tracks were observed on a small concrete bridge located within the 300 m reach associated with site ACk05 (Figure 5-10). ACk05 also had a lot of trash observed adjacent to the bridge at FM 888. Refuse in the form of used diapers, vehicle seats, candles, and metal cans and bottles.
