Leona River Watershed Geographic Information System Inventory and Bacteria Source Survey

**Texas State Soil and Water Conservation Board
Project 11-50**

**Texas Institute for Applied Environmental Research
Tarleton State University
Stephenville, Texas**

TR1304

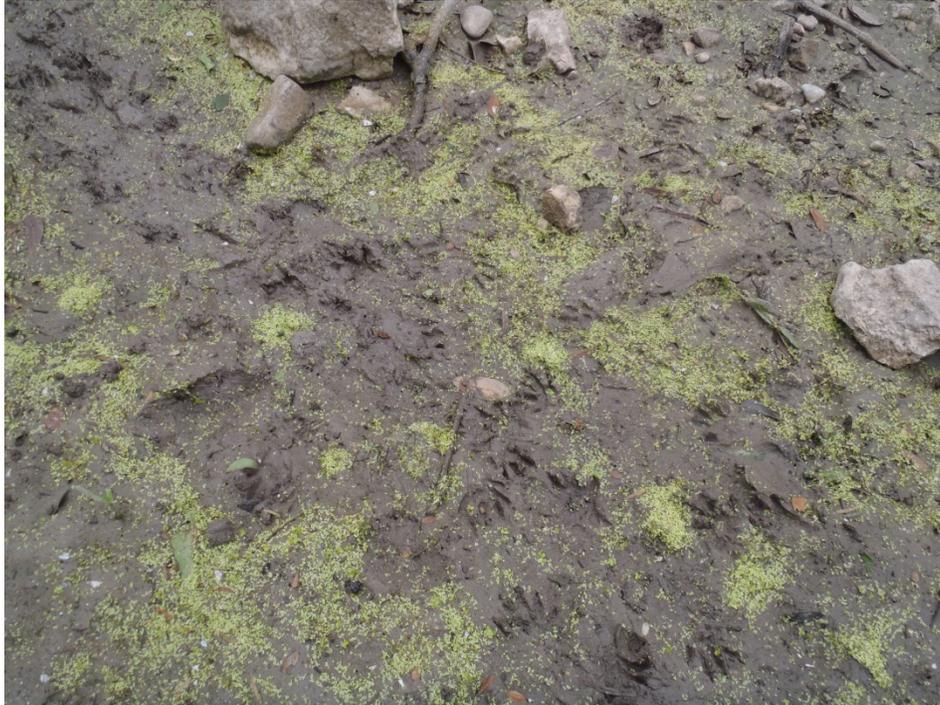
Figure 8 Raccoon tracks along the banks of the Leona River near the confluence with Todos Santo Creek. Photo taken May 25, 2012.

As part of the routine monitoring, RUAA surveys, and collection of known source bacteria samples conducted for this project, TIAER field staff noted any observations of potential bacteria sources to Leona River. The most common potential sources observed were wildlife (primarily deer and raccoon) and feral hogs (Figures 8-11). Some livestock and exotic ungulates were seen on the uplands of the Leona River, but none within the riparian area or riverbed as traversed during the RUAA.

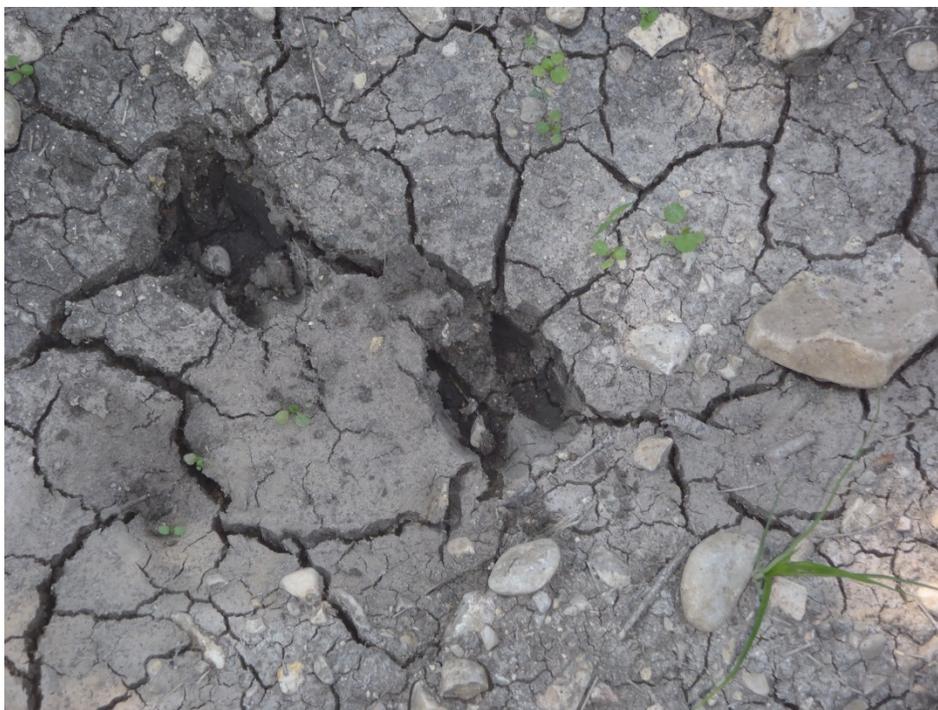
Figure 9 Deer tracks along the banks of the Leona River north of Uvalde, Texas. Photo taken May 22, 2012.

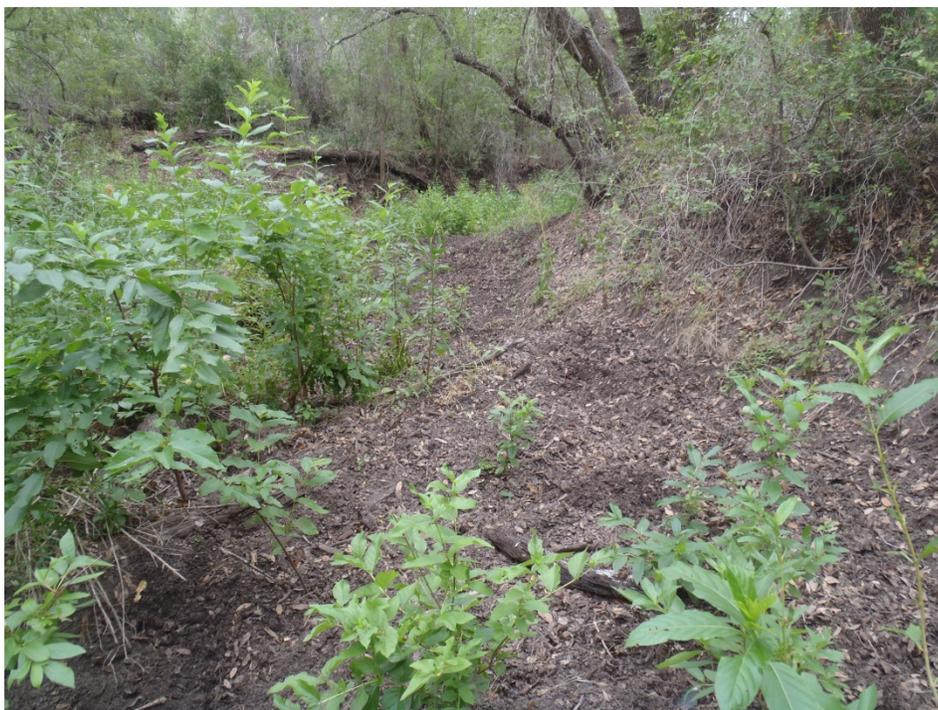
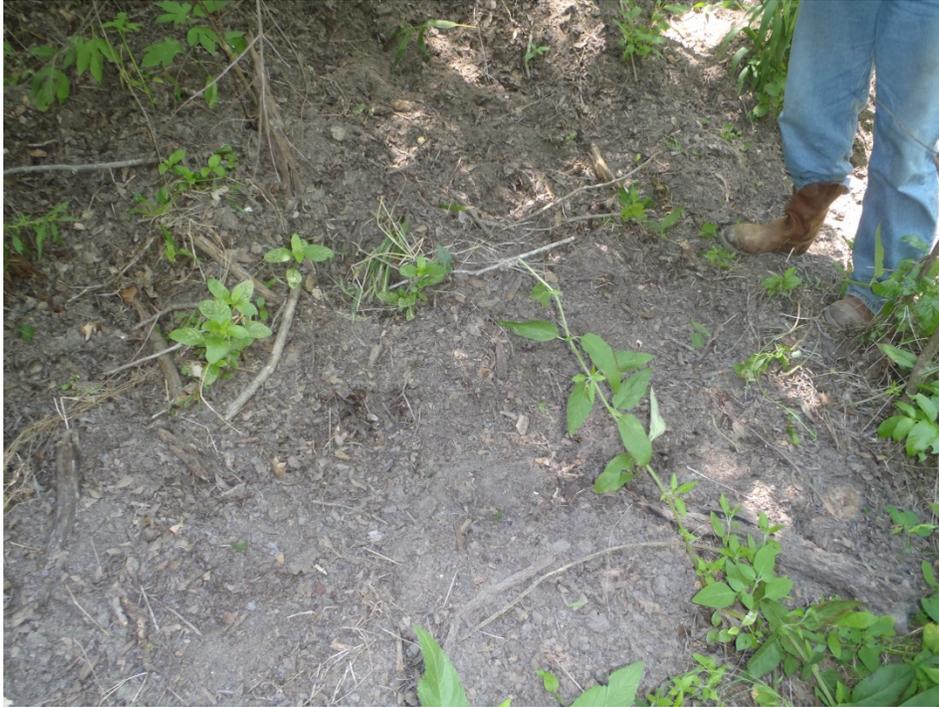
Figure 10 Hog trail along the banks of the Leona River near the confluence with Todos Santos Creek. Photo taken July 18, 2012.

Figure 11 Hog trail along the banks of the Leona River near the confluence with Todos Santos Creek. Photo taken May 23, 2012.

While feral hogs are not natural wildlife, they are an invasive, unmanaged species found throughout Texas that contribute bacteria to streams in a manner similar to native wildlife. Feral hogs are noted for moving in groups along waterways, and particularly in times of drought will congregate near perennial water sources to drink and wallow. Feral hogs are classified by TPWD as unprotected, exotic, non-game animals (Taylor, 2003). Although found throughout much of Texas, there is a scarcity of data on feral hog densities in Texas. Studies in comparable bottomland habitats indicate typical densities of nearly 30 hogs per square mile (Tate, 1984 and Hone, 1988). Signs of feral hogs were encountered at several of the RUAA survey sites as noted in the field survey results.
