Recreational Use Attainability Analysis for Dixon Creek (0101A) in the Canadian River Basin

DRAFT for PUBLIC REVIEW

Prepared for:
Texas State Soil and Water Conservation Board
Project 12-52

TR1307
November 2013

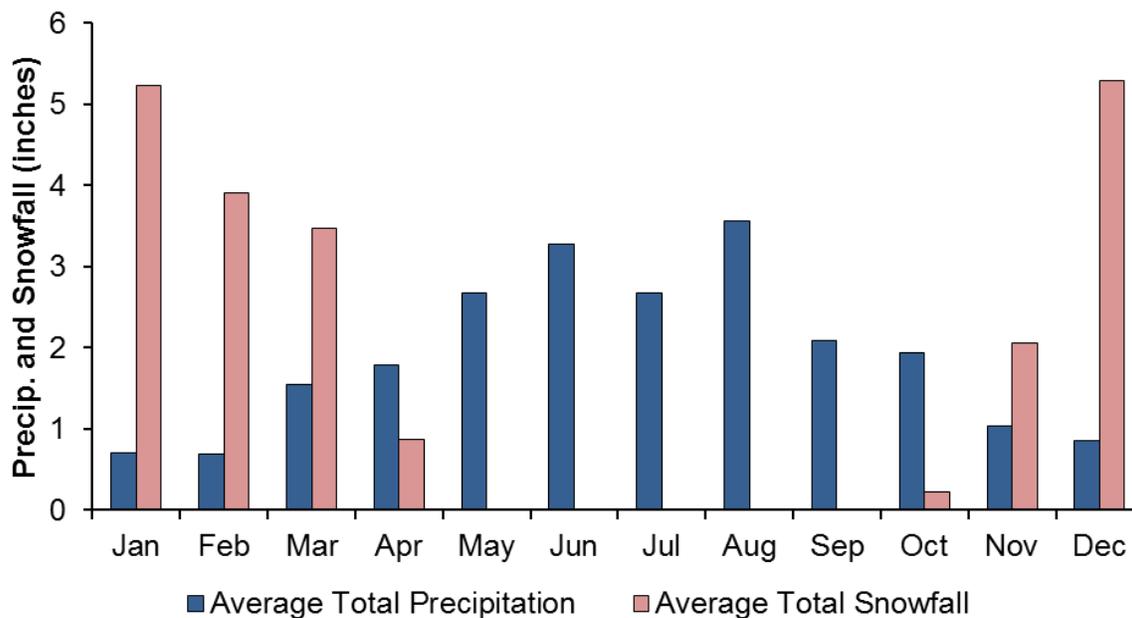
Annual precipitation for the Dixon Creek watershed was based on data for Borger, Texas. Normal precipitation (1981-2010) for Borger, Texas averages 22.9 inches with snowfall averaging 21.1 inches (WRCC, 2013). Peak rainfall months tend to be May through August with peak snowfall occurring in December and January (Figure 2-1).

Figure 2-1 Monthly average precipitation and snowfall for Borger, Texas.

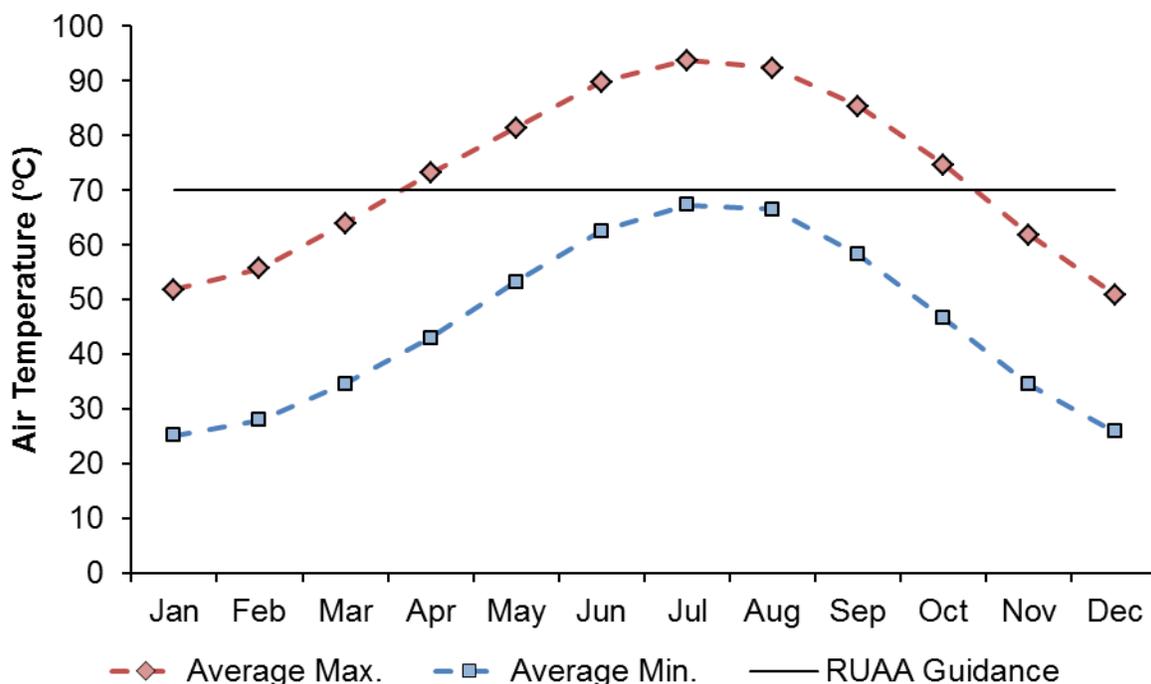
With regard to temperatures, average maximum temperatures for Borger, Texas ascend above 70° F (21° C) beginning in April and continuing through October (Figure 2-2). March through October are the months noted as generally suitable for assessing recreational use, but only if temperatures reach above 70° F (TCEQ, 2012).

Figure 2-2 Monthly average maximum and minimum air temperatures for Borger, Texas compared to RUA A guidance for field surveys.

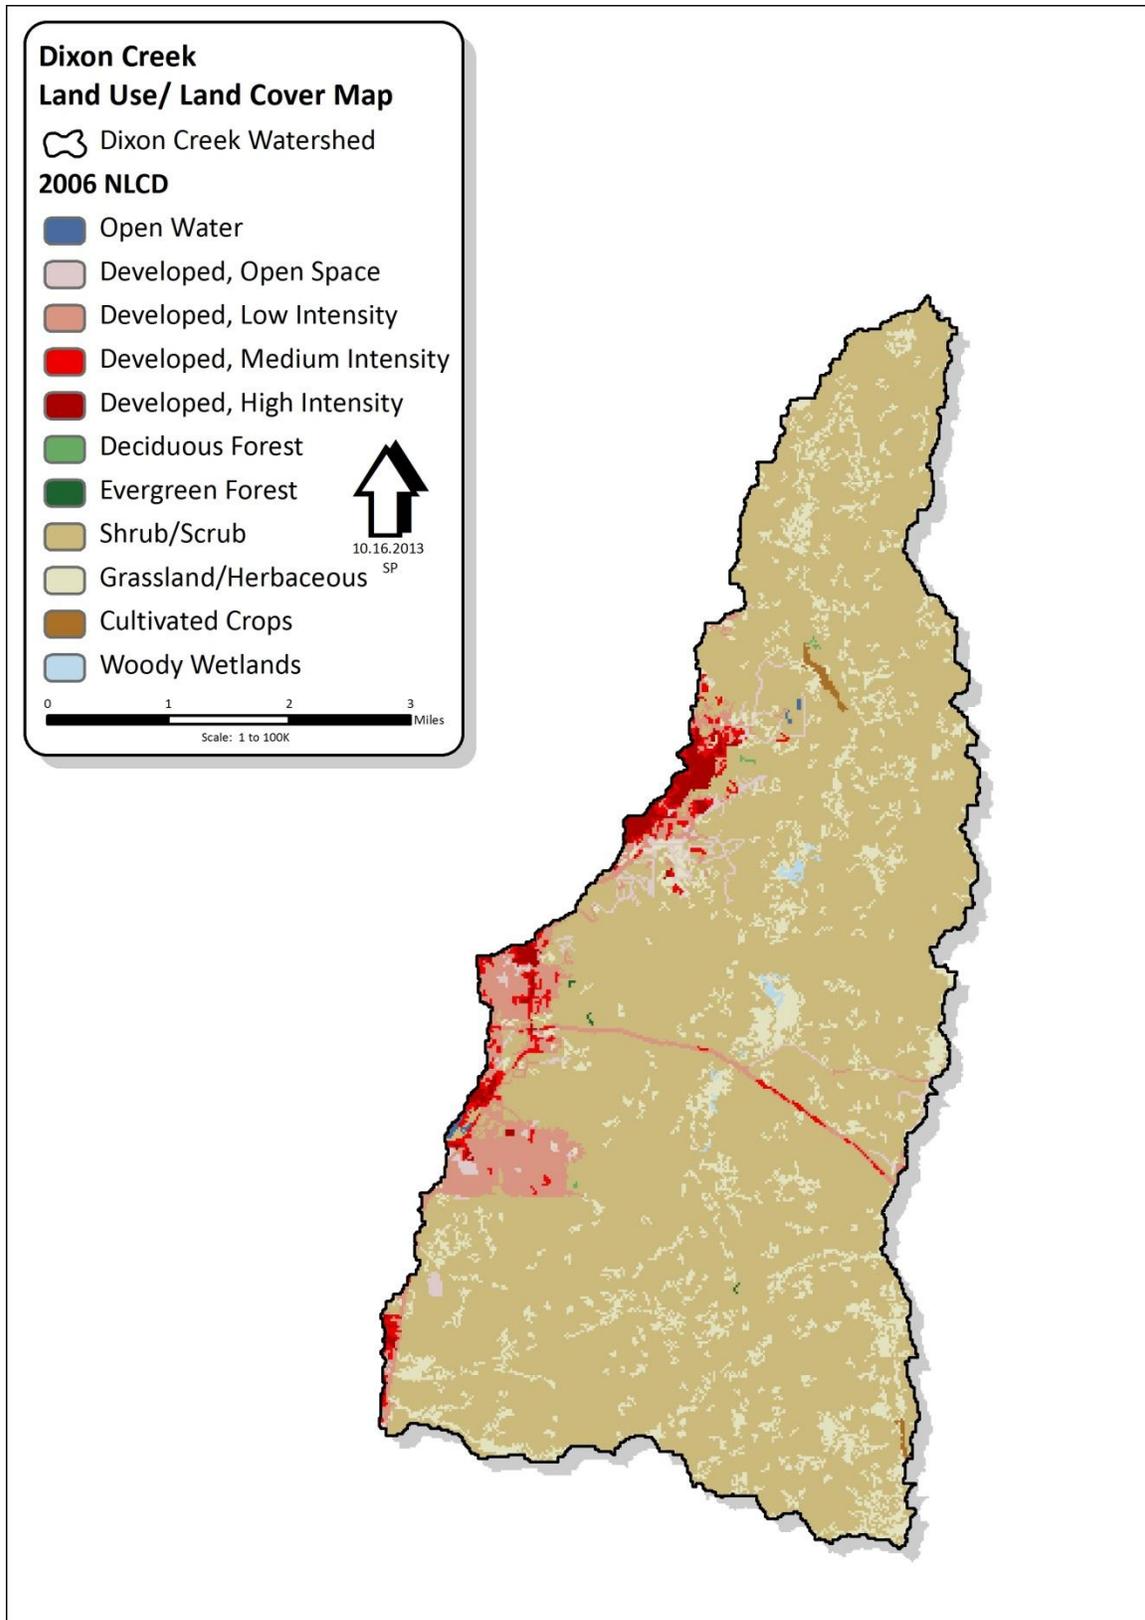
Figure 2-3 Land Use and land cover of the Dixon Creek watershed water body (0101A). Source: 2006 National Land Cover Database USGS, 2013).

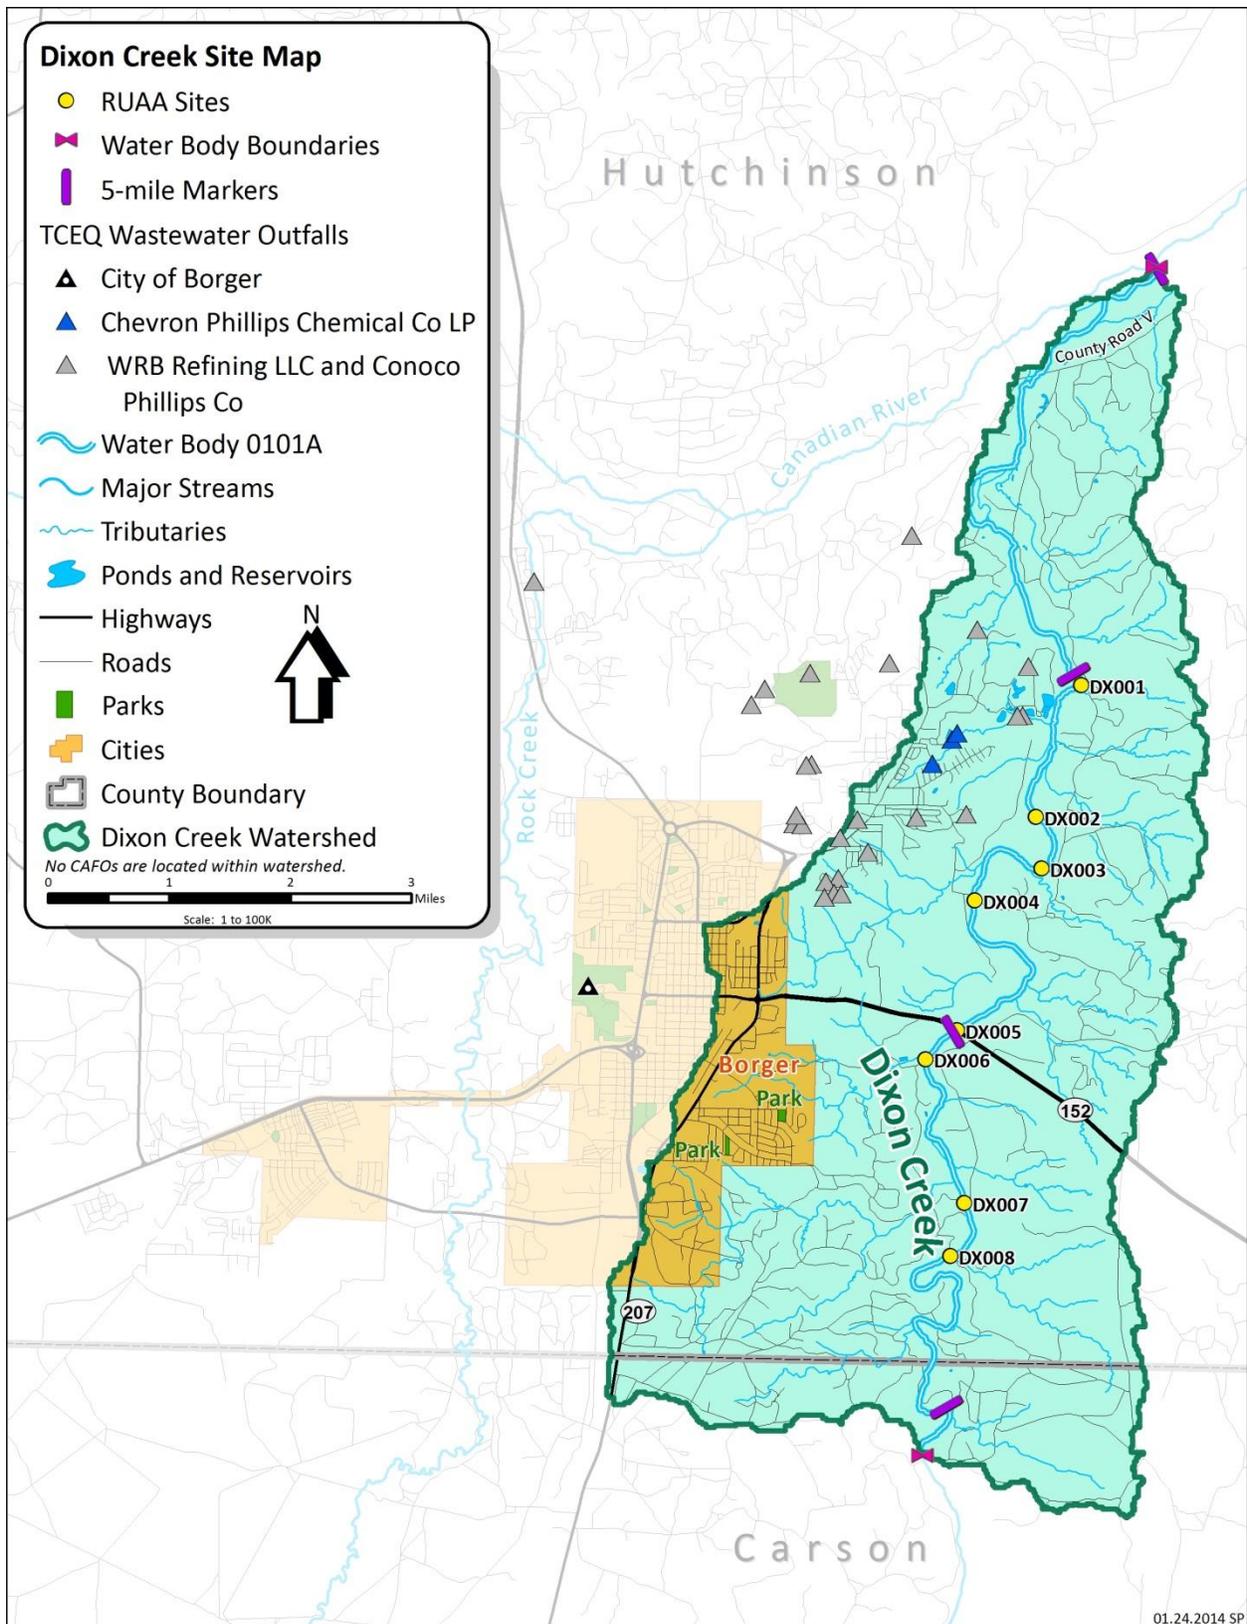
Figure 3-1 RUAA site locations along Dixon Creek (0101A) and other features of interest within the Dixon Creek watershed.

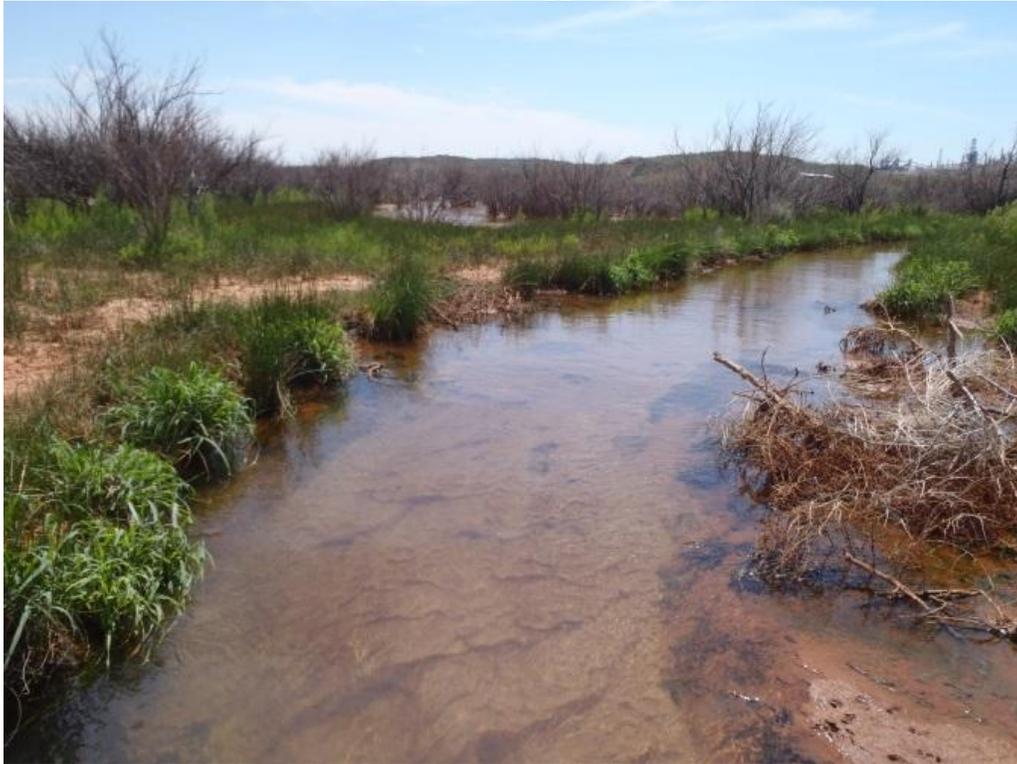
Figure 4-1 Photograph of Dixon Creek at Site DX001 taken on July 27, 2013 of the upstream view of the 300-m transect.

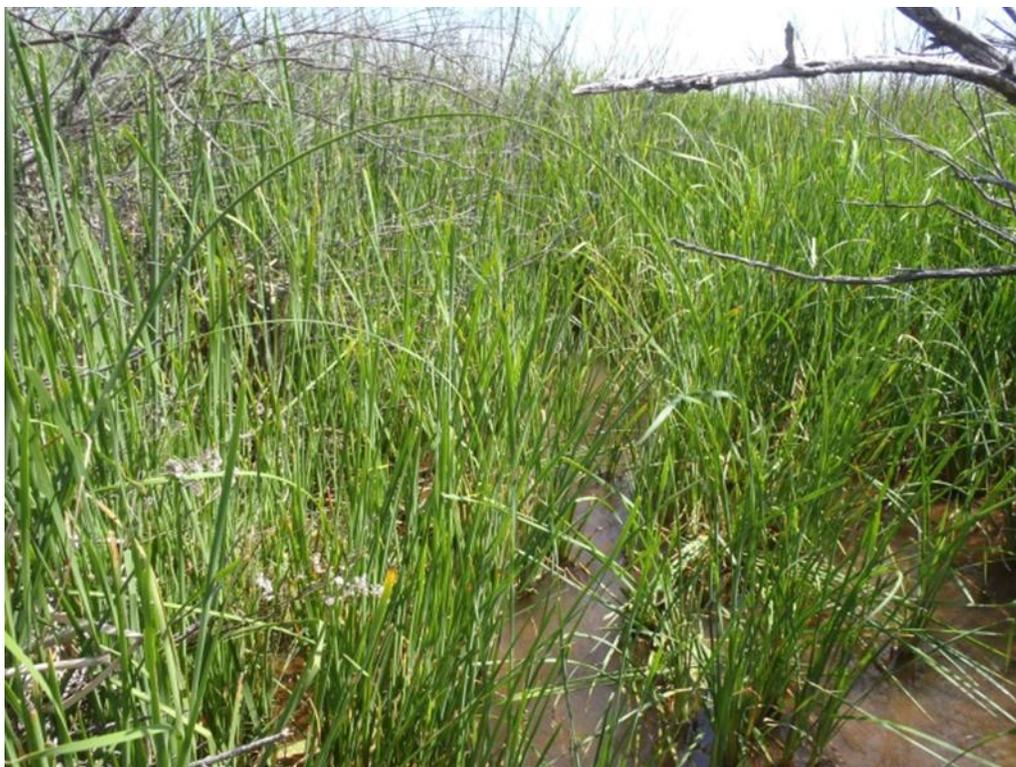
Figure 4-2 Photograph of Dixon Creek Site DX001 taken on July 27, 2013 of the upstream view of the 30-m transect.

Site DX001 was wadeable for the entire 300-m reach length. The only flow observed was from the permitted discharge from the Conoco Phillips facility into the stream. Water depths during both surveys were predominately less than 0.5 meters (1.6 ft) deep. Wading in the stream was challenging due to the mud\clay bottom with sludge deposits. Additionally, in the lower half of the reach, dense vegetation consisting of cattails made wading more difficult. The flows observed were considered normal for this location and typical stream widths varied from 25 m (82 ft) in May to 15 m (49 ft) in July with maximum and minimum widths from both surveys occurring in May (Tables 4-3 and 4-4).

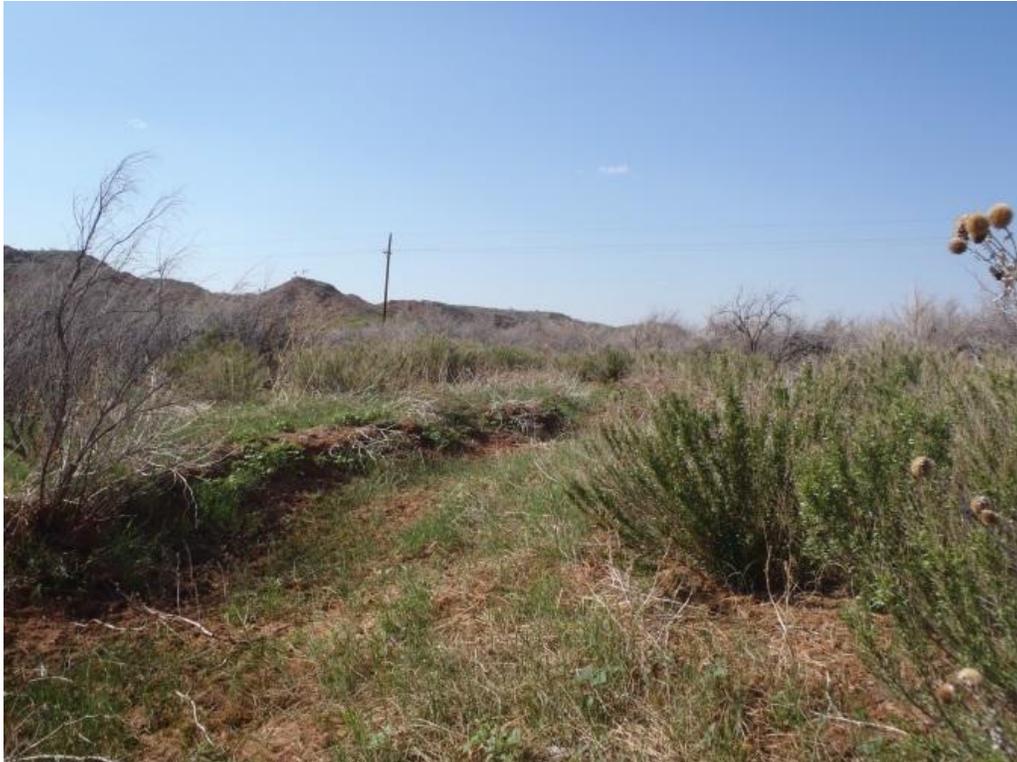
Figure 4-3 Photograph of Dixon Creek at Site DX002 taken on May 25, 2013 of the downstream view of the 150-m transect.

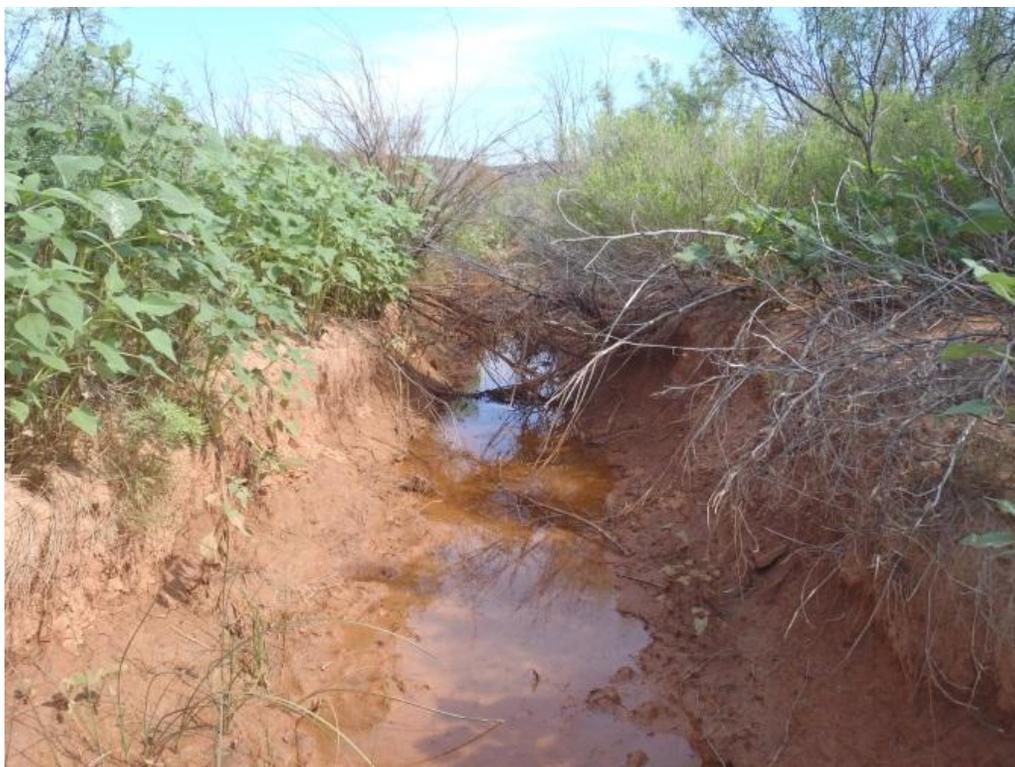
Site DX002 was wadeable for the entire 300-m reach length in that limited water was encountered. Most of the reach was dry except for a few small pockets of water at various locations. Figure 4-4 depicts the water observed at the site. The water depth recorded at each transect for both surveys was 0 meters. Walking in the stream was easy due to the dry mud\clay bottom. As the stream at transect sites was dry during both visits, minimum, maximum and typical average stream widths were also 0 m (Tables 4-3 and 4-4).

Figure 4-4 Photograph of Dixon Creek at Site DX002 taken on July 27, 2013 showing the small pockets of water encountered during the second survey.

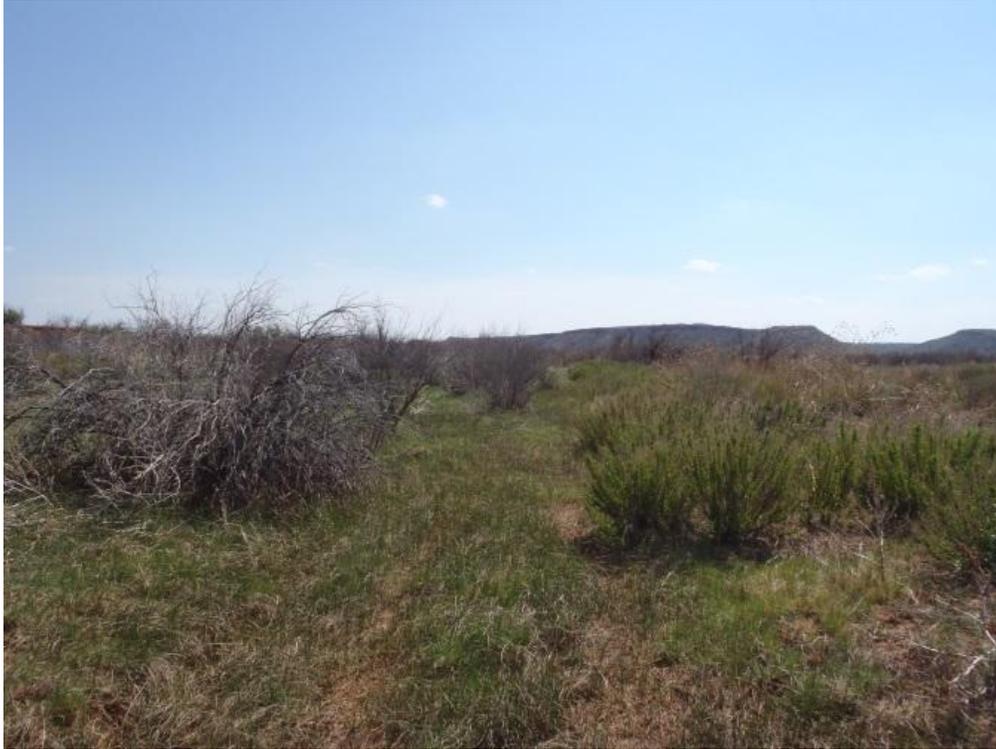
Figure 4-5 Photograph of Dixon Creek at site DX003 taken on May 25, 2013 of the upstream view of the 30-m transect.

Site DX003 was easily wadeable for the entire 300-m reach length due to a lack of water. Water depths recorded at each transect for both surveys were 0 meters, although small pockets of water were encountered during the second survey in July 2013, similar to those noted for DX002. As the stream at transect sites was dry during both visits, minimum, maximum and typical average stream widths were 0 m (Tables 4-3 and 4-4).

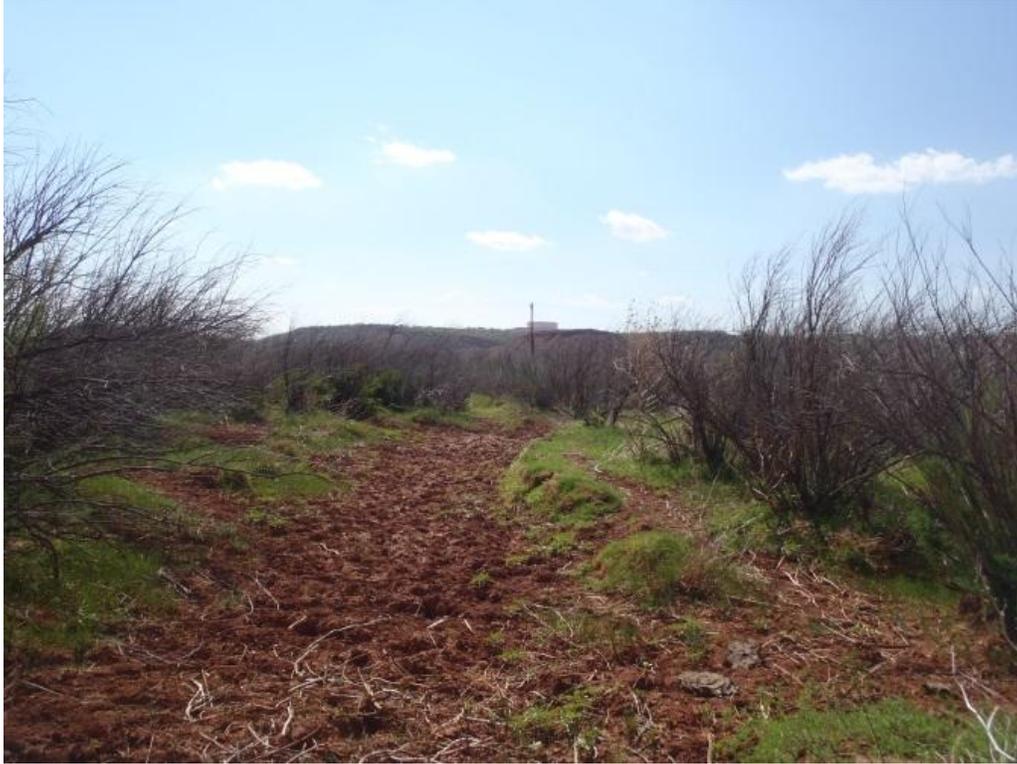
Figure 4-6 Photograph of Dixon Creek at Site DX003 taken on May 25, 2013 of the upstream view of the 300-m transect.

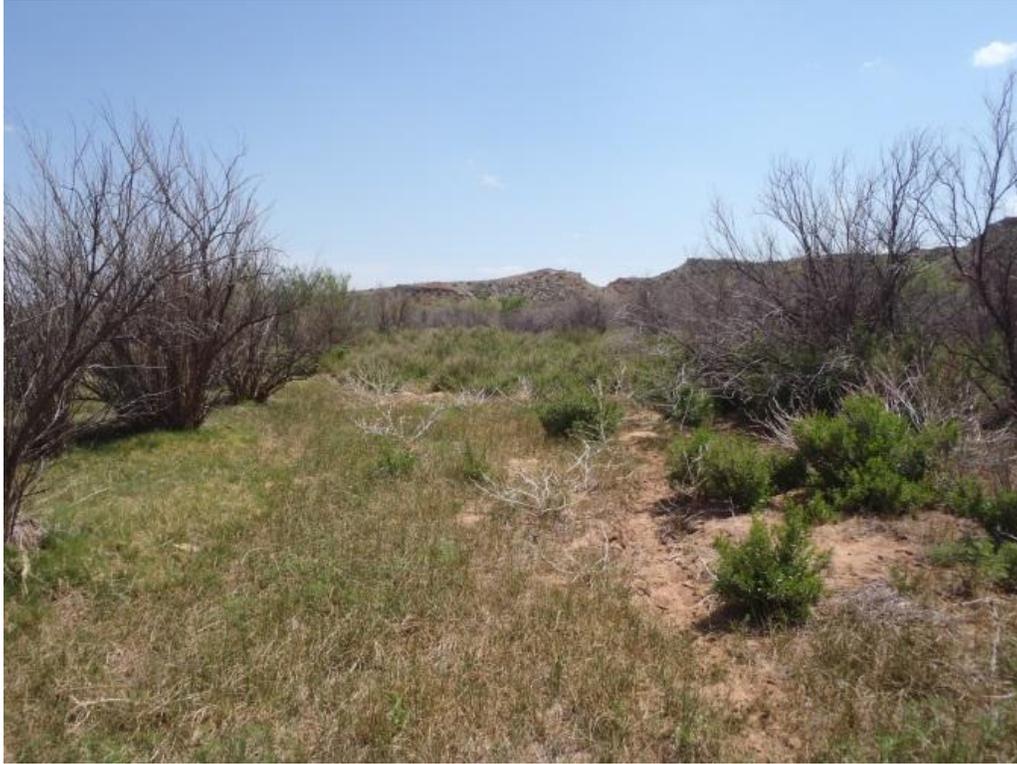
Figure 4-7 Photograph of Dixon Creek at Site DX004 taken on May 25, 2013 of the upstream view of the 300-m transect.

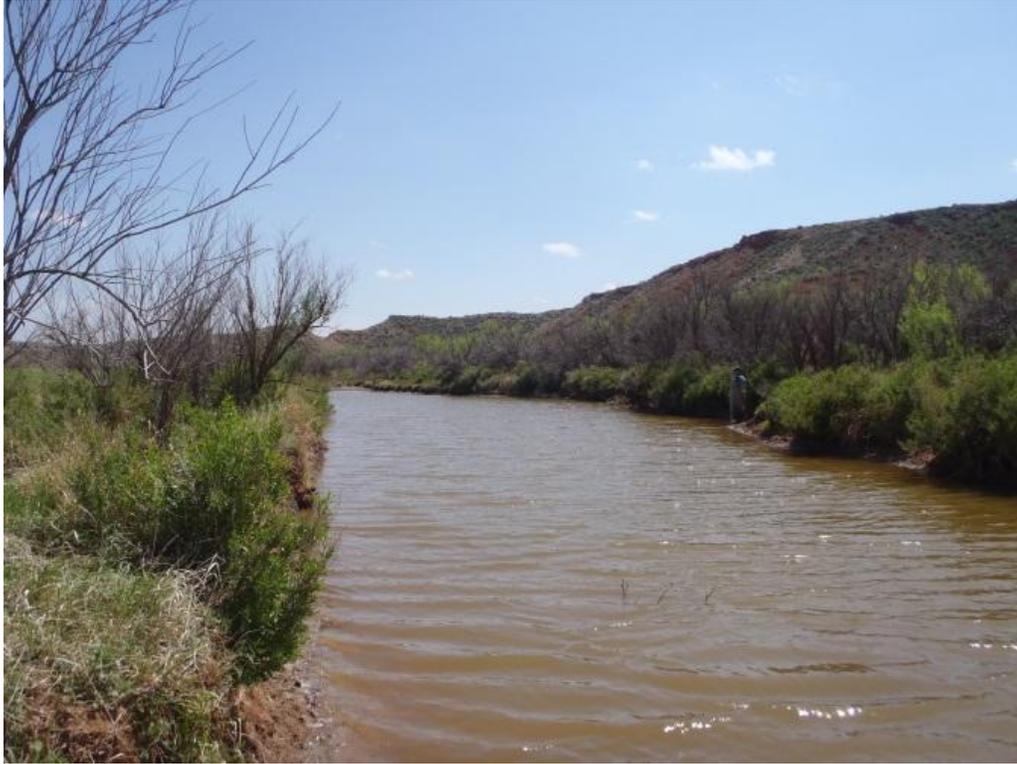
Site DX004 was wadeable for the entire 300-m reach length. One pool was identified within the reach from around the 150-m transect to around the 240-m transect (Figure 4-8). Total length of the pool was 107 meters (351 ft) with a maximum width of 14 meters (46 ft). Maximum depth of the pool was 0.62 meters (2.0 ft). The mud/clay dominant substrate made for easy walking except for within the one identified pool. Sludge and fine sediment in the bottom of the pool made wading challenging. While the typical width of the stream at Site DX003 was 0 m, the maximum width was 14 m (46 ft), as recorded for the pool (Tables 4-3 and 4-4).

Figure 4-8 Photograph of Dixon Creek at Site DX004 taken on May 25, 2013 of the upstream view of the 150-m transect.

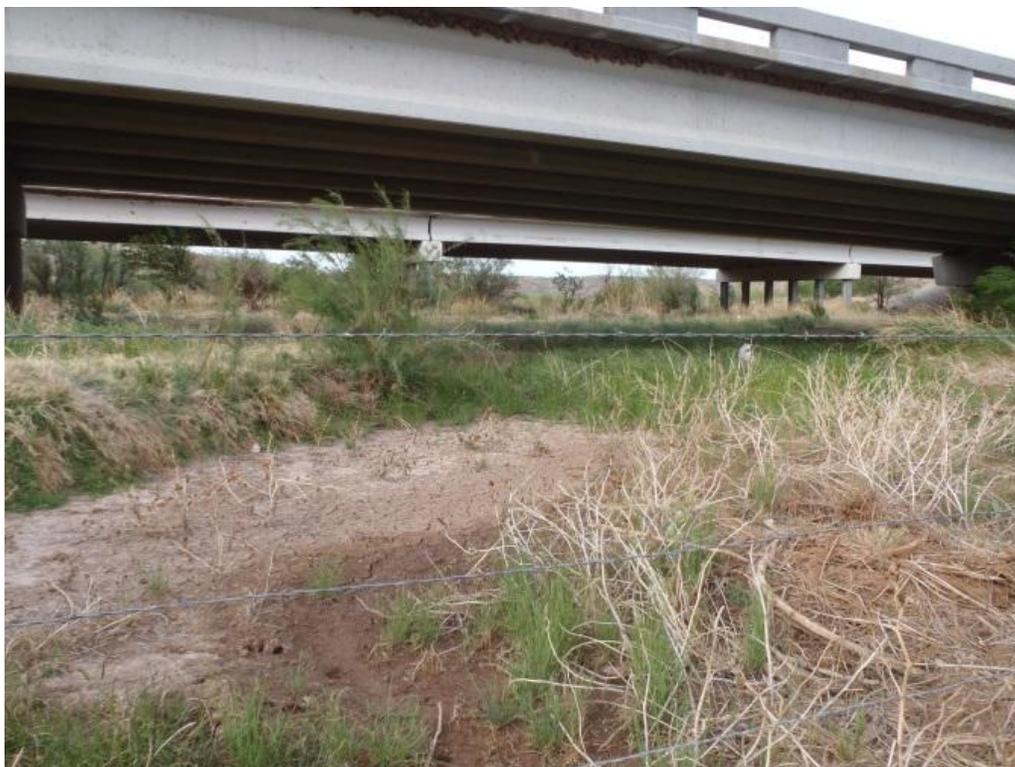
Figure 4-9 Photograph of Dixon Creek at Site DX005 taken May 25, 2013 of the downstream view of the 30-m transect showing the barbed-wire fence.

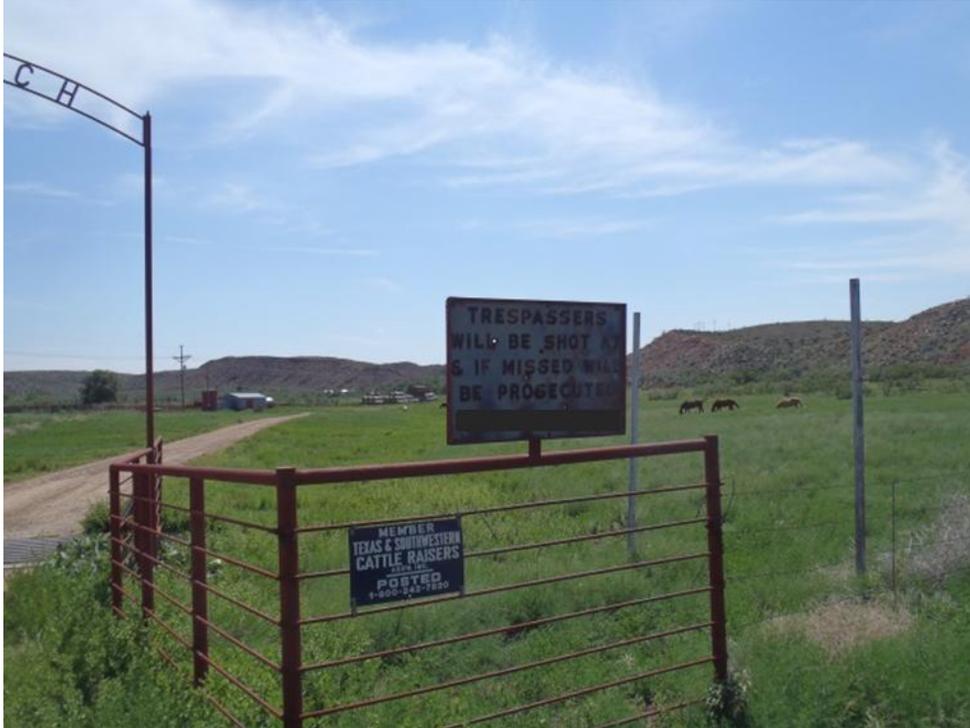
Figure 4-10 Photograph of Dixon Creek near Site DX005 taken on May 25, 2013 showing the no trespassing sign at the property entrance.

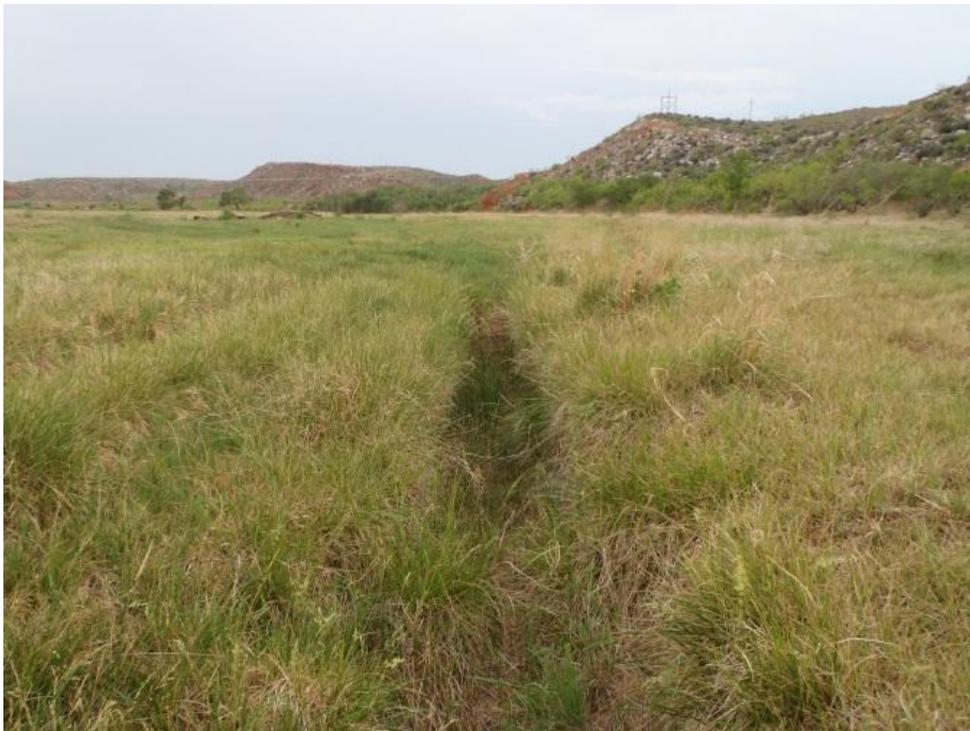
Figure 4-11 Photograph of Dixon Creek at Site DX005 taken on May 25, 2013 of the upstream view of the 150-m transect.

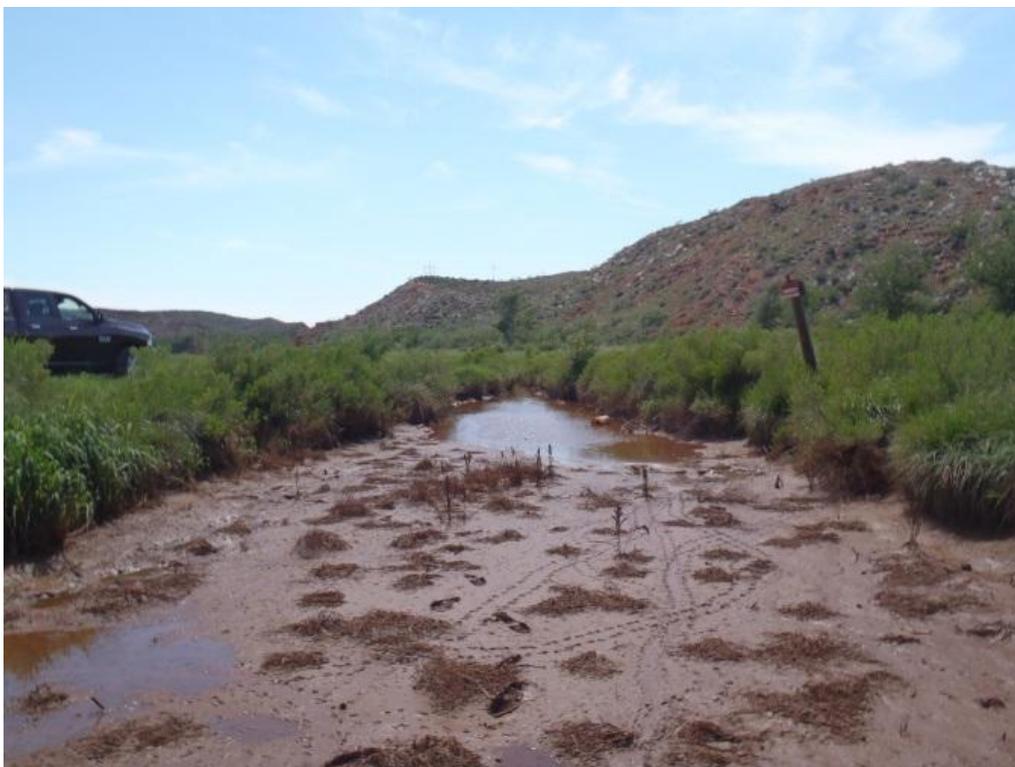
Site DX005 was wadeable for the entire 300-m reach length as only one area of water was encountered. This area with water was located between the 50-m transect and the 110-m transect as depicted in Figure 4-12. With depths of 0.25 meters (0.82 ft) or less, TIAER personnel did not identify this as a significant pool. Dimensions of this pocket of water were between 4.6 m (15 ft) to 5.5 m (18 ft) wide and approximately 60 m (20 ft) long during both of the surveys. The mud/clay dominant substrate made for easy walking except along the one identified pocket of water. Fine sediment on top of a clay bottom made wading challenging in the areas with water present. Typical widths encountered were 0 m with dry conditions noted for most transects, while maximum widths were associated with the one area with water (Tables 4-3 and 4-4).

Figure 4-12 Photograph of Dixon Creek at Site DX005 taken on July 27, 2013 showing the pocket of water, which was encountered during both surveys.

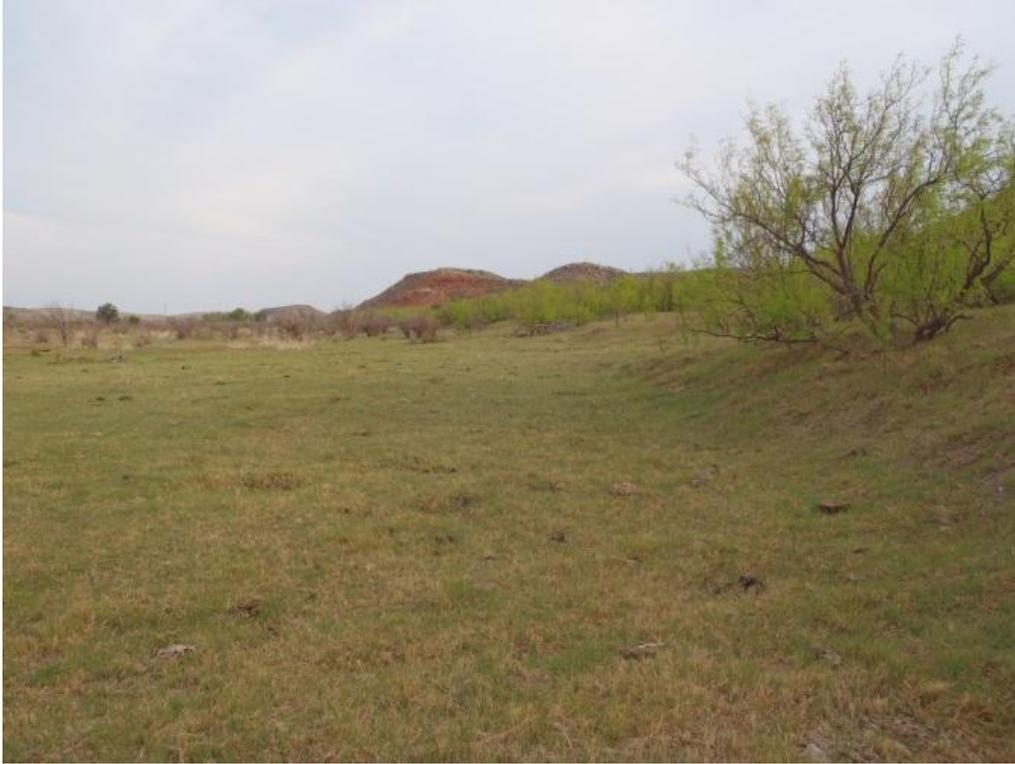
Figure 4-13 Photograph of Dixon Creek at Site DX006 taken May 25, 2013 of the upstream view of the 300-m transect.

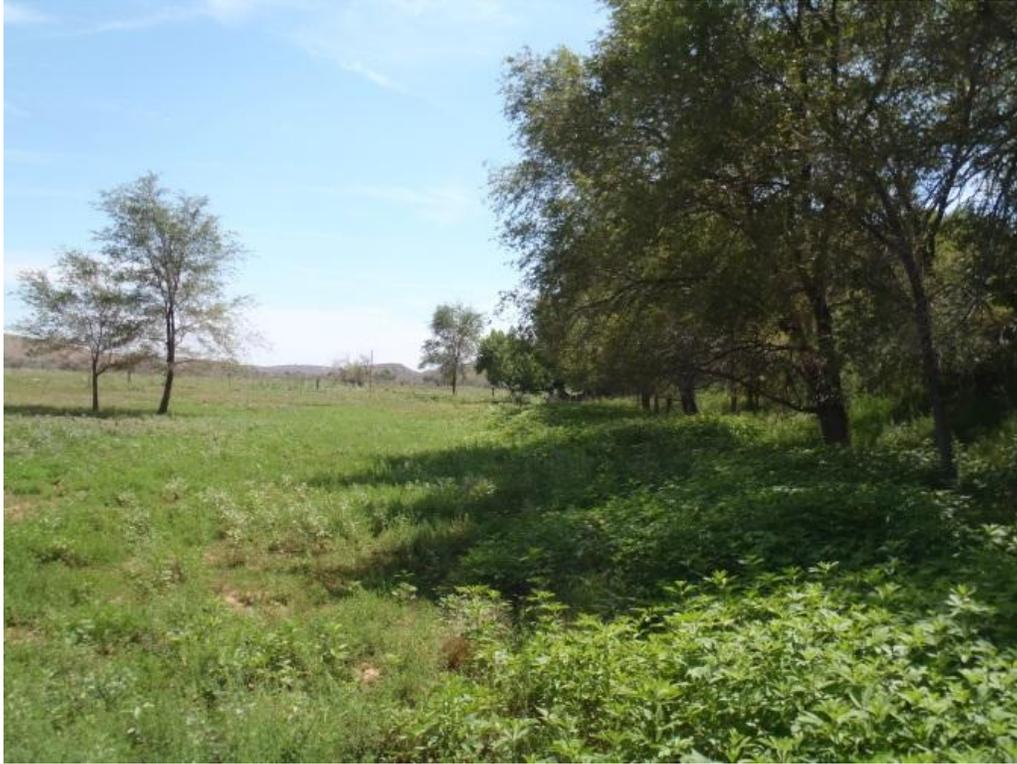
Figure 4-14 Photograph of Dixon Creek at Site DX006 taken July 27, 2013 of the upstream view of the 30-m transect.

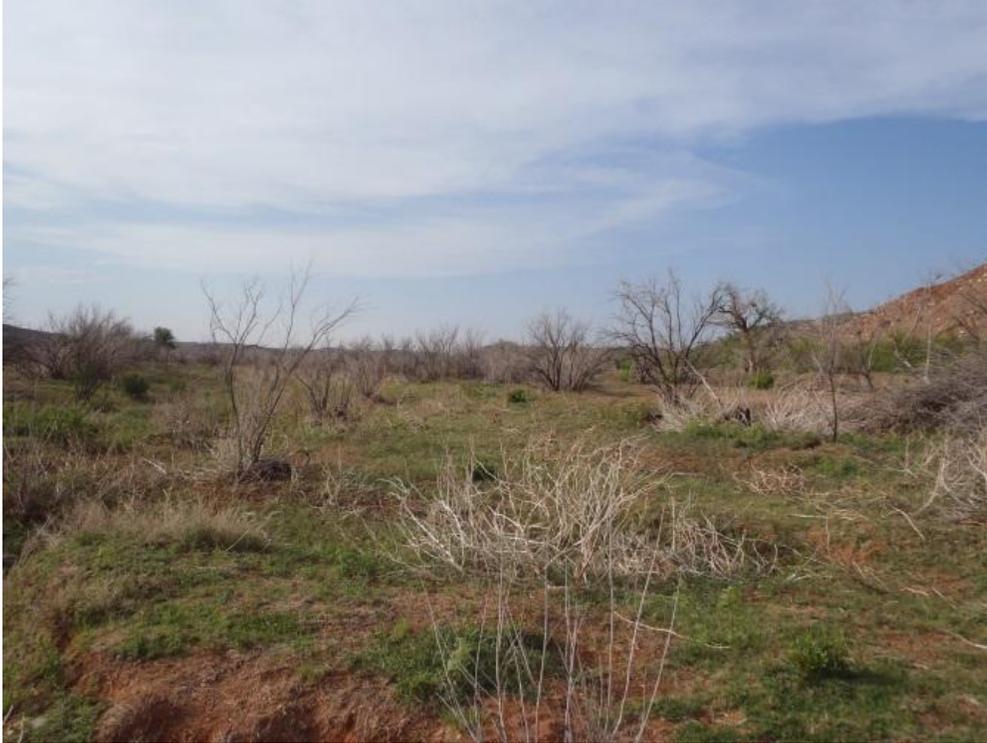
Figure 4-15 Photograph of Dixon Creek at Site DX007 taken May 25, 2013 of the downstream view of the 300-m transect.

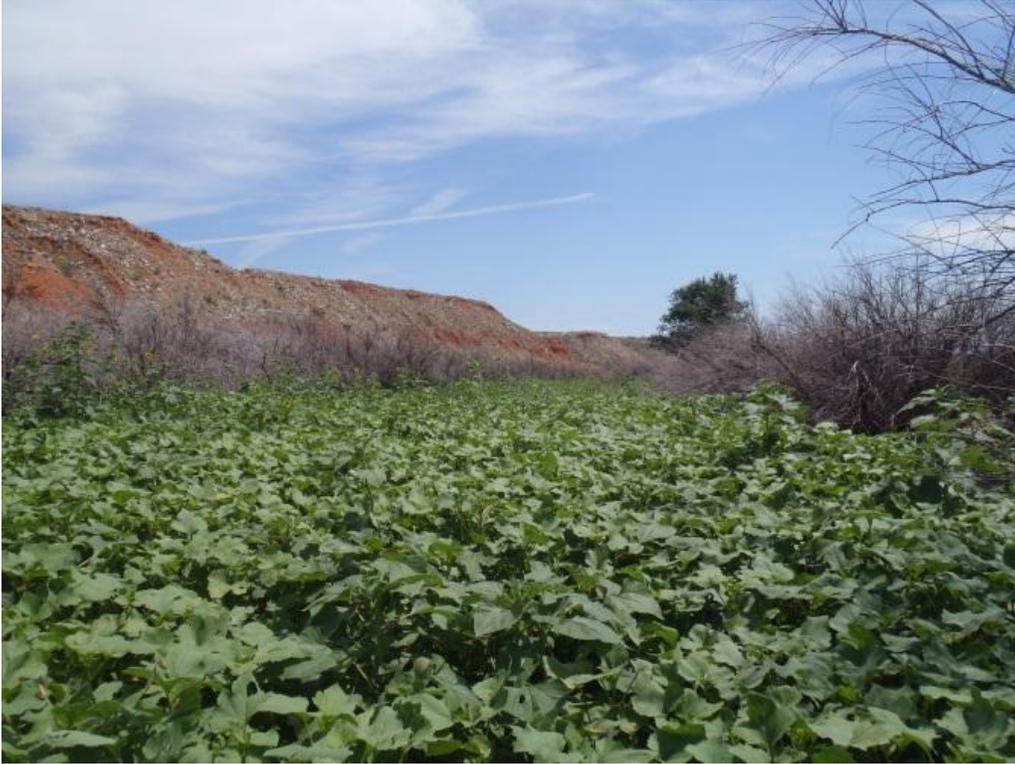
Figure 4-16 Photograph of Dixon Creek at Site DX007 taken July 27, 2013 of the upstream view of the 30-m transect showing the sunflowers.

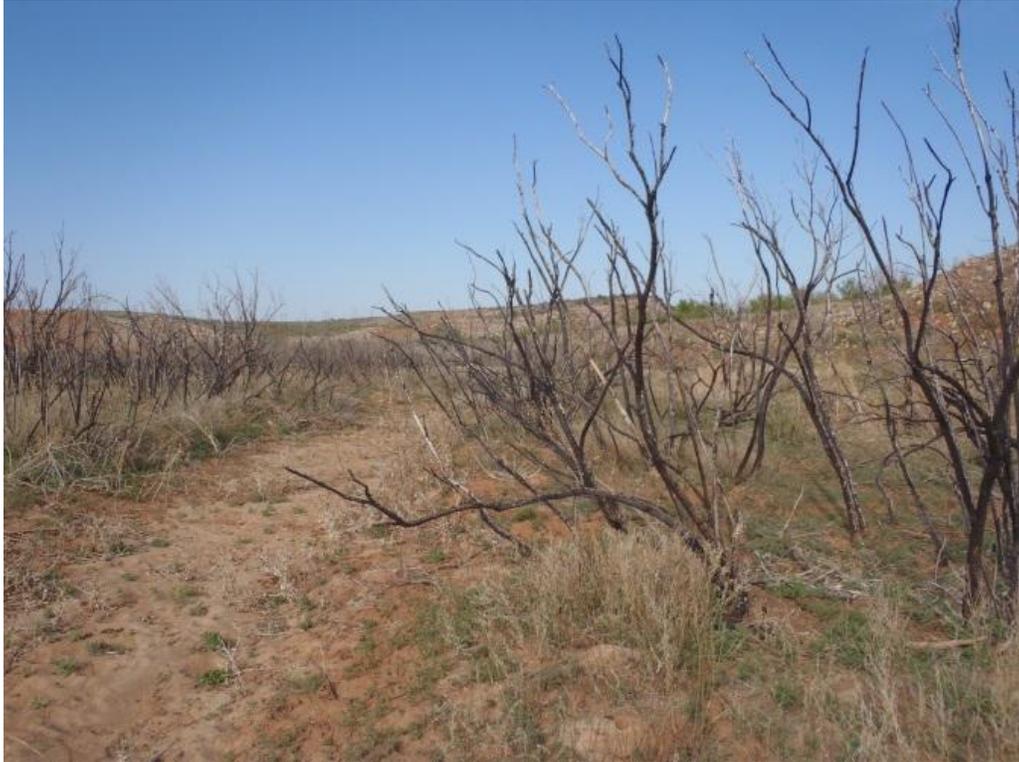
Figure 4-17 Photograph of Dixon Creek at Site DX008 taken May 25, 2013 of the downstream view of the 300-m transect.

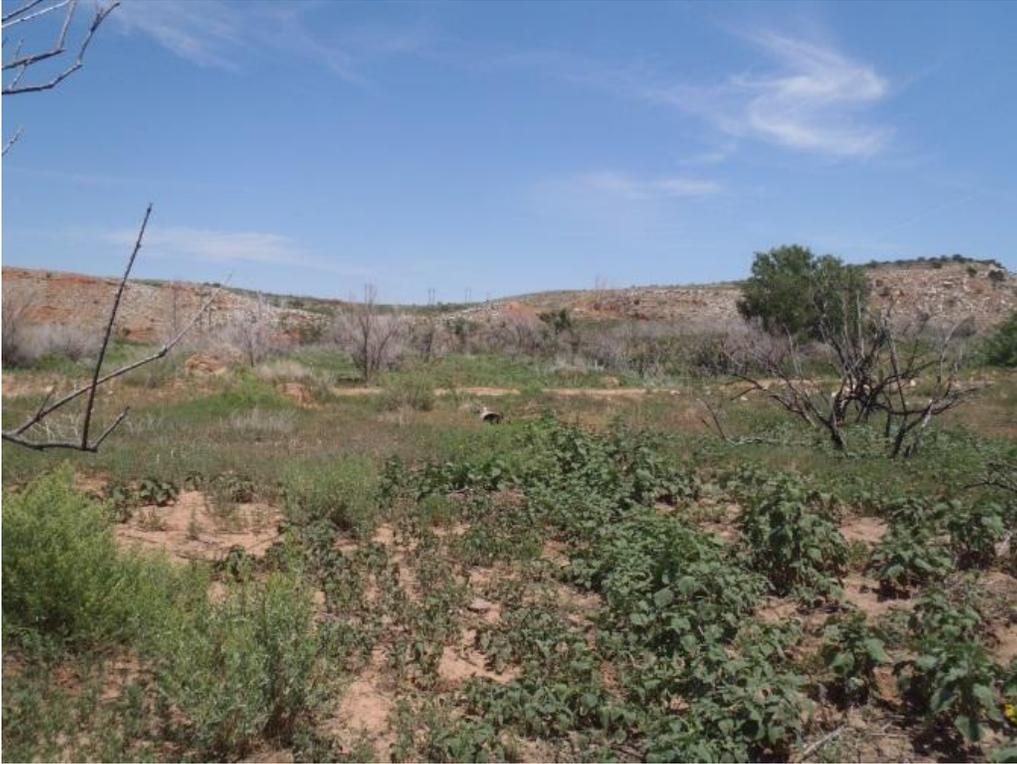
Figure 4-18 Photograph of Dixon Creek at Site DX008 taken taken July 27, 2013, of the downstream view of the 30-m transect showing the sunflowers.

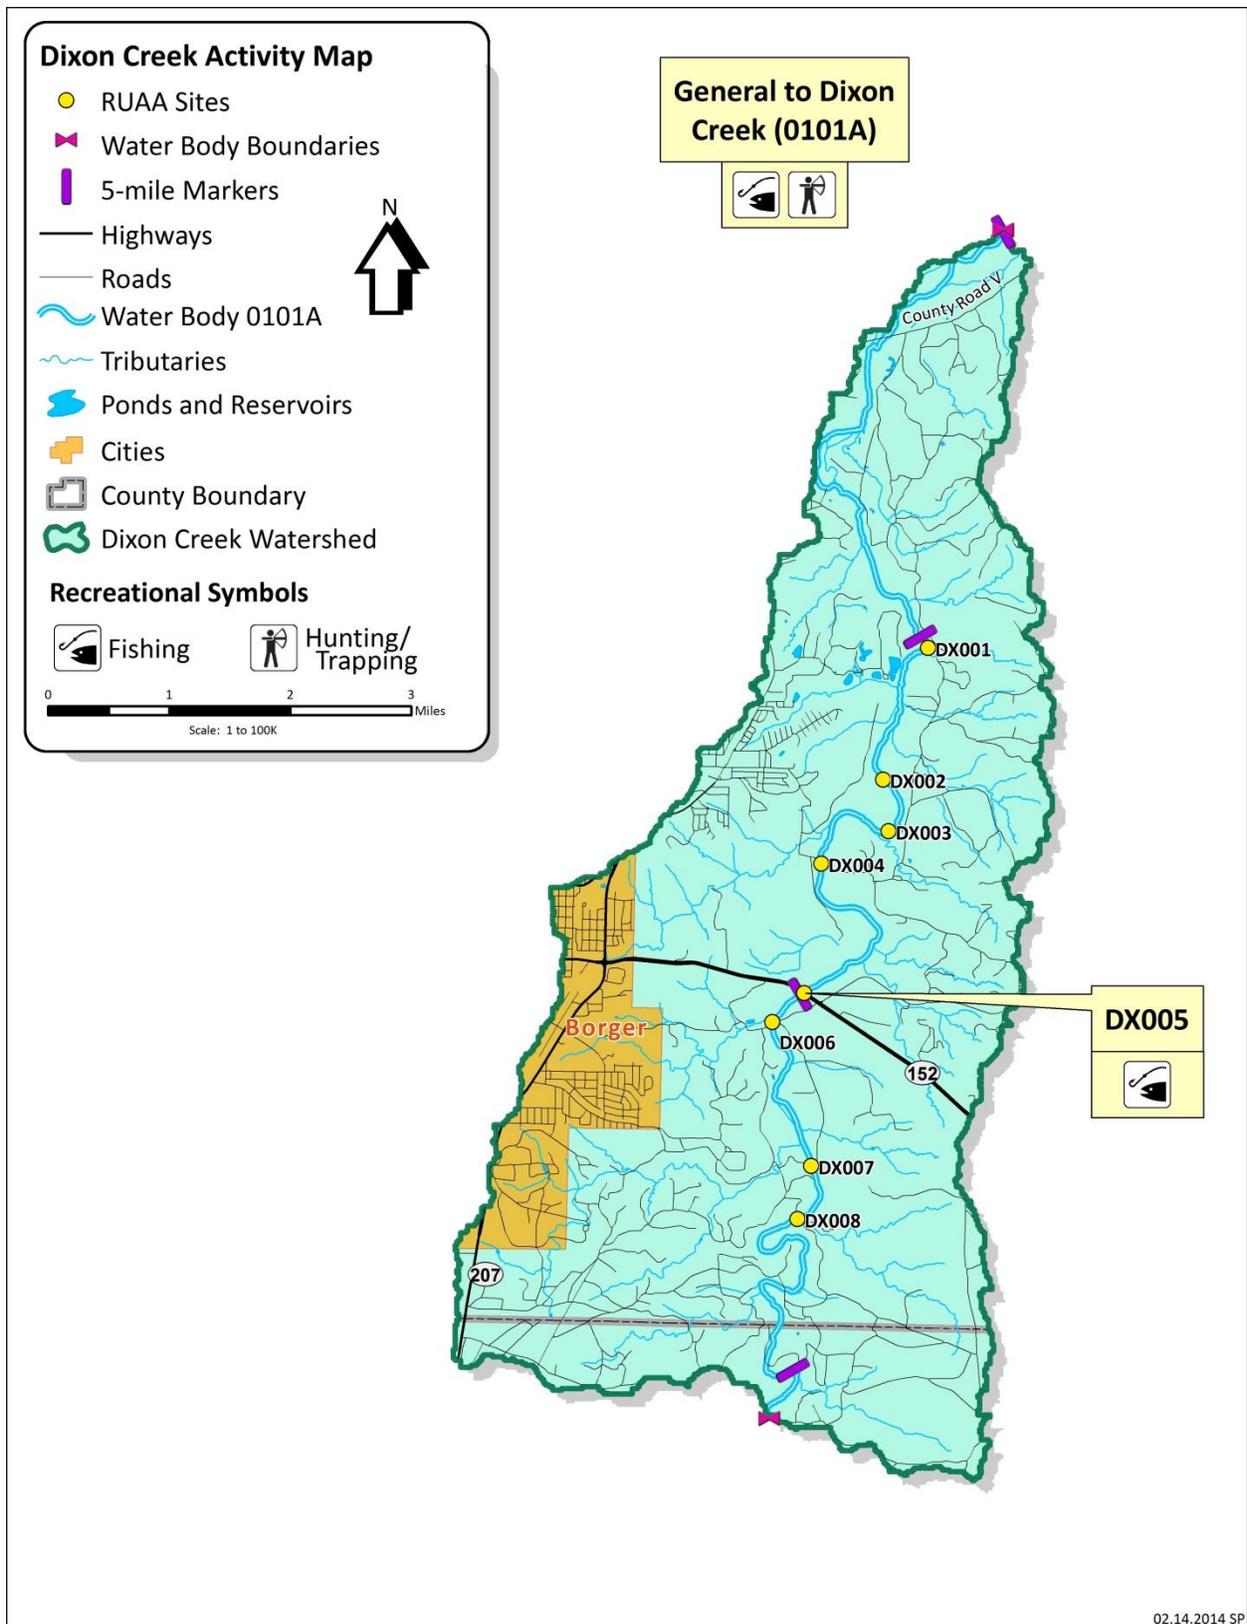
Figure 6-1 Summary of observed and interviewed human activities on Dixon Creek (0101A).
