**Leona River
Recreational Use Attainability Analysis**

**Texas State Soil and Water Conservation Board
Project 11-50**

**Texas Institute for Applied Environmental Research
Tarleton State University
Stephenville, Texas**

June 2013

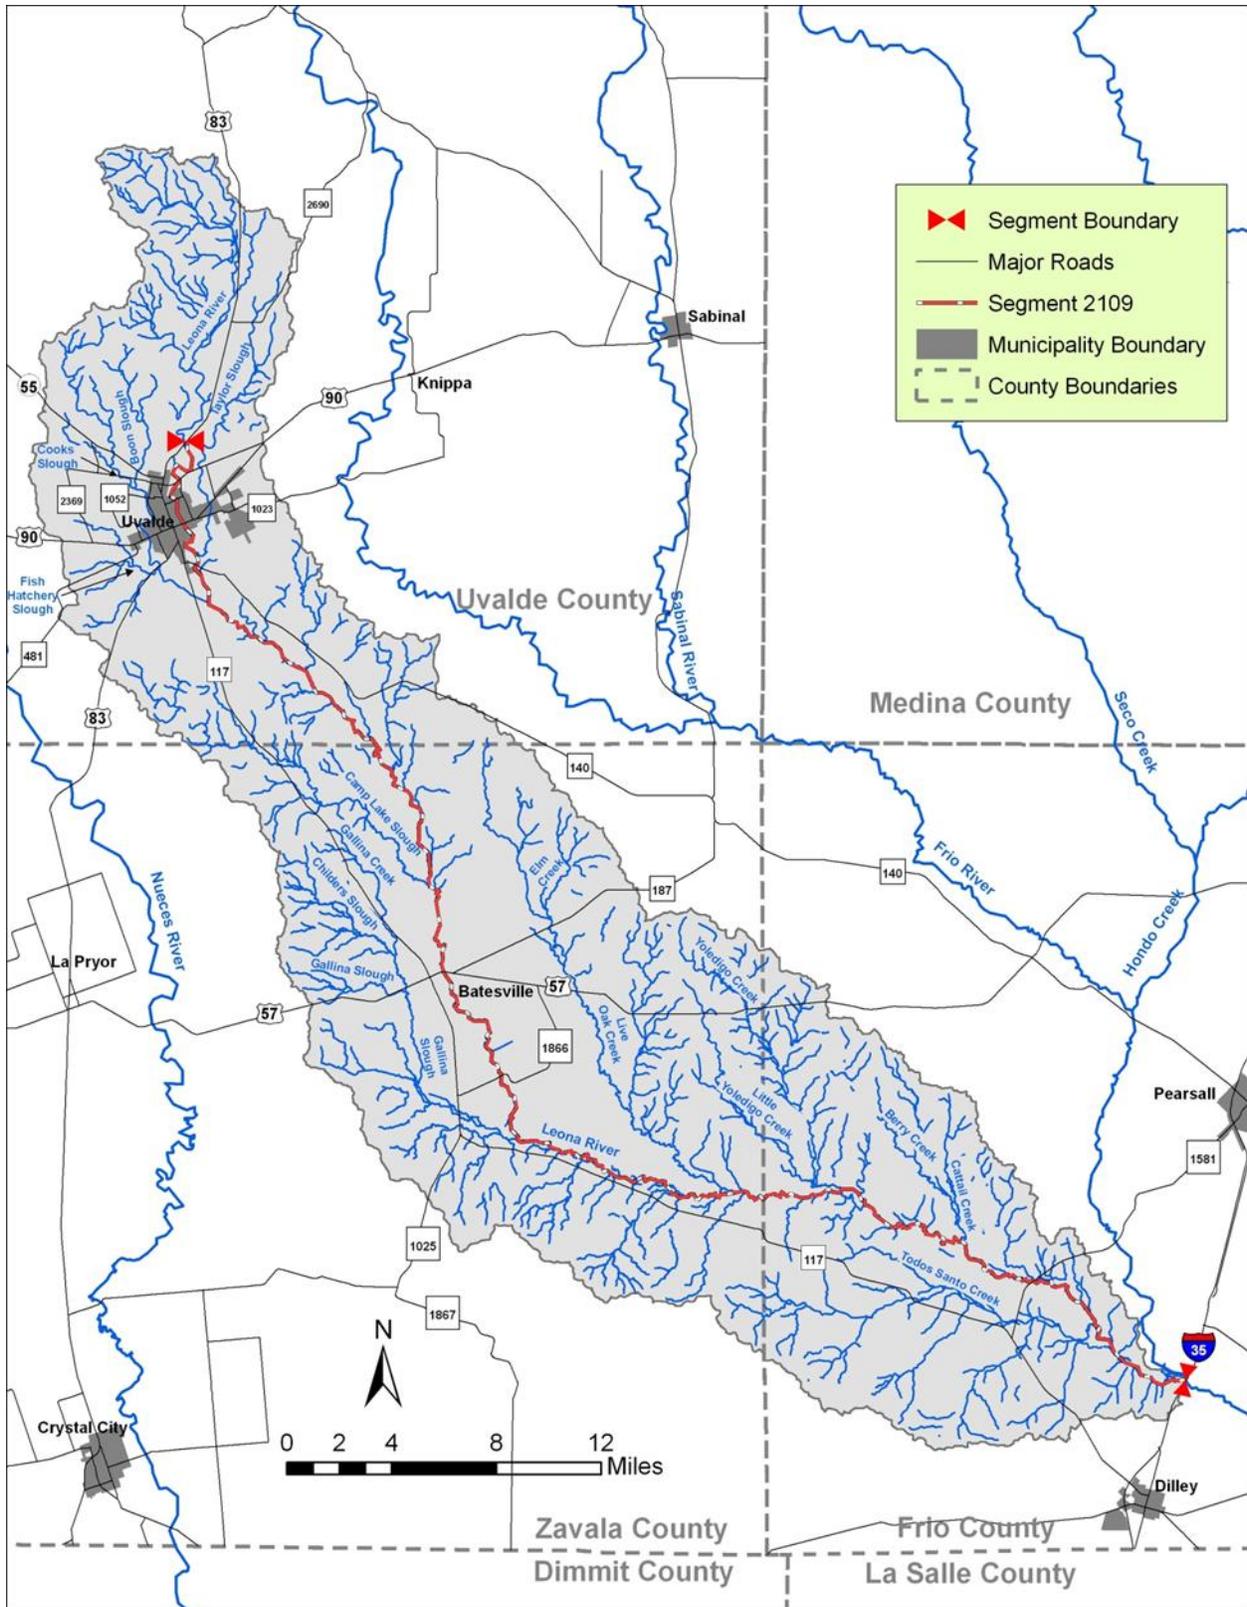
Figure 1-1 Map of Leona River watershed, Segment 2109.

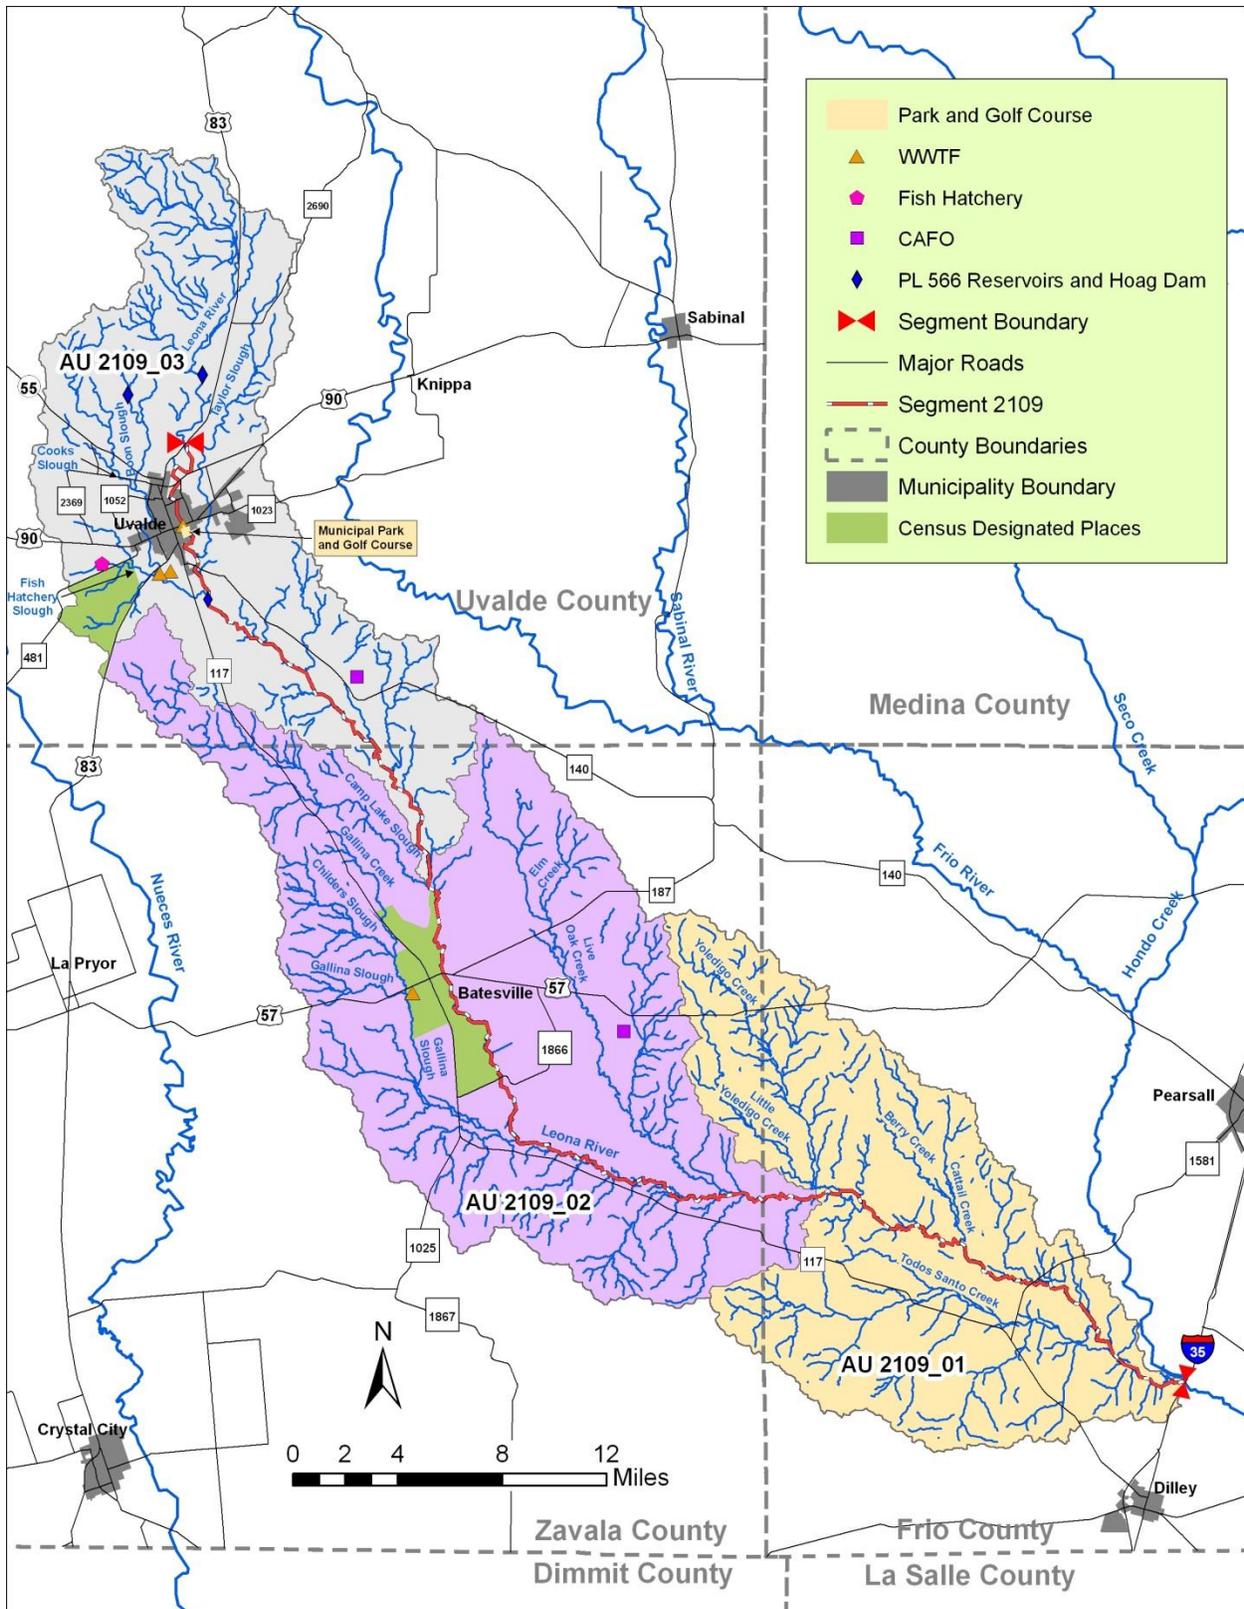
Figure 2-1 Major features throughout the Leona River watershed.

There are two permitted WWTFs located within Segment 2109, the City of Uvalde and the Batesville Water Supply Corporation (WSC). A third permitted discharge represents flush water from the U.S. Fish and Wildlife Service National Fish Hatchery in Uvalde (Figure 2-1). A vegetable processing plant operated by TAFMI, Inc (previously Agrilink Foods) located north of Uvalde had a permit to discharge processing wastewater via land irrigation, but according to TCEQ records queried on February 7, 2012, this operation no longer has an active permit, thus, it is not included in Figure 2-1.

There are currently two permitted concentrated animal feeding operations (CAFO) located within Segment 2109 (Figure 2-1). The Chaparral Cattle Feedlot is located south of Uvalde in AU 2109_03 and the Live Oak Feedlot located southeast of Batesville within the watershed of Liveoak Creek in AU 2109_02. The Live Oak Feedlot is permitted for 8,000 head of beef cattle, while the Chaparral Cattle Feedlot is permitted for 10,000 head of beef cattle. A query of the TCEQ water quality permit database conducted on February 7, 2012 indicated no violations for either facility. These CAFOs have zero discharge permits for wastewaters and manure.

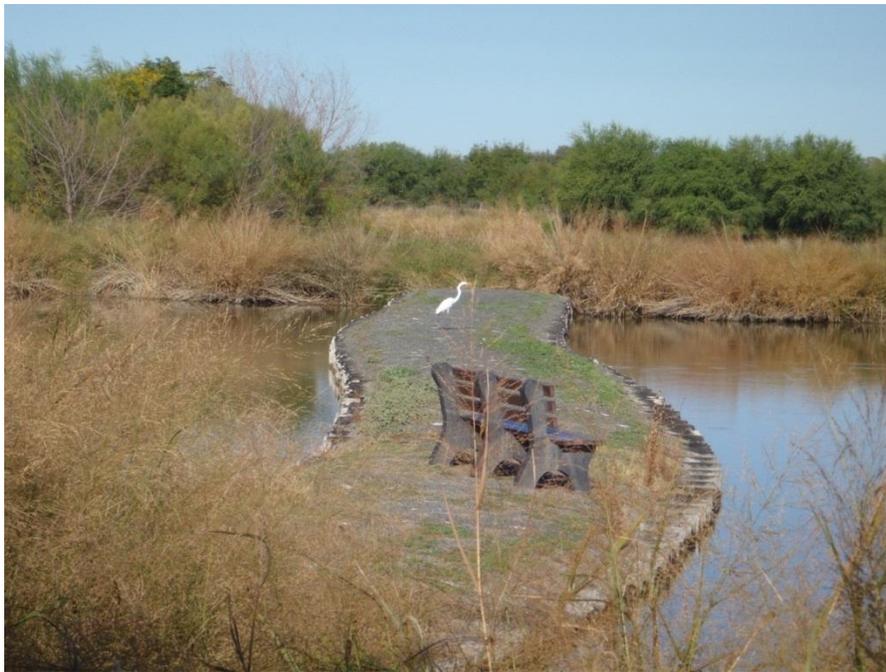
Figure 2-2 Uvalde WWTF wetland ponds that feed into Cooks Slough. Photo taken November 22, 2011.

The City of Uvalde WWTF has three outfalls permitted for a total average daily flow of 0.97 million gallon per day (MGD). Outfall 001 is located at the facility south of the City and discharges into a series of ponds developed as wetlands (Figure 2-2), which then flow into Cooks Slough, a tributary of the Leona River. A portion of the effluent is generally diverted and piped to Outfall 002, which discharges directly into the Leona River at a point within the Uvalde City Park (Figure 2-3). Of the effluent diverted to the Uvalde City Park, a small portion is often pumped into a holding pond for use as irrigation water on the Municipal Golf Course. Based on a review of discharge records, Outfall 003 for the City of Uvalde is seldom used but is located near the facility and directly discharges into Cooks Slough, bypassing the wetland ponds.

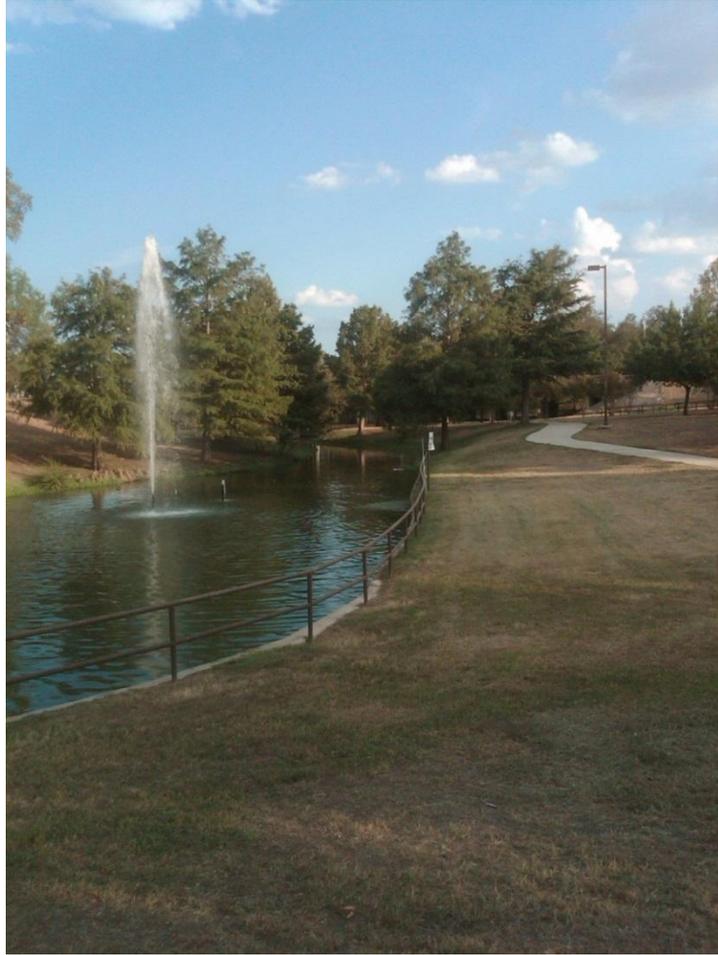
Figure 2-3 Uvalde WWTF discharge location with the Uvalde City Park. Photo taken September 28, 2011.

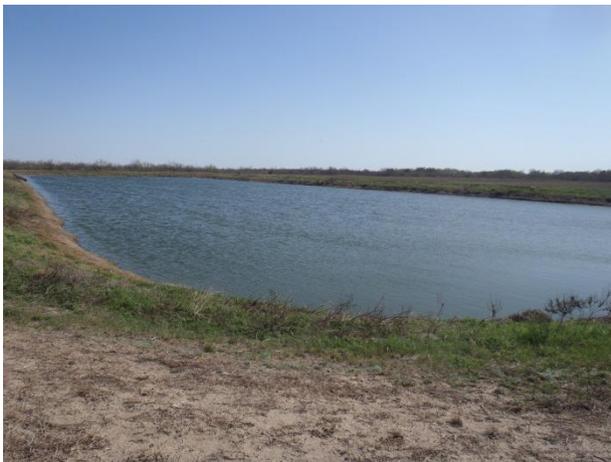
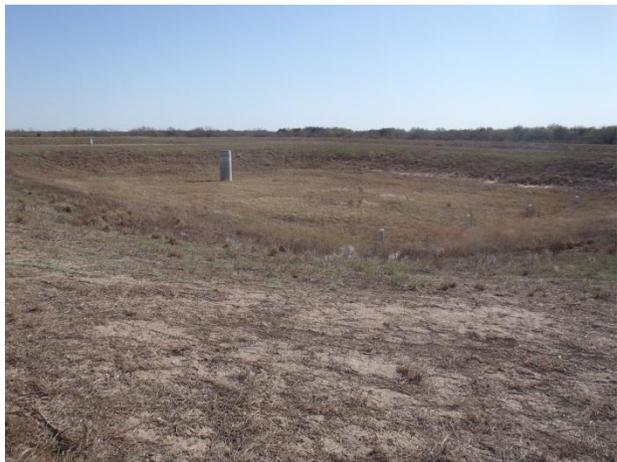
Figure 2-4 Batesville WWTF effluent holding ponds 1 and 2. Photos taken March 9, 2011.

The Batesville WSC WWTF is a pond system that includes four stabilization lagoons in series (No. WQ0014394001, TX0125385). As of December 2011, only one of the four lagoons in the series had filled. Evaporation is the primary means of effluent removal from the lagoons (Figure 2-4), and based on a records review of available data through December 2011, no discharges and, thus, no sampling had been reported. According to the permit amendment issued December 16, 2011, no sludge has been removed from the pond system. If sludge is removed it is to be disposed of at a TCEQ authorized land application site or co-disposal landfill. If a discharge were to occur from the Batesville pond system, it would flow into Gallina Slough, a major tributary of the Leona River located in AU 2109_02. The permitted discharge for the Batesville WWTF is 0.184 MGD.

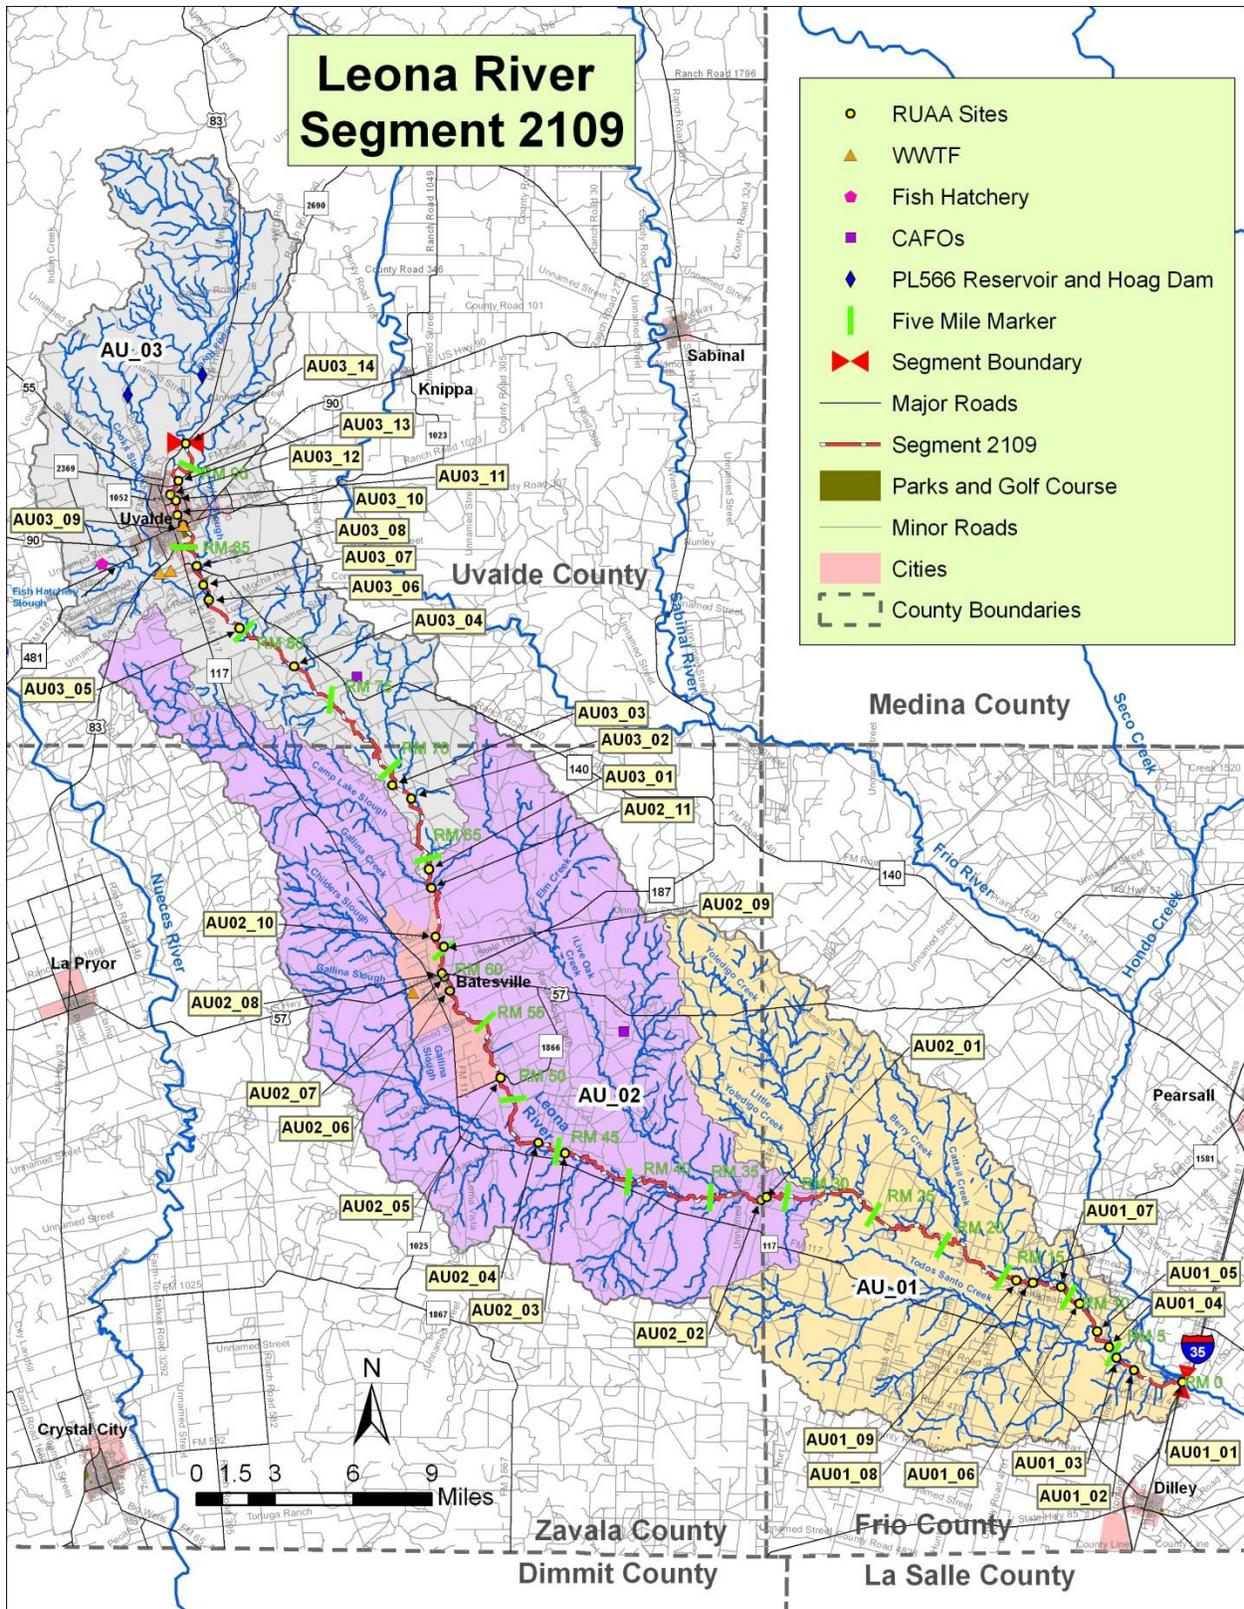
Figure 3-1 Map of Leona River, Segment 2109, RUA survey sites.

- The location of areas along the segment that were accessible to the public and had the highest potential for recreational use (see Figure 3-1);
- The location of wastewater treatment facility outfalls and other potential point sources (see Figure 3-1);
- The hydrologic characteristics, such as stream type, streamflow, hydrologic alterations, etc. (see Figure 3-1, and McFarland and Adams, 2012); and
- The location of proposed sites for data collection following TCEQ guidance (TCEQ, 2009).

On January 19, 2012, TIAER presented a list of proposed RUAA sites to an aggregate of state and local agencies including TCEQ, TSSWCB, NRA, TPWD, City of Uvalde, and others. The final RUAA sites noted in Figure 3-1 and Table 3-1 reflect the results of input received following the meeting. Site selection was also greatly aided by efforts of the NRA in soliciting the cooperating of landowners for this project.

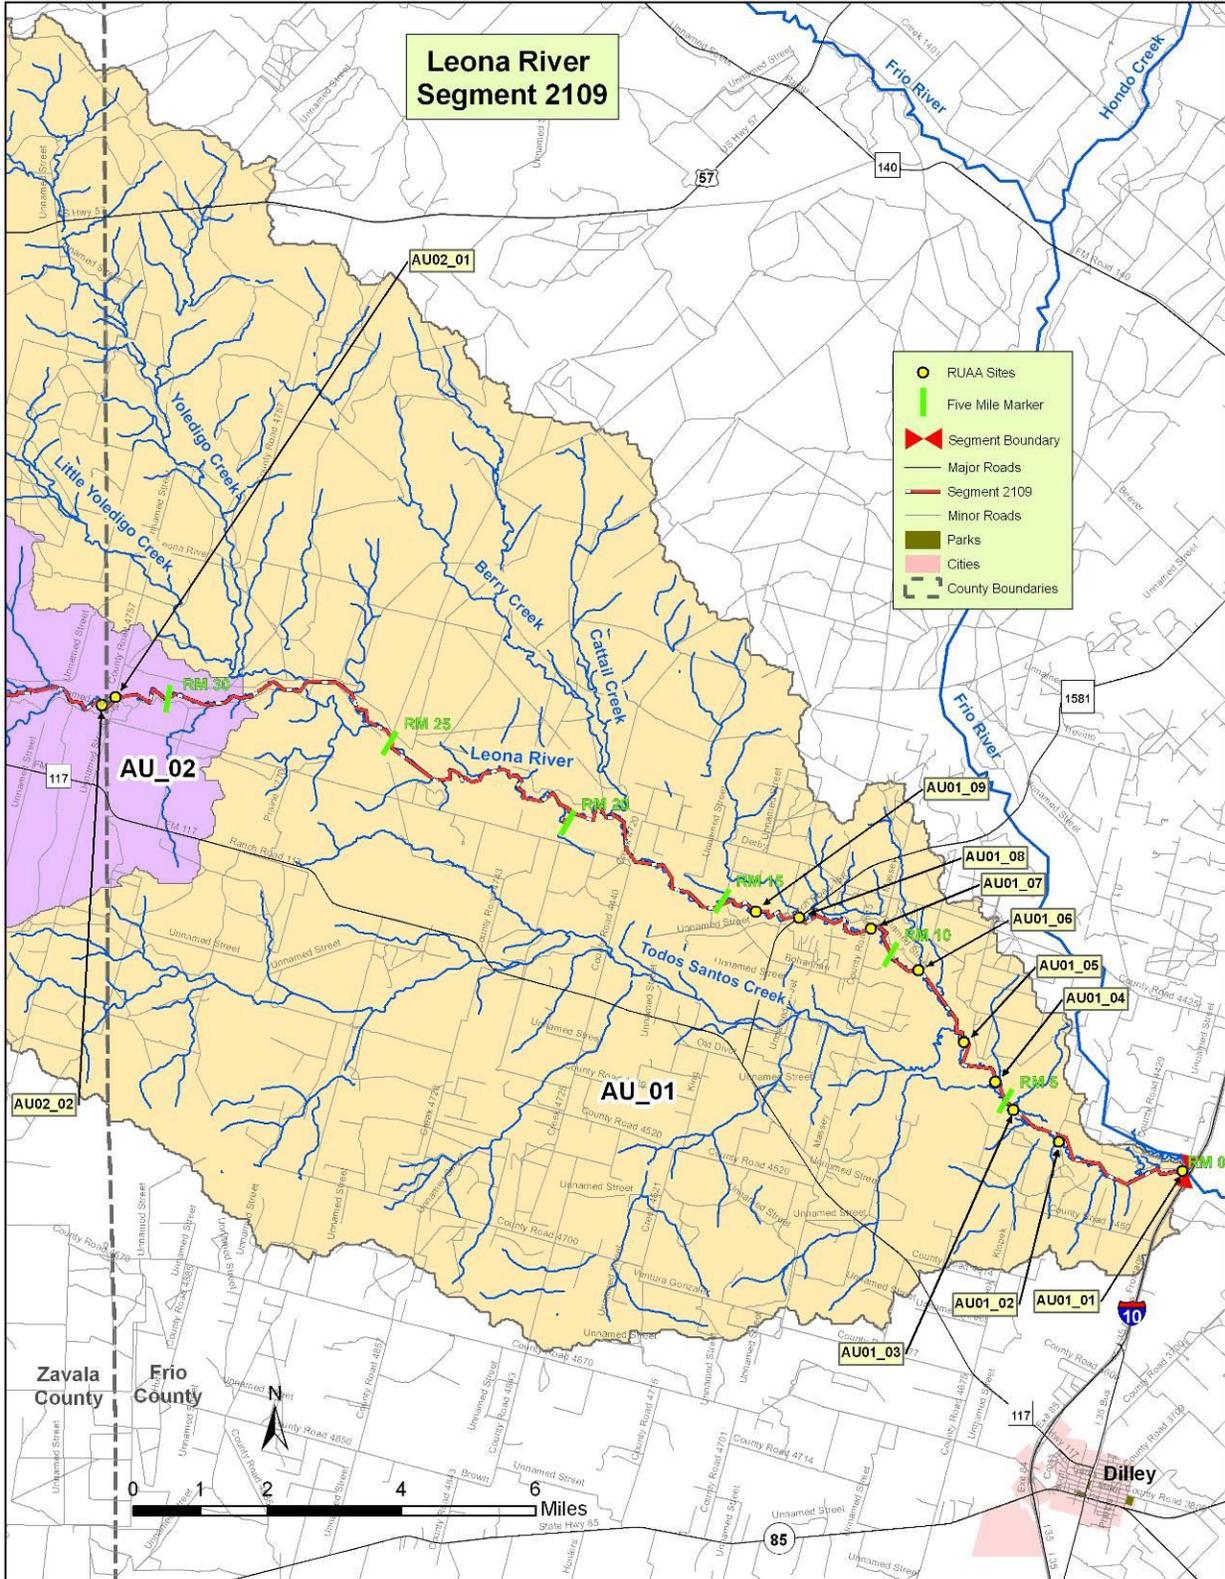
Figure 4-1 Leona River AU 2109_01 showing RUA sites

Nine sampling sites were located in AU 2109_01 (Figure 4-1). Although 17 sampling sites were sought, only three landowners were willing to offer access through their properties. One site was chosen at a public road crossing that did not require permission for access to the river. Several large ranches that border the Leona River in this AU were approached about the RUAA survey, but opted not to participate. These eight privately controlled sites were selected to provide physical characterization of the Leona River in areas between public access points. Entrances to sites on private lands were limited by fences and locked gates and were often several meters to kilometers from the stream. The site located at the public crossing provided easy access to the stream. RUAA surveys were performed in May and July of 2012 at these locations. A brief description of each site follows.

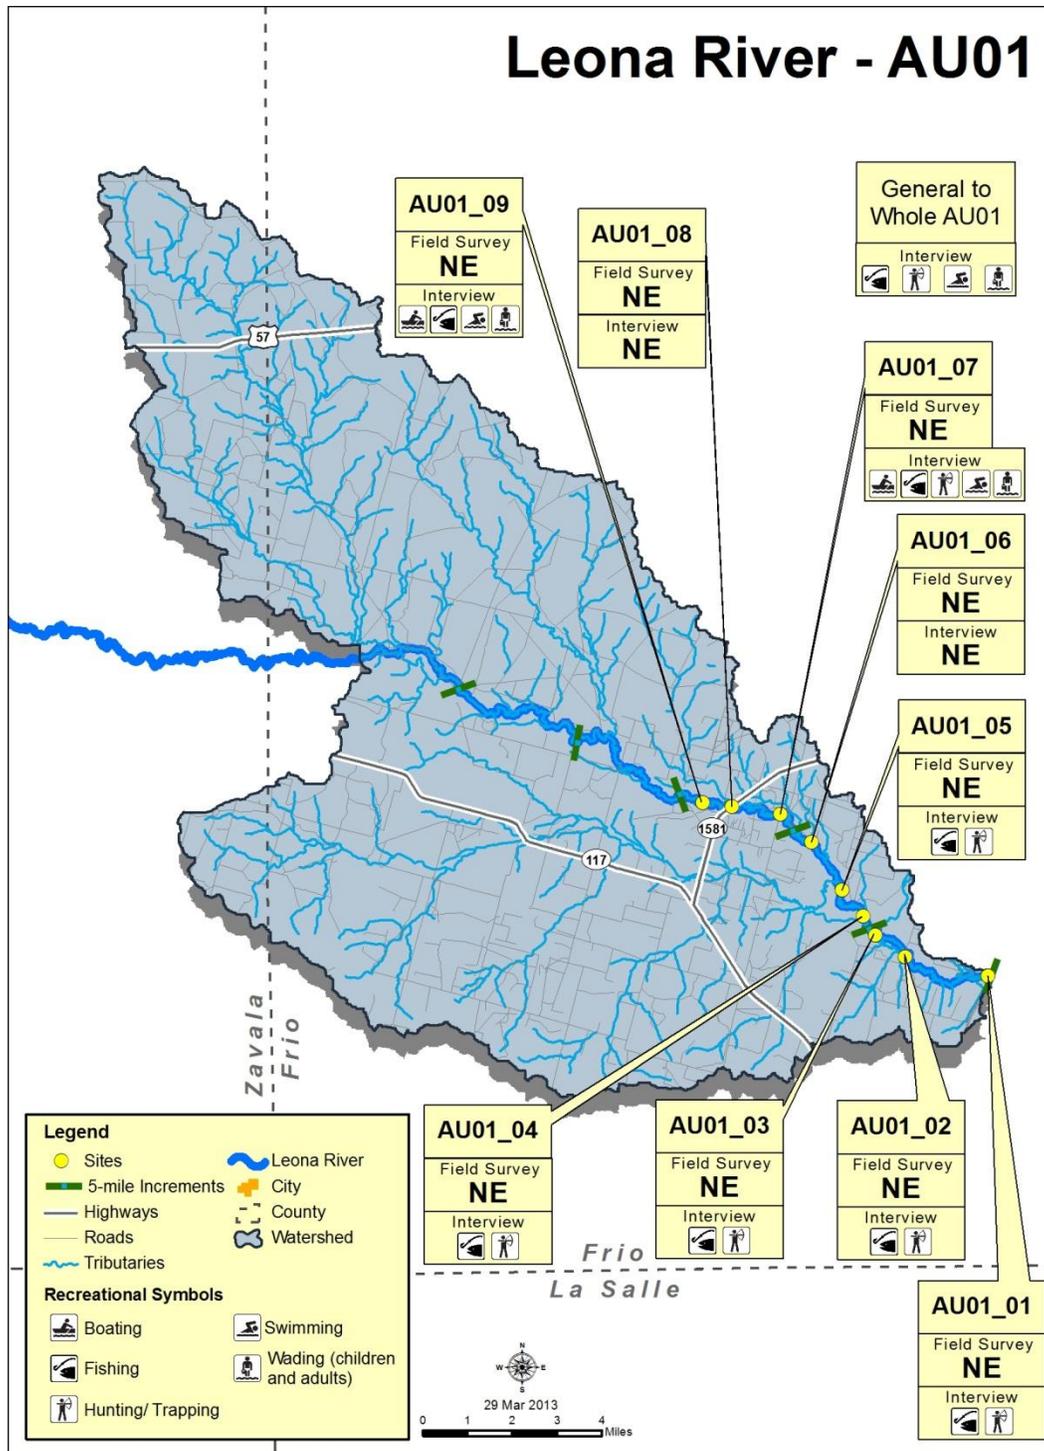
Figure 4-2 Summary of activities from field surveys and interviews in AU 2109_01. NE indicates not encountered.

The Leona River in AU2109_01 flows primarily through privately owned properties of substantial acreages. Public access is limited to two road crossings (CR 4440 and FM 1581), and the right-of-way on CR 4440 was very limited due to high game fences on either side. Fences, locked gates, steep banks, and dense vegetation all combine to limit access to the river in this segment. In the channel, fallen trees and log piles were often encountered obstructions. No aquatic recreational activities were observed by TIAER field staff during the surveys, with the exception of two fishing bobbers observed at sites AU01_01 and Site AU01_08. The bobbers were suspected to have washed in from upstream, but with the reports of fishing from the interviews, it is possible that they did not wash in from upstream. The individuals interviewed in AU 2109_01 were all property owners within the Leona River watershed, most with land directly along the river. Fishing and hunting occur throughout the watershed while swimming, wading, and boating were generally more site specific. All of the persons interviewed stated that it had been years since any form of recreation had occurred due to the lack of water. These activities are summarized in Table 4-6 and Figure 4-2.

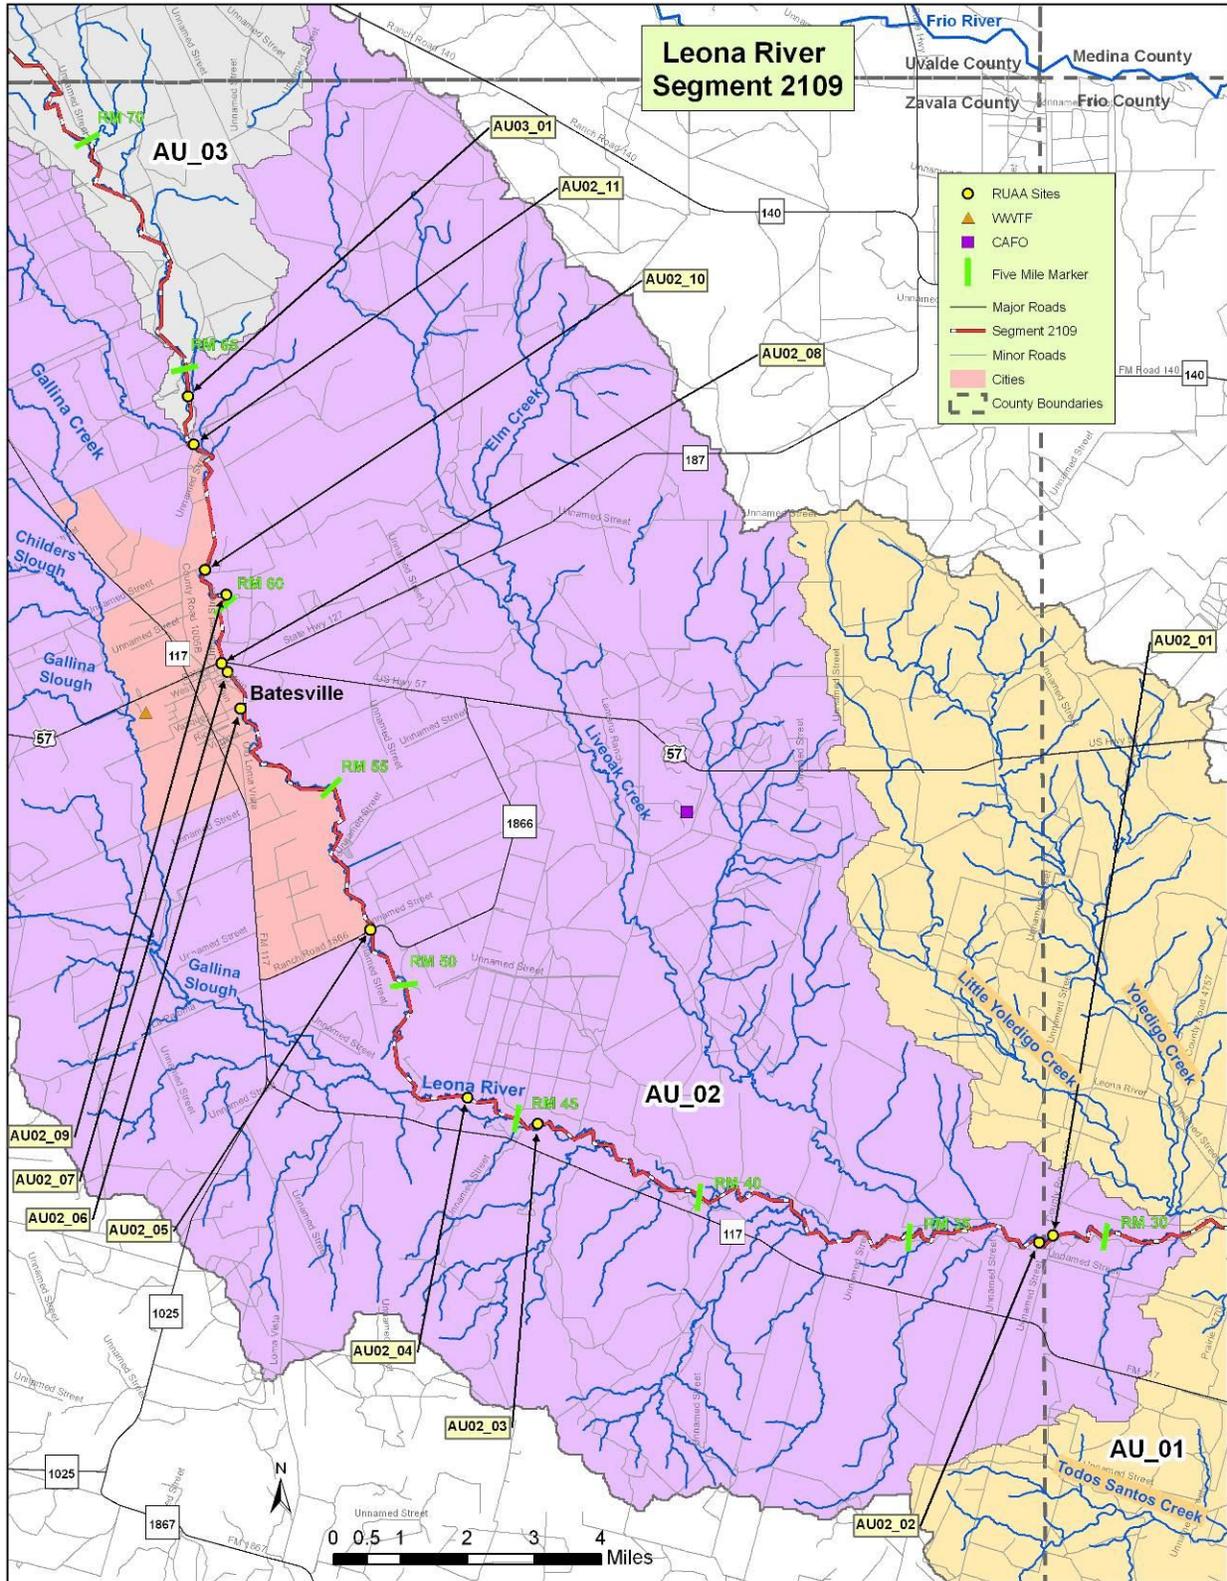
Figure 5-1 Leona River AU 2109_02 showing RUAA sites

AU 2109_02 of the Leona River runs about 34 miles from the confluence with Yolidigo Creek upstream to the confluence with Camp Lake Slough (Figure 5-1). AU 2109_02 crosses portions of Frio and Zavala Counties. Reconnaissance of this section of the river yielded six publicly accessible locations. With assistance from the NRA, TIAER was able to gain landowner cooperation, as needed, at all six of the public sites and five additional sites that had private access only.

No permitted facilities directly discharge into the Leona River within AU 2109_02 (see Figure 5-1). There is one WWTF, the Batesville WSC, which discharges into Gallina Slough, a major tributary of the Leona River. There is also one CAFO within the subwatershed of Liveoak Creek.

Twenty sites were sought for this AU but only a limited number of landowners granted permission for access to their property. With the cooperating landowners and publicly accessible locations, TIAER was able to establish 11 survey sites within AU 2109_02 (Figure 5-1). RUAA surveys were performed twice in 2012 at each of these 11 sites.

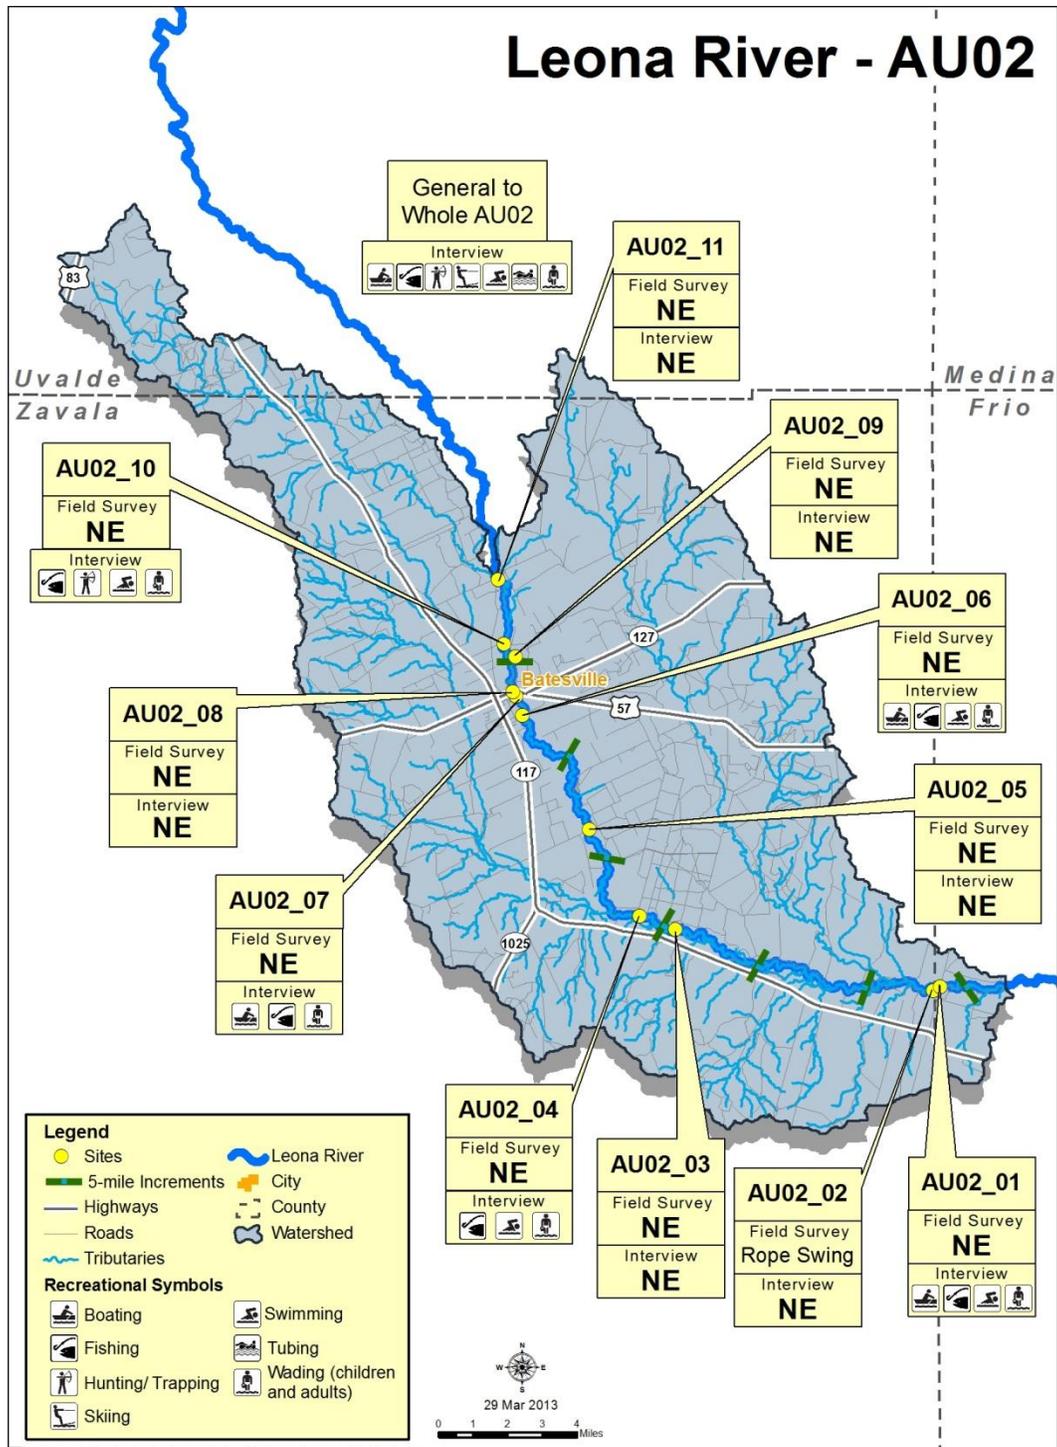
Figure 5-2 Summary of activities from field surveys and interviews in AU 2109_02. NE indicates not encountered.

As observed in AU2109_01, the Leona River in AU2109_02 flows primarily through privately owned properties of substantial acreages. Public access is limited to the right-of-way at four road crossings, a park area off CR 1011, and the Batesville City Park. Fences, locked gates, steep banks, and dense vegetation all combine to limit access to the river in this approximately 34-mile long segment. No aquatic recreational activities were observed by TIAER field staff during the surveys in May and July 2012. The individuals interviewed in the AU02 were all either property owners on whose property we had permission to conduct the surveys or other citizens with knowledge of recreational activities occurring on the Leona River. Fishing, swimming, and wading were the primary recreational activities reported as occurring since 1975. In addition, all forms of boating, hunting, and trapping were also reported to have occurred. All of the interviews stated that no recreation has occurred since the river went dry several years ago. The survey information is summarized in Table 5-6 and Figure 5-2.

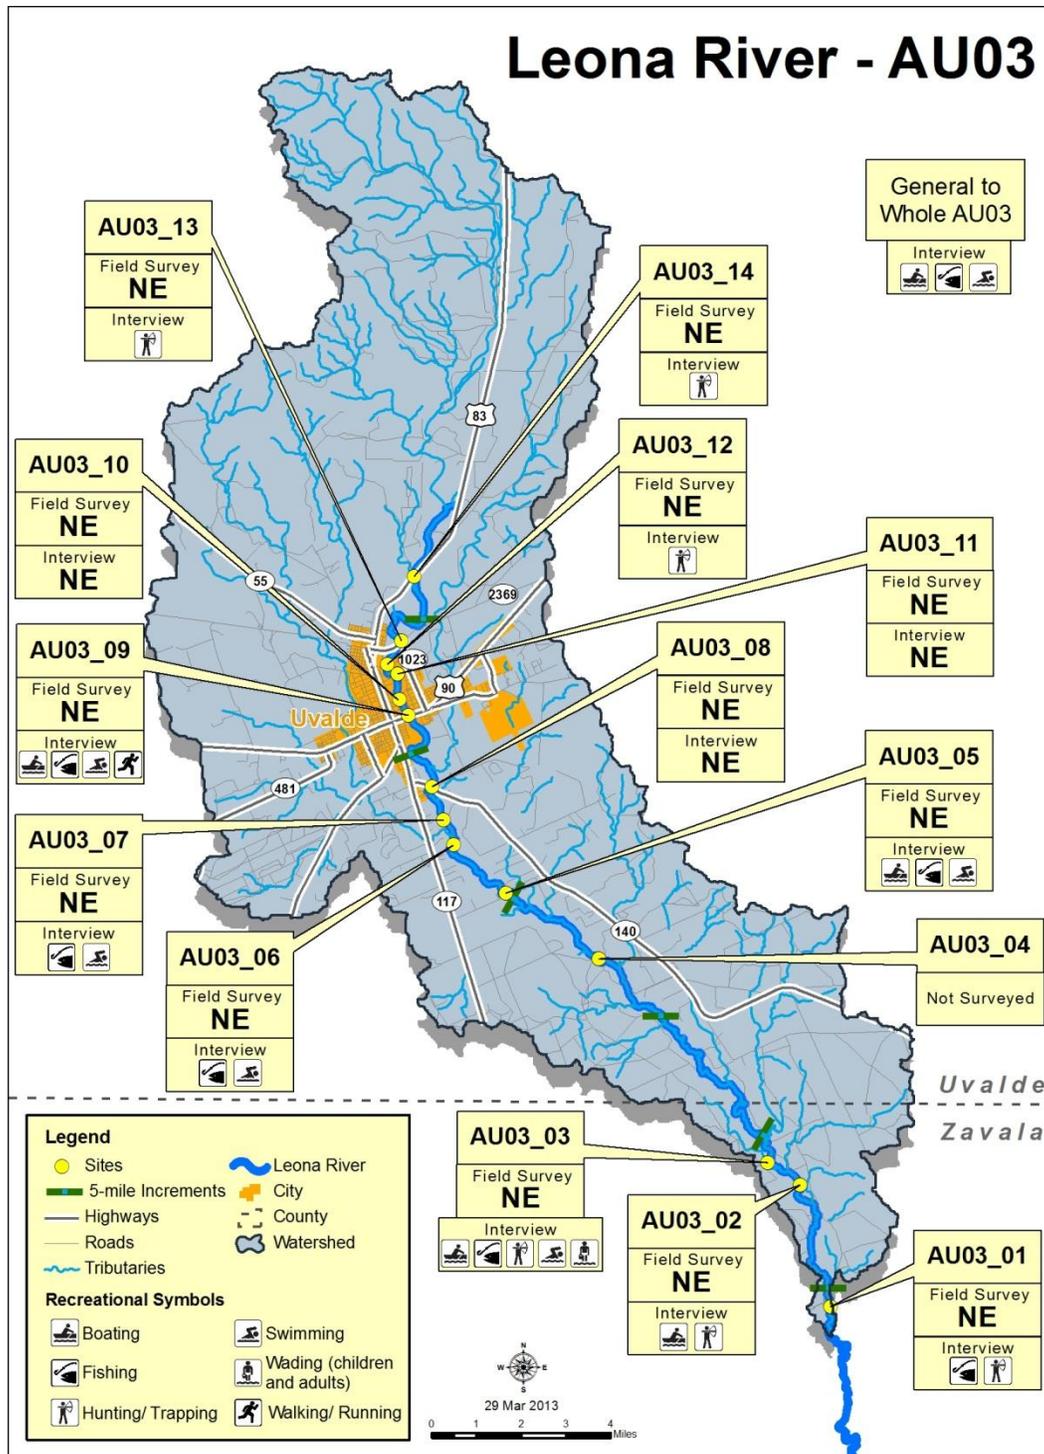
Figure 6-2 Summary of activities from field surveys and interviews in AU 2109_03. NE indicates not encountered.

No aquatic recreational activities (either primary or secondary) were observed by TIAER field staff during the surveys on 2012. Within the City of Uvalde, several areas did provide easy access to the river, including the Uvalde City Park. Within the Uvalde City Park, a city ordinance prohibits swimming, wading, and fishing, because these activities may cause damage to the impoundment liner at this location and also because the water within the river at the Uvalde City Park includes recycled wastewater from the Uvalde WWTF. Outside the City of Uvalde, fences, locked gates, and distance available to recreate at road crossings limited recreational opportunities along large sections of the Leona River. Within the Fort Inge Historical Park, no recreational activities were observed, but interviewees indicated that swimming, fishing, and boating had occurred at this location and access to the water was relatively easy. Information shared by landowners and other people within the segment revealed fishing, swimming, hunting, and some boating had occurred within this AU. These activities took place primarily at Sites AU03_06 and AU03_07 at Fort Inge and Site AU03_09, the Uvalde City Park. A summary of observed and interviewed activities by site are provided in Table 6-6 and Figure 6-2.

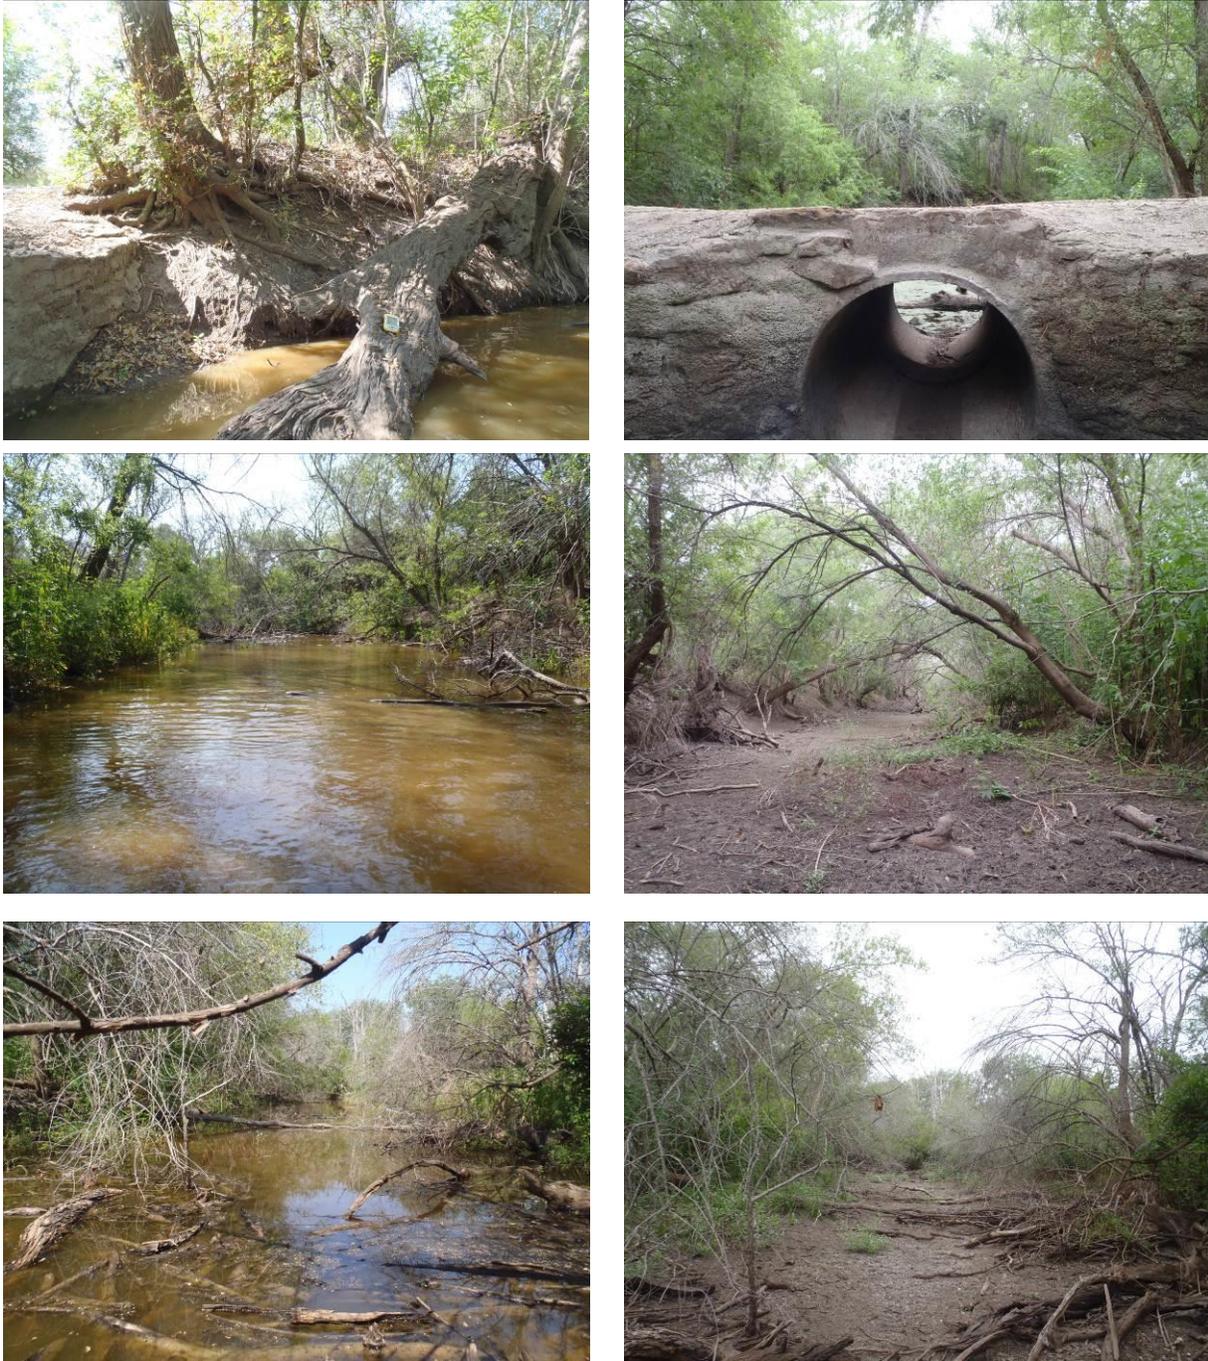
Photogroup 4-1 Leona River Site AU01_01 depicting access and the general appearance of the stream. Top Left - 0-m transect, right bank view, May 2012; Top Right - 0-m transect, downstream view, July 2012; Middle Left – 150-m transect downstream view, May 2012; Middle Right – 150-m transect upstream view, July 2012; Bottom Left – 300-m transect upstream view, May 2012; Bottom Right – 300-m transect upstream view, July 2012.

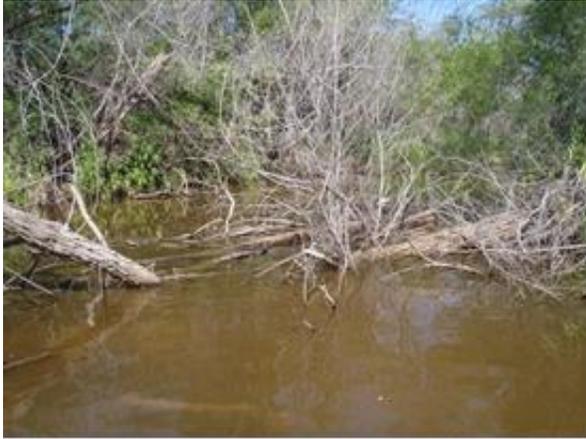
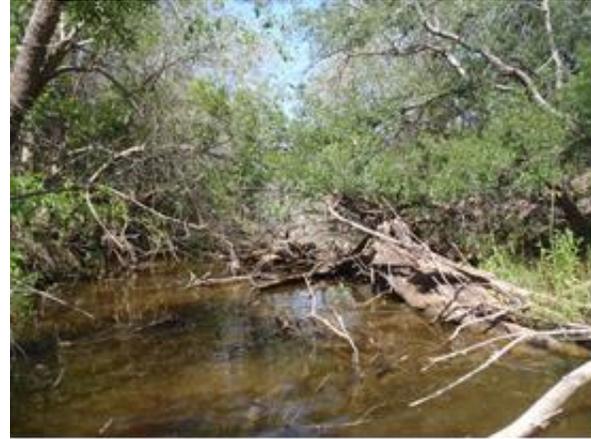
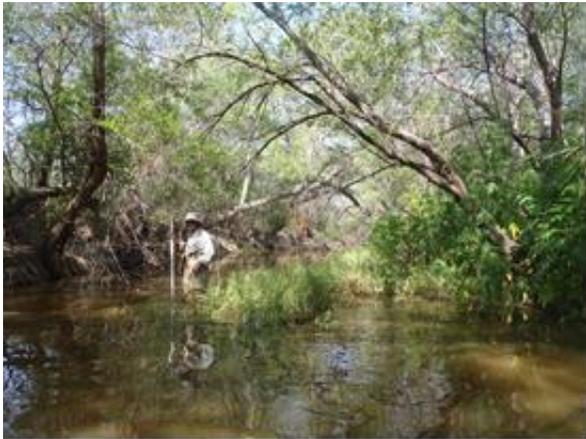
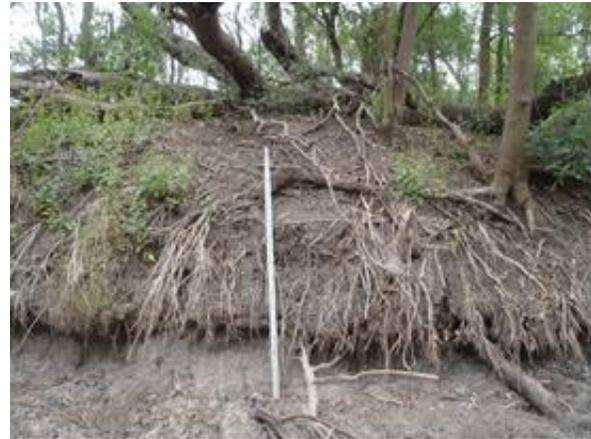
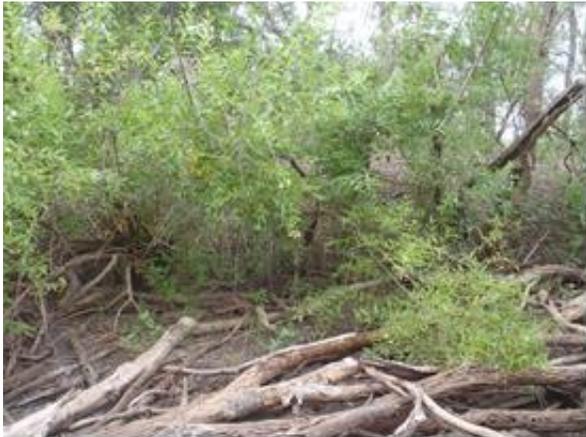
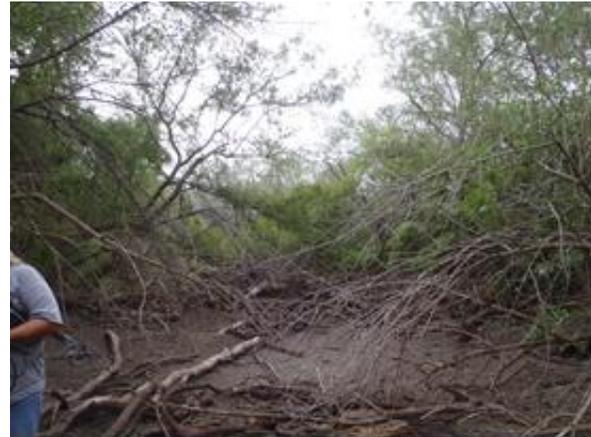
Photogroup 4-2 Leona River Site AU01_01 depicting obstructions, field staff wading in the stream, and streambank access. (All individuals pictured are TIAER staff.) Top Left – obstruction 1, May 2012; Top Right – obstruction 2, May 2012; Middle Left – 0-m transect upstream view, May 2012; Middle Right – 150-m transect left bank view, July 2012; Bottom Left – 300-m transect, right bank view, July 2012; Bottom Right – 300-m transect downstream view, July 2012.
