**Leona River
Recreational Use Attainability Analysis**

**Texas State Soil and Water Conservation Board
Project 11-50**

**Texas Institute for Applied Environmental Research
Tarleton State University
Stephenville, Texas**

June 2013

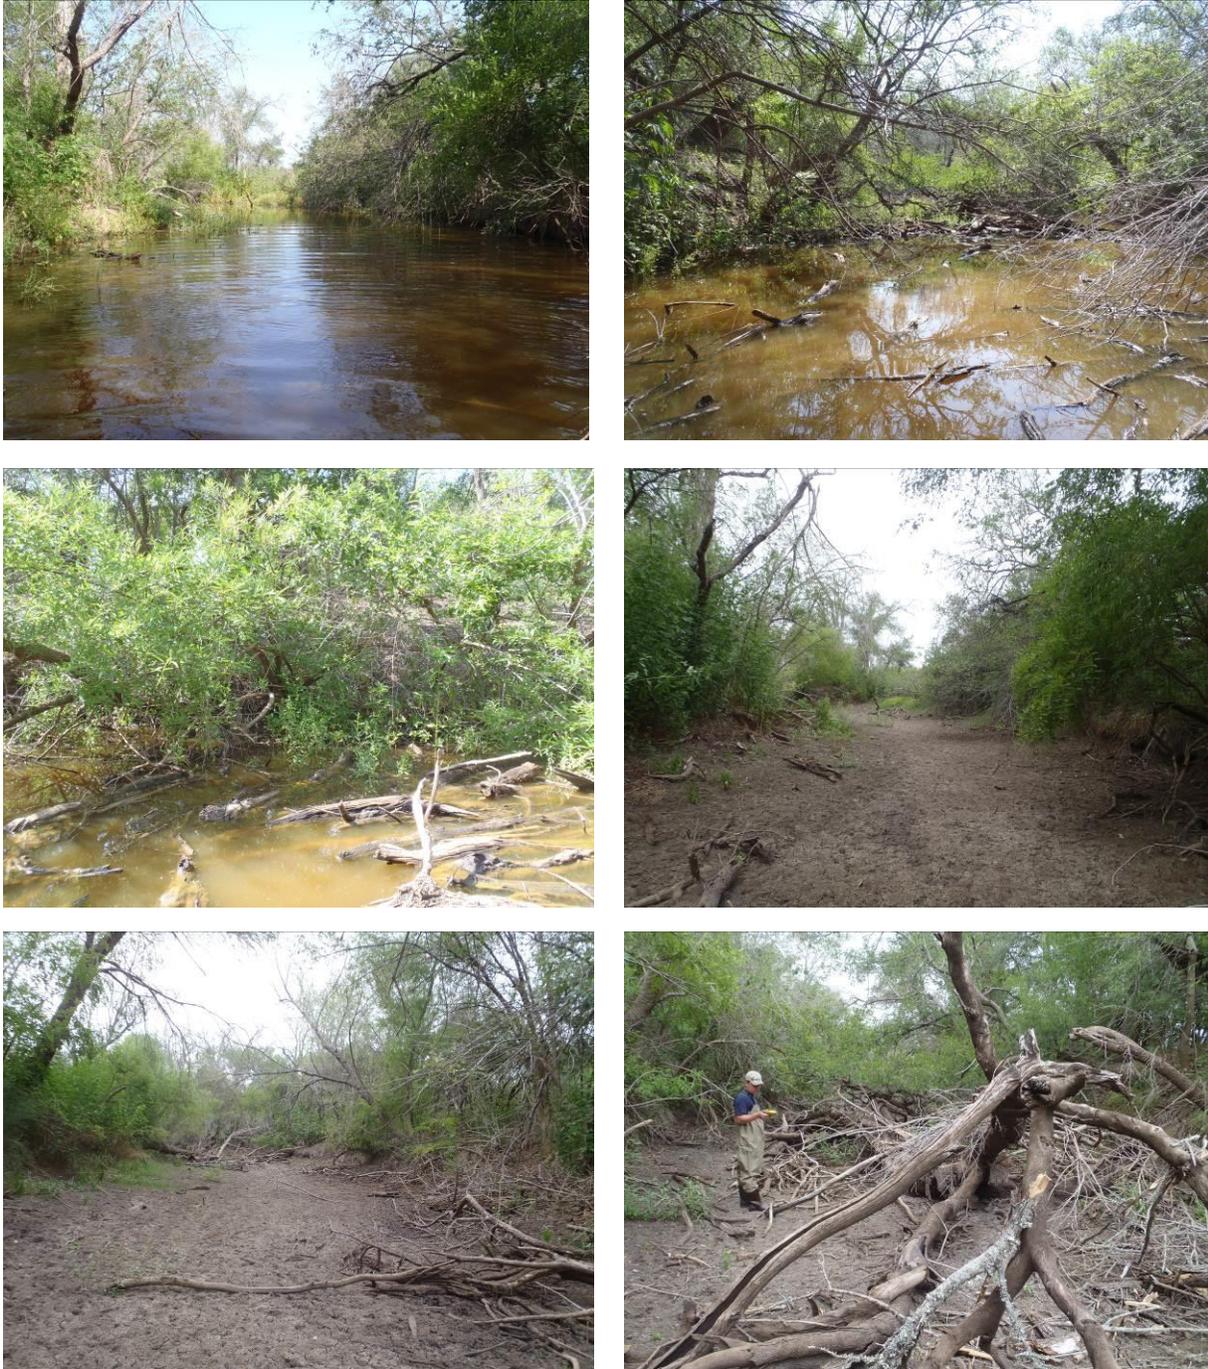
Photogroup 4-3 Leona River Site AU01_01 illustrating the water color, general appearance and clarity of the water surface and obstructions. (All individuals pictured are TIAER staff.) Top Left – 150-m transect upstream, May 2012; Top Right – 300-m transect downstream, May 2012; Middle Left – 300-m transect right bank view, May 2012; Middle Right – 0-m transect upstream view, July 2012; Bottom Left – 150-m transect downstream view, July 2012; Bottom Right – 270-m transect obstruction, July 2012.

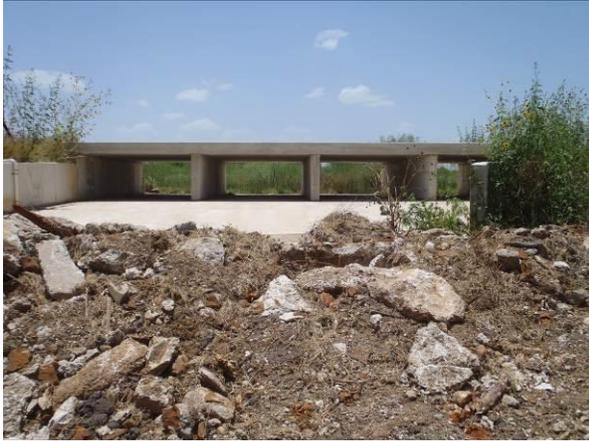
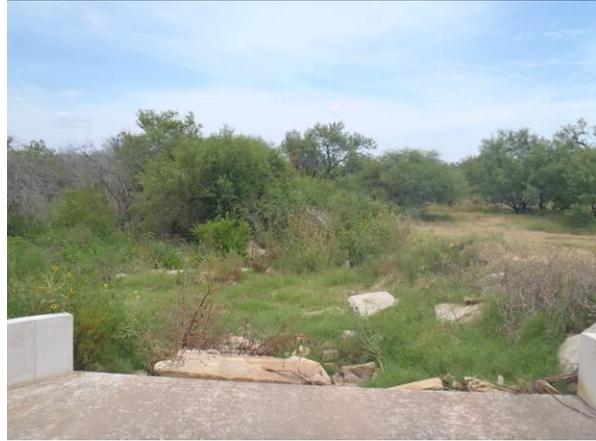
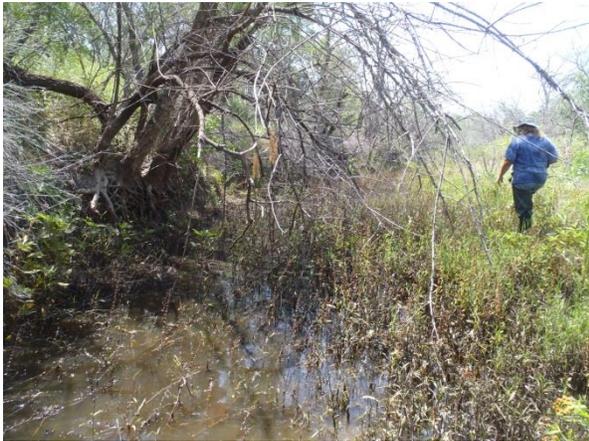
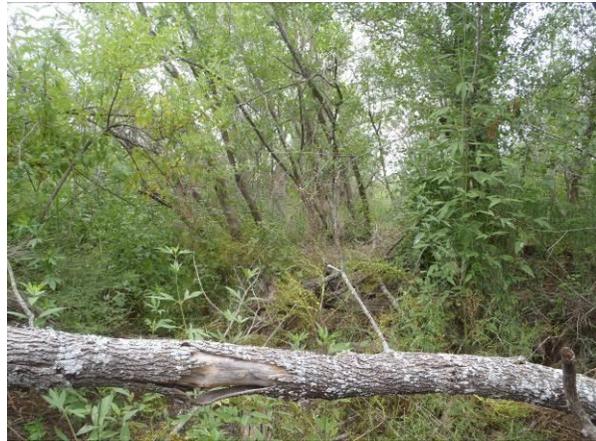
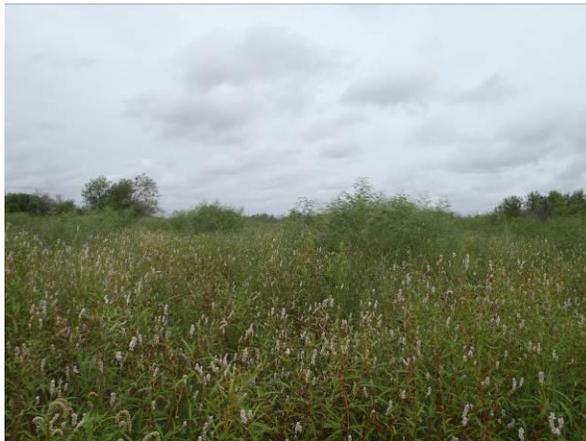
Photogroup 4-4 Leona River Site AU01_02 depicting stream access and typical setting. (All individuals pictured are TIAER staff.) Top Left – 270-m transect culvert upstream view, July 2012; Top Right – 270-m transect culvert upstream, July 2012; Middle Left – 150-m transect downstream view, May 2012; Middle Right – 150-m transect downstream view, July 2012; Bottom – 300-m upstream view, July 2012.

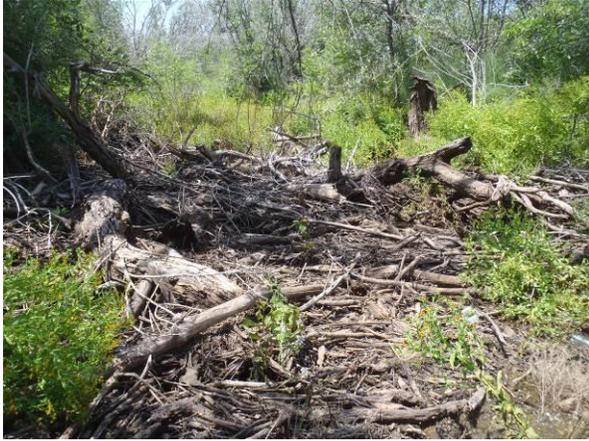
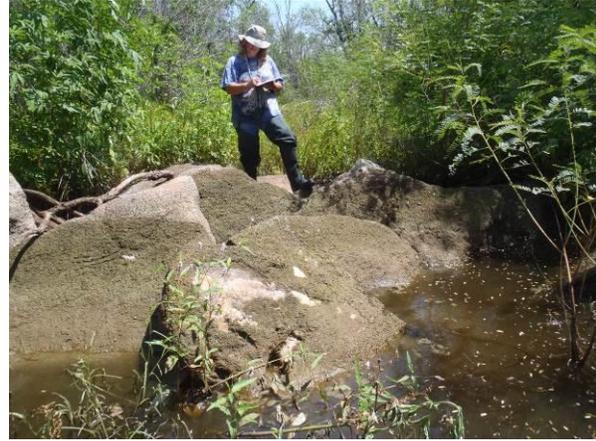
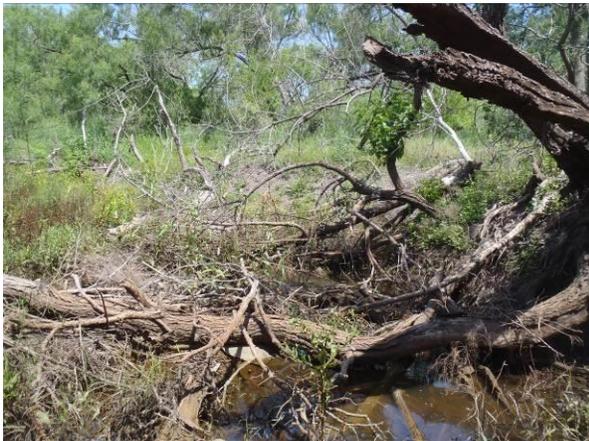
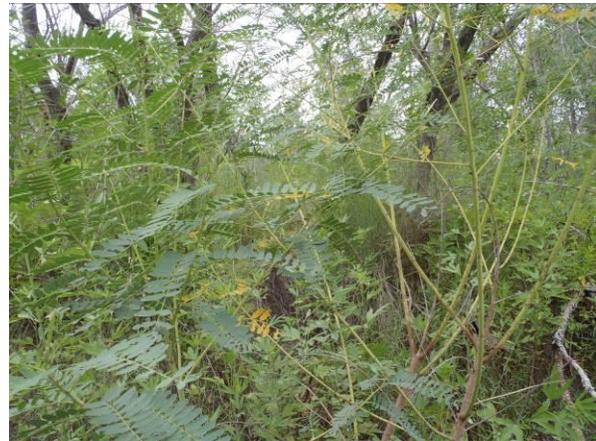
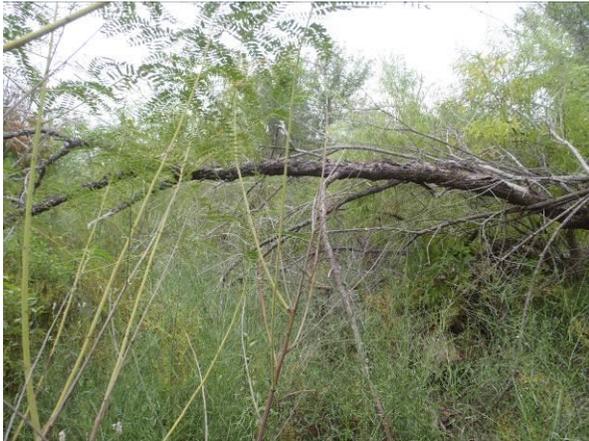
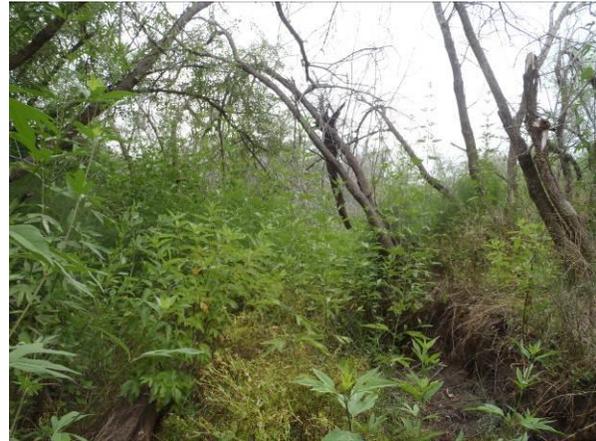
Photogroup 4-5 Leona River Site AU01_02 depicting obstructions and density of vegetation in stream channel. (All individuals pictured are TIAER staff.) Top Left – obstruction 3, May 2012; Top Right – obstruction 4, May 2012; Middle Left – 150-m transect upstream view, May 2012; Middle Right – 0-m transect left bank view, July 2012; Bottom Left – 0-m transect upstream view, July 2012; Bottom Right – 150-m upstream view, July 2012.

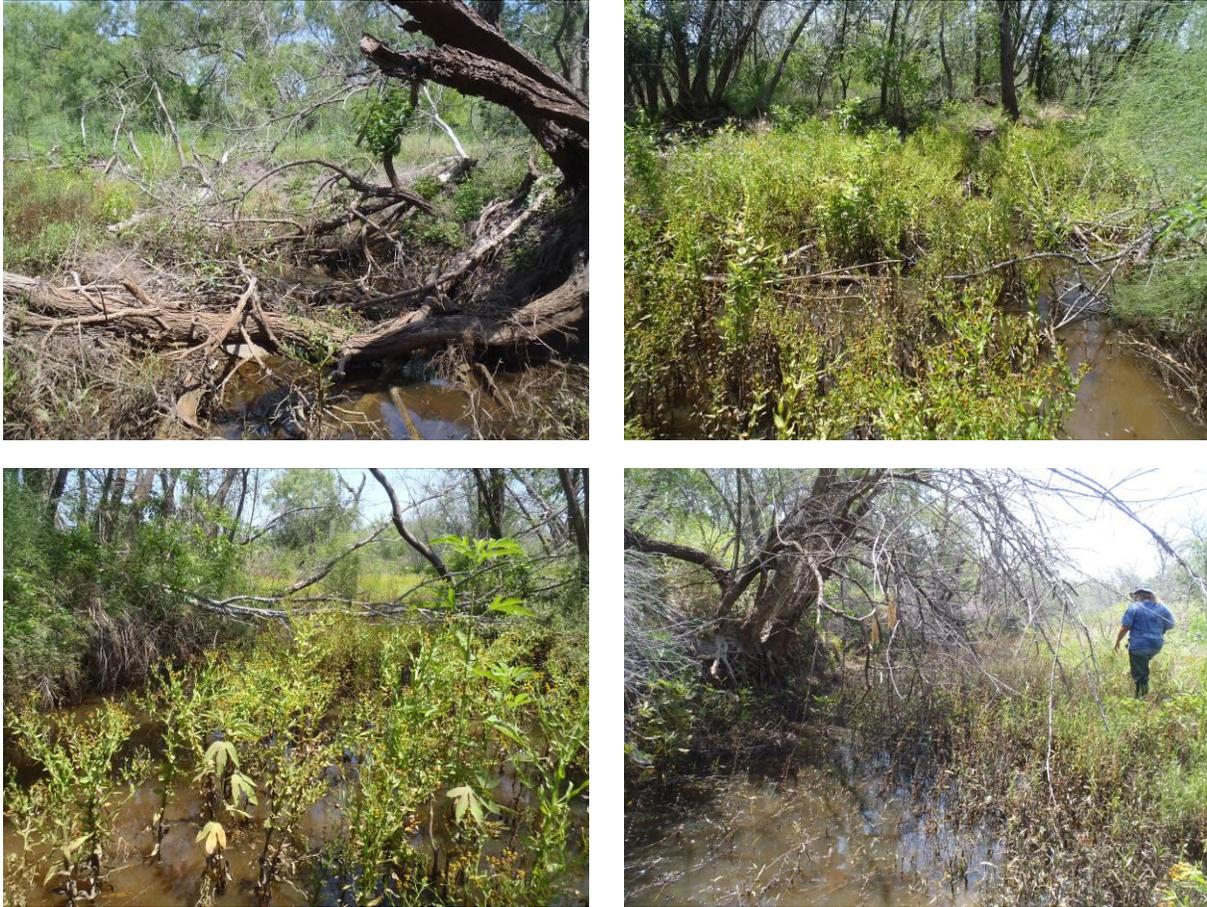
Photogroup 4-6 Leona River Site AU01_02 depicting water color and clarity of surface. (All individuals pictured are TIAER staff.) Top Left – 150-m transect upstream view, May 2012; Top Right – 0-m transect downstream view, May 2012; Middle Left – 0-m transect upstream view, May 2012; Middle Right – 150-m transect downstream view, May 2012.

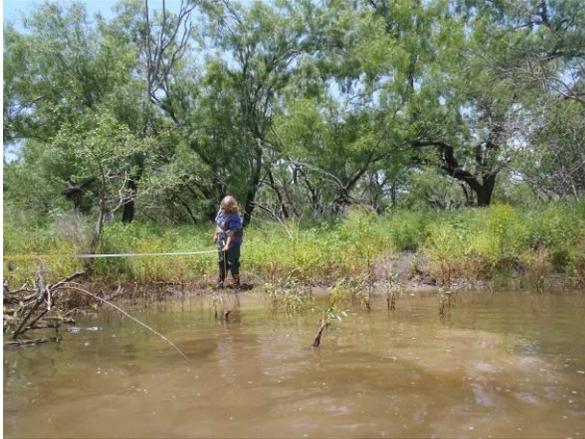
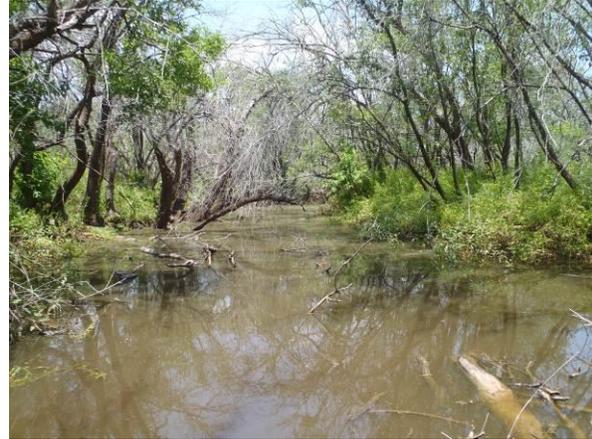
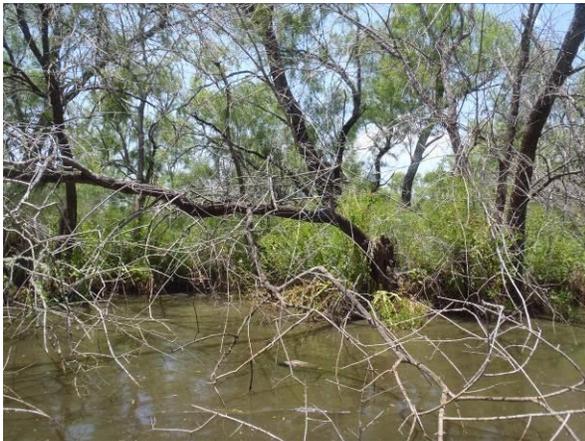
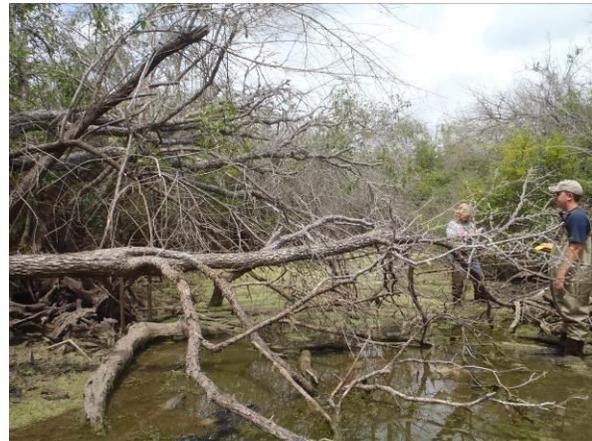
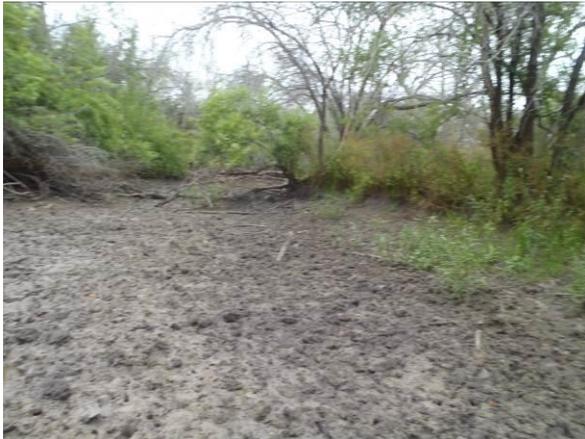
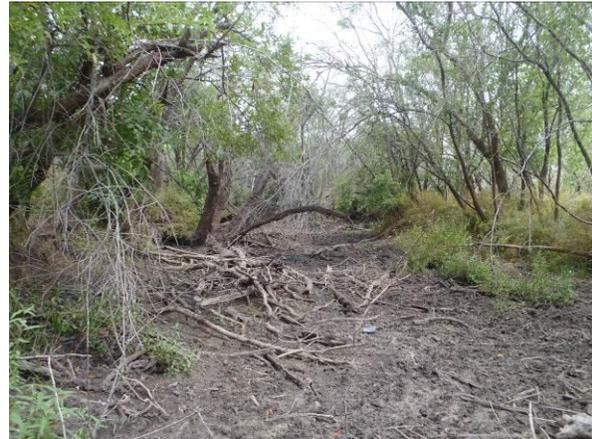
Photogroup 4-7 Leona River Site AU01_03 depicting stream access and general appearance of stream. (All individuals pictured are TIAER staff.) Top Left – 150-m transect right bank, May 2012; Top Right – 300-m transect upstream view, May 2012; Middle Left – 0-m transect right bank view, May 2012; Middle Right – 0-m transect upstream view, July 2012; Bottom Left – 150-m transect upstream view, July 2012; Bottom Right – 300-m upstream view, July 2012.

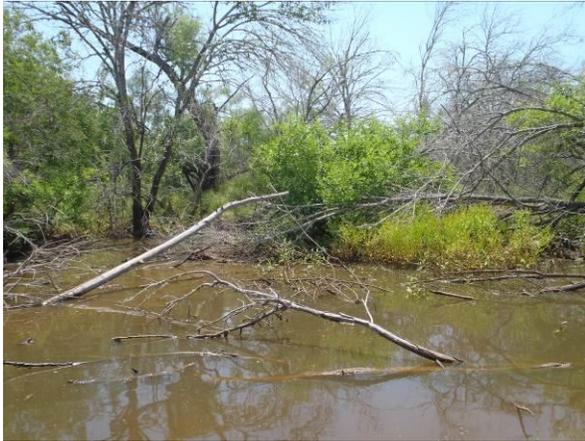
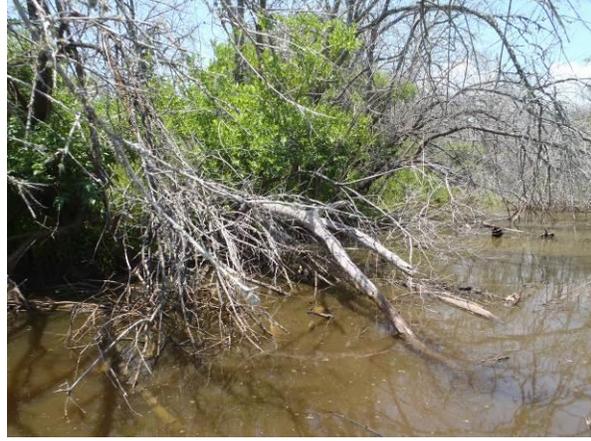
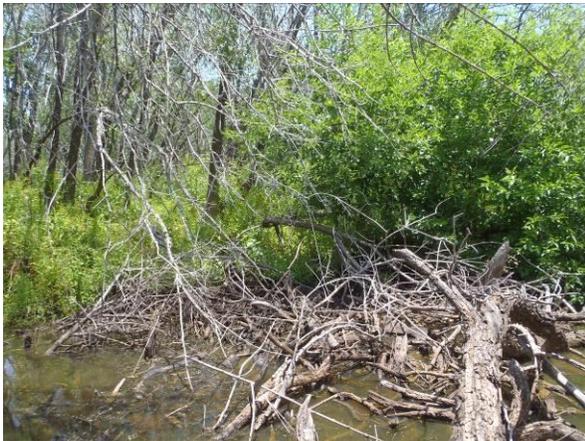
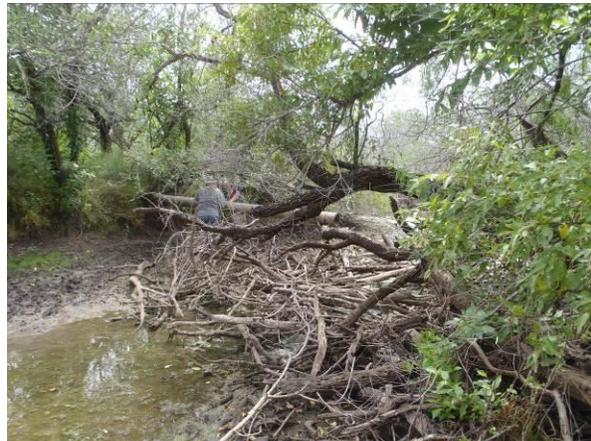
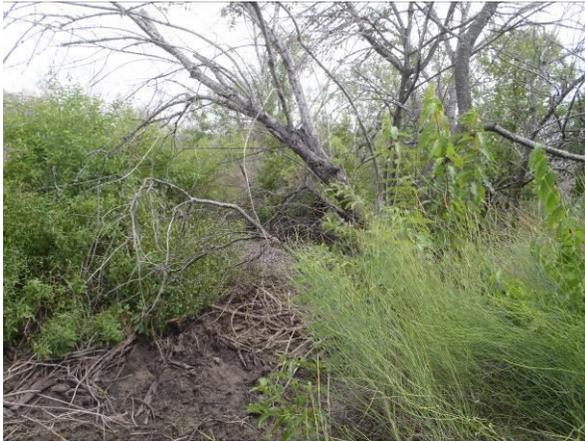
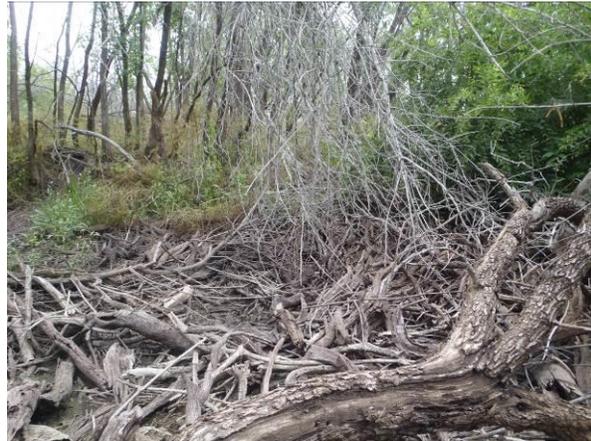
Photogroup 4-8 Leona River Site AU01_03 depicting obstructions and dense vegetation. (All individuals pictured are TIAER staff.) Top Left – obstruction 1, May 2012; Top Right – obstruction 2, May 2012; Middle Left – 300-m transect left bank view, May 2012; Middle Right – 20-m obstruction, July 2012; Bottom Left – 180-m obstruction, July 2012; Bottom Right – 300-m left bank view, July 2012.

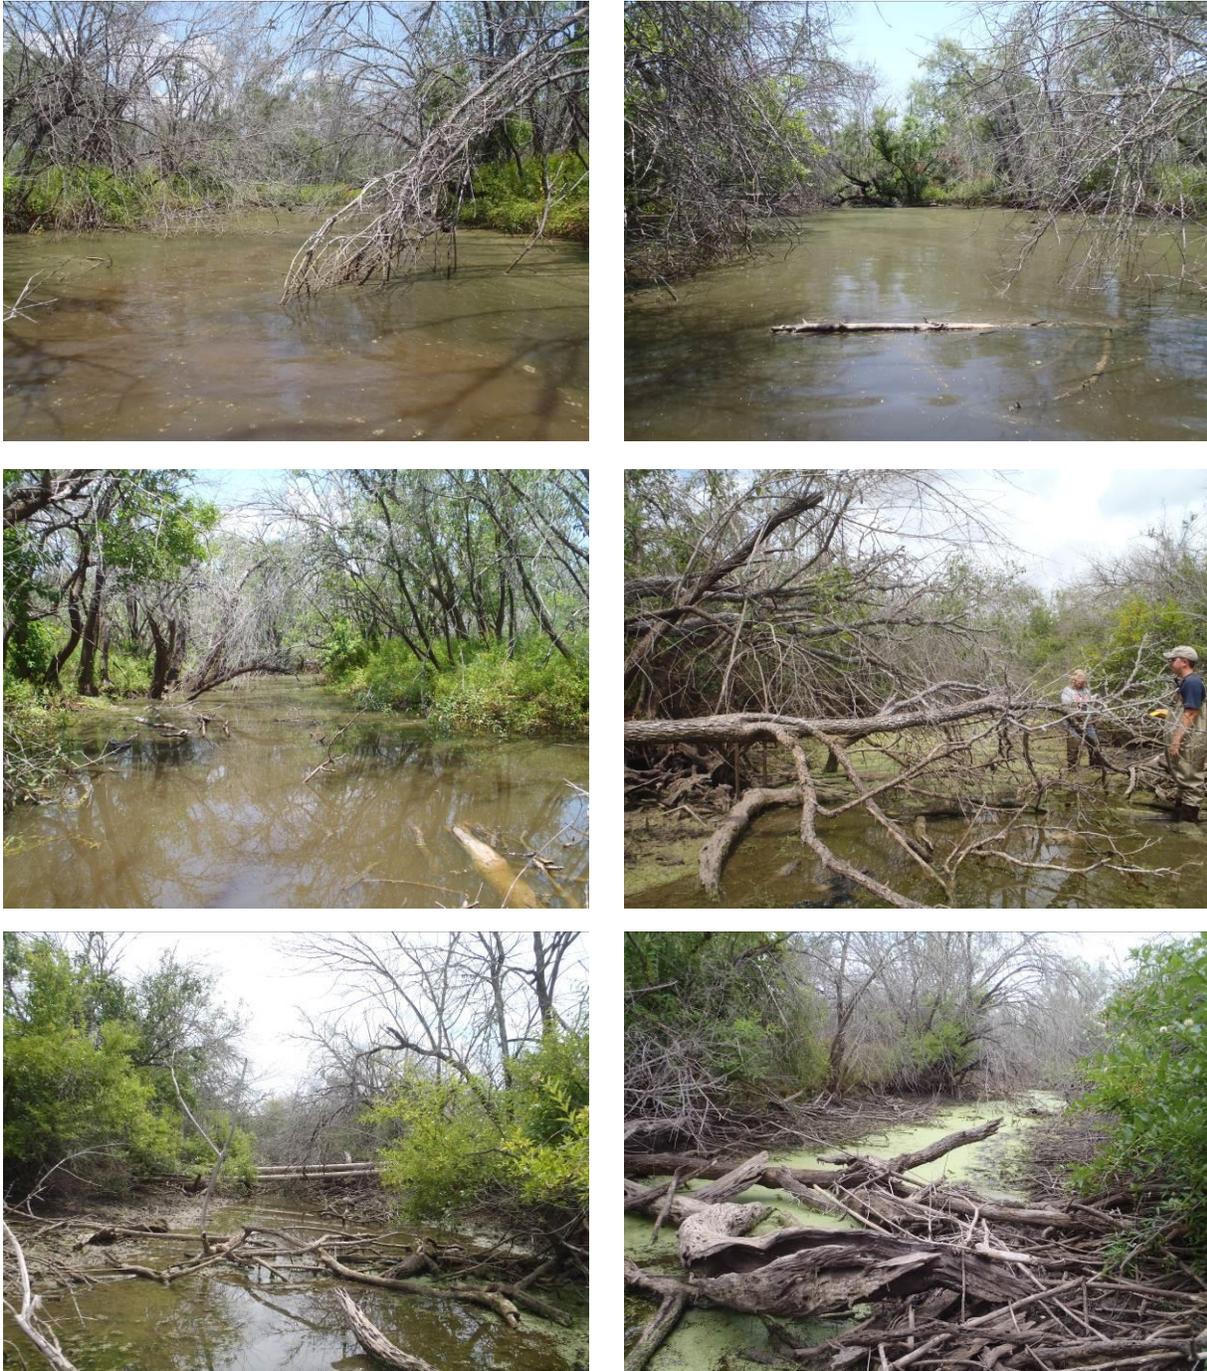
Photogroup 4-9 Leona River Site AU01_03 illustrating the water color and surface clarity of the water. (All individuals pictured are TIAER staff.) Top Left – 0-m transect upstream view, May 2012; Top Right – 0-m transect downstream view, May 2012; Middle Left – 300-m transect upstream view, May 2012; Middle Right – 0-m transect upstream view, July 2012; Bottom Left – 0-m transect downstream view, July 2012; Bottom Right – 300-m upstream view, July 2012.

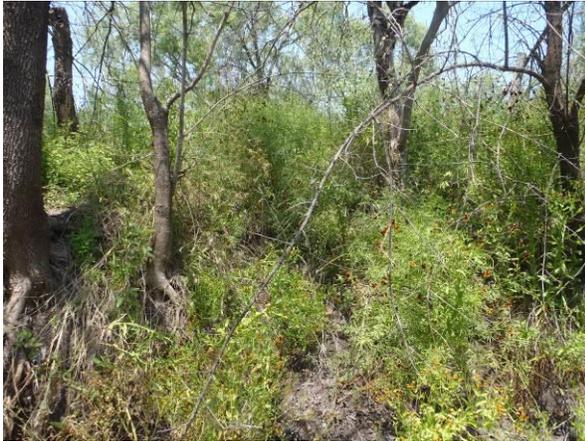
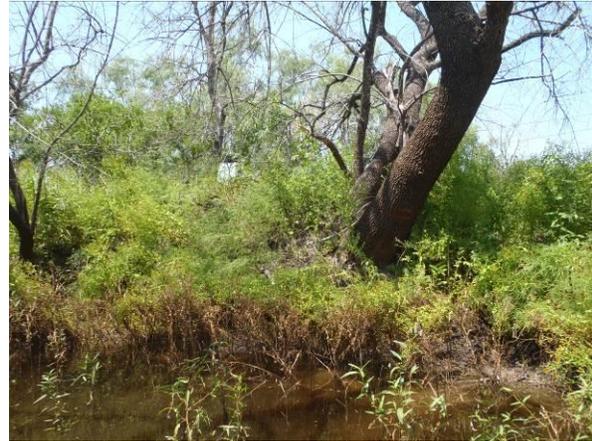
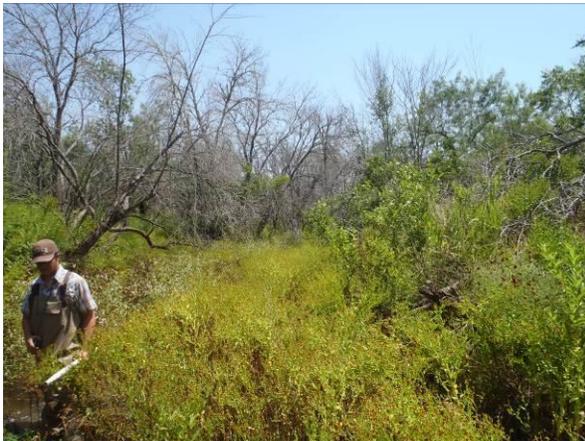
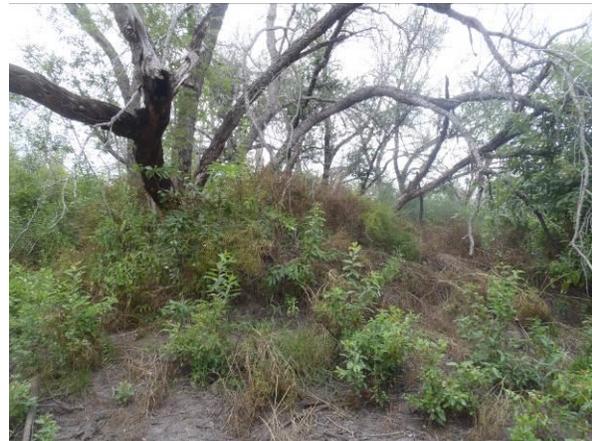
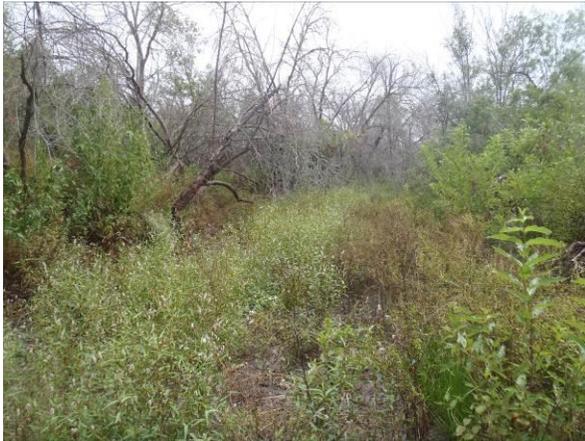
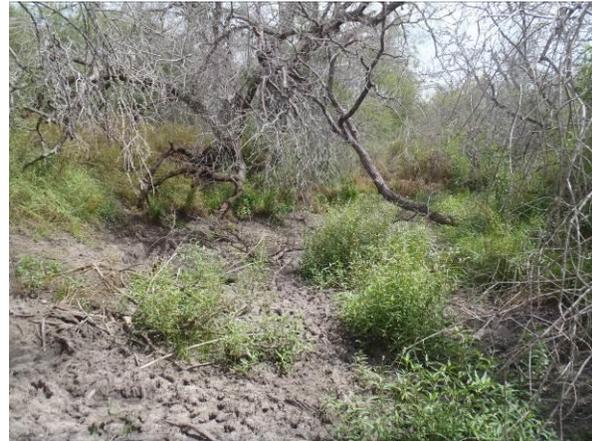
Photogroup 4-10 Leona River Site AU01_04 depicting stream access and general appearance of the stream at AU01_04. (All individuals pictured are TIAER staff.) Top Left – 300-m transect right bank view, May 2012; Top Right – 150-m transect right bank view, May 2012; Middle Left – 0-m transect upstream view, May 2012; Middle Right – 0-m transect left bank view, July 2012; Bottom Left – 150-m transect upstream view, July 2012; Bottom Right – 3000-m upstream view, July 2012.

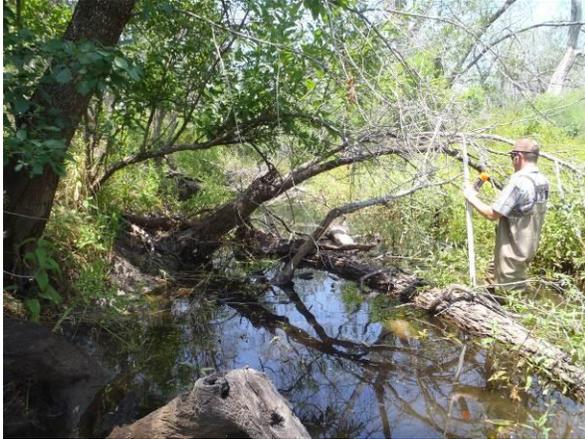
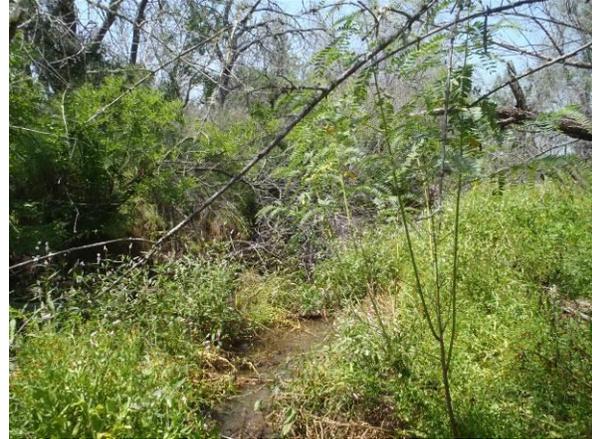
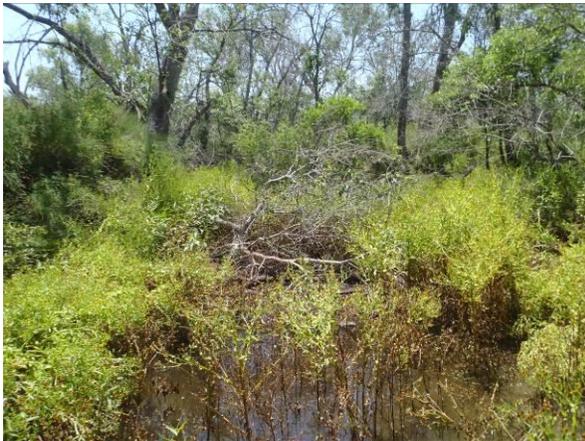
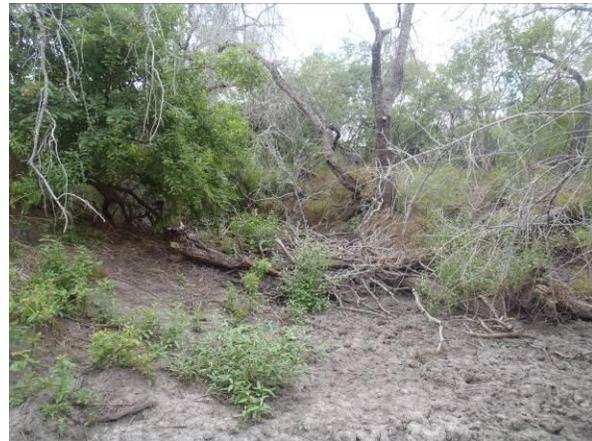
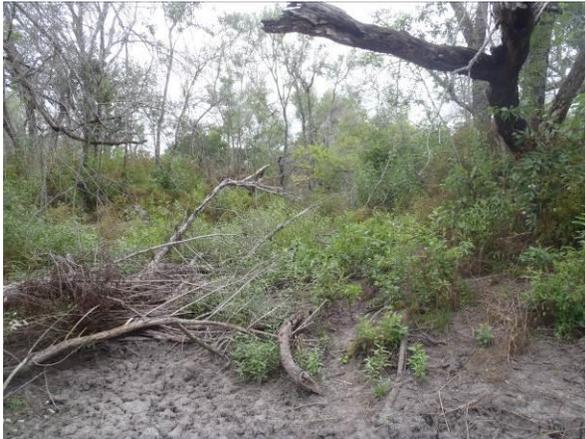
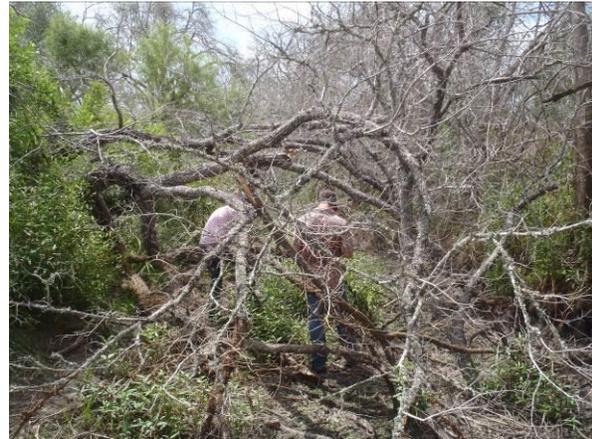
Photogroup 4-11 Leona River Site AU01_04 depicting obstructions and dense vegetation. (All individuals pictured are TIAER staff.) Top Left – obstruction 1, May 2012; Top Right – obstruction 2, May 2012; Middle Left – obstruction 3, May 2012; Middle Right – 0-m transect downstream view, July 2012; Bottom Left – 0-m transect upstream view, July 2012; Bottom Right – 300-m downstream view, July 2012.

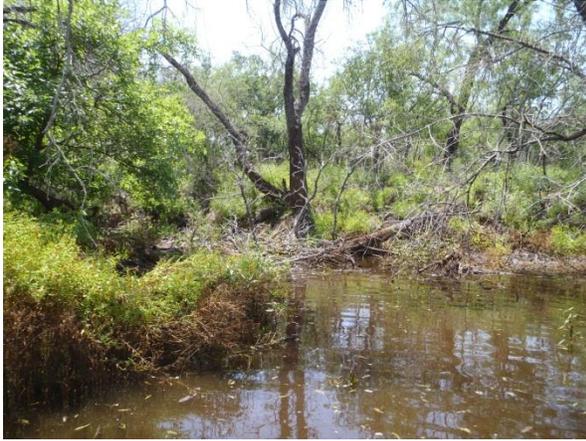
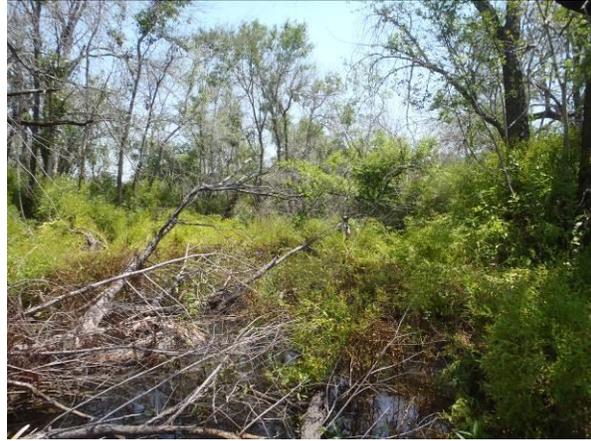
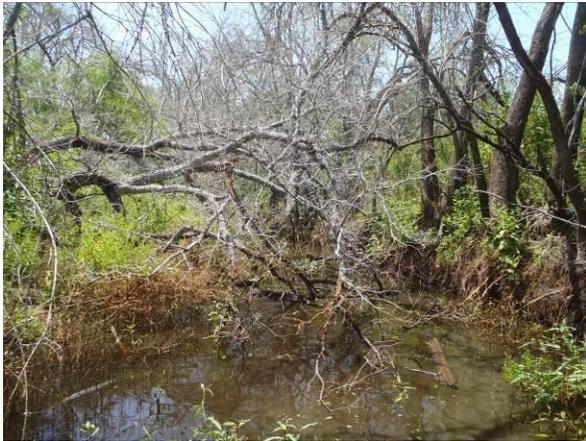
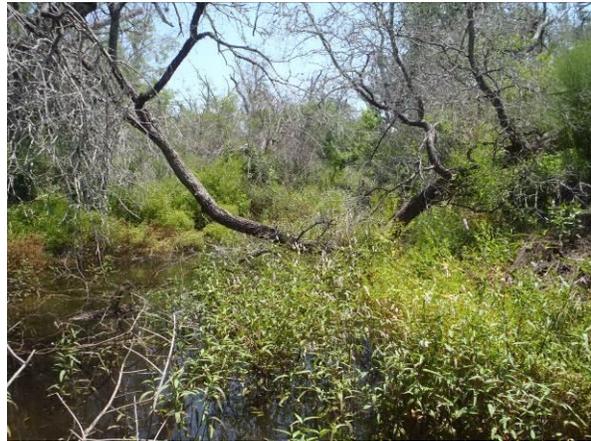
Photogroup 4-12 Leona River Site AU01_04 depicting water color and clarity of the surface. (All individuals pictured are TIAER staff.) Top Left – 150-m transect downstream view, May 2012; Top Right – 150-m transect upstream view, May 2012; Middle Left – 300-m transect downstream view, May 2012; Middle Right – 300-m transect upstream view.

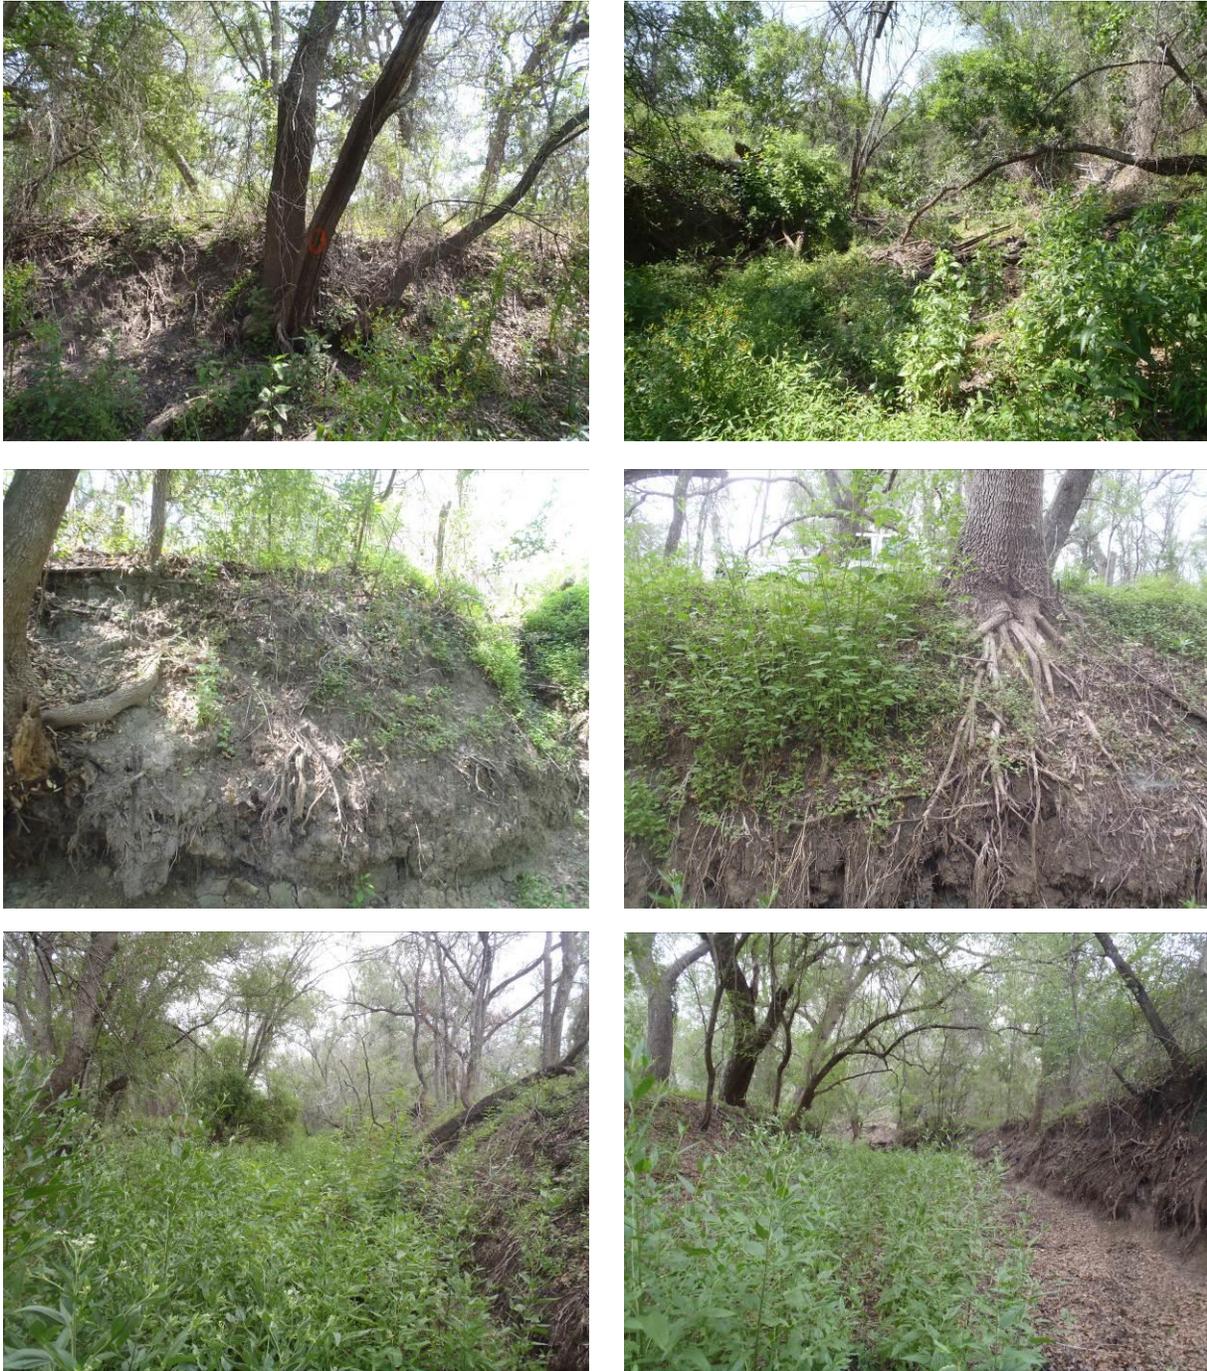
Photogroup 4-13 Leona River Site AU01_05 depicting steep banks, access and general appearance of stream. (All individuals pictured are TIAER staff.) Top Left – 0-m transect left bank view, May 2012; Top Right – 150-m transect downstream view, May 2012; Middle Left – 300-m transect right bank view, May 2012; Middle Right – 0-m transect right bank view, July 2012; Bottom Left – 0-m transect downstream view, July 2012; Bottom Right – 300-m downstream view, July 2012.

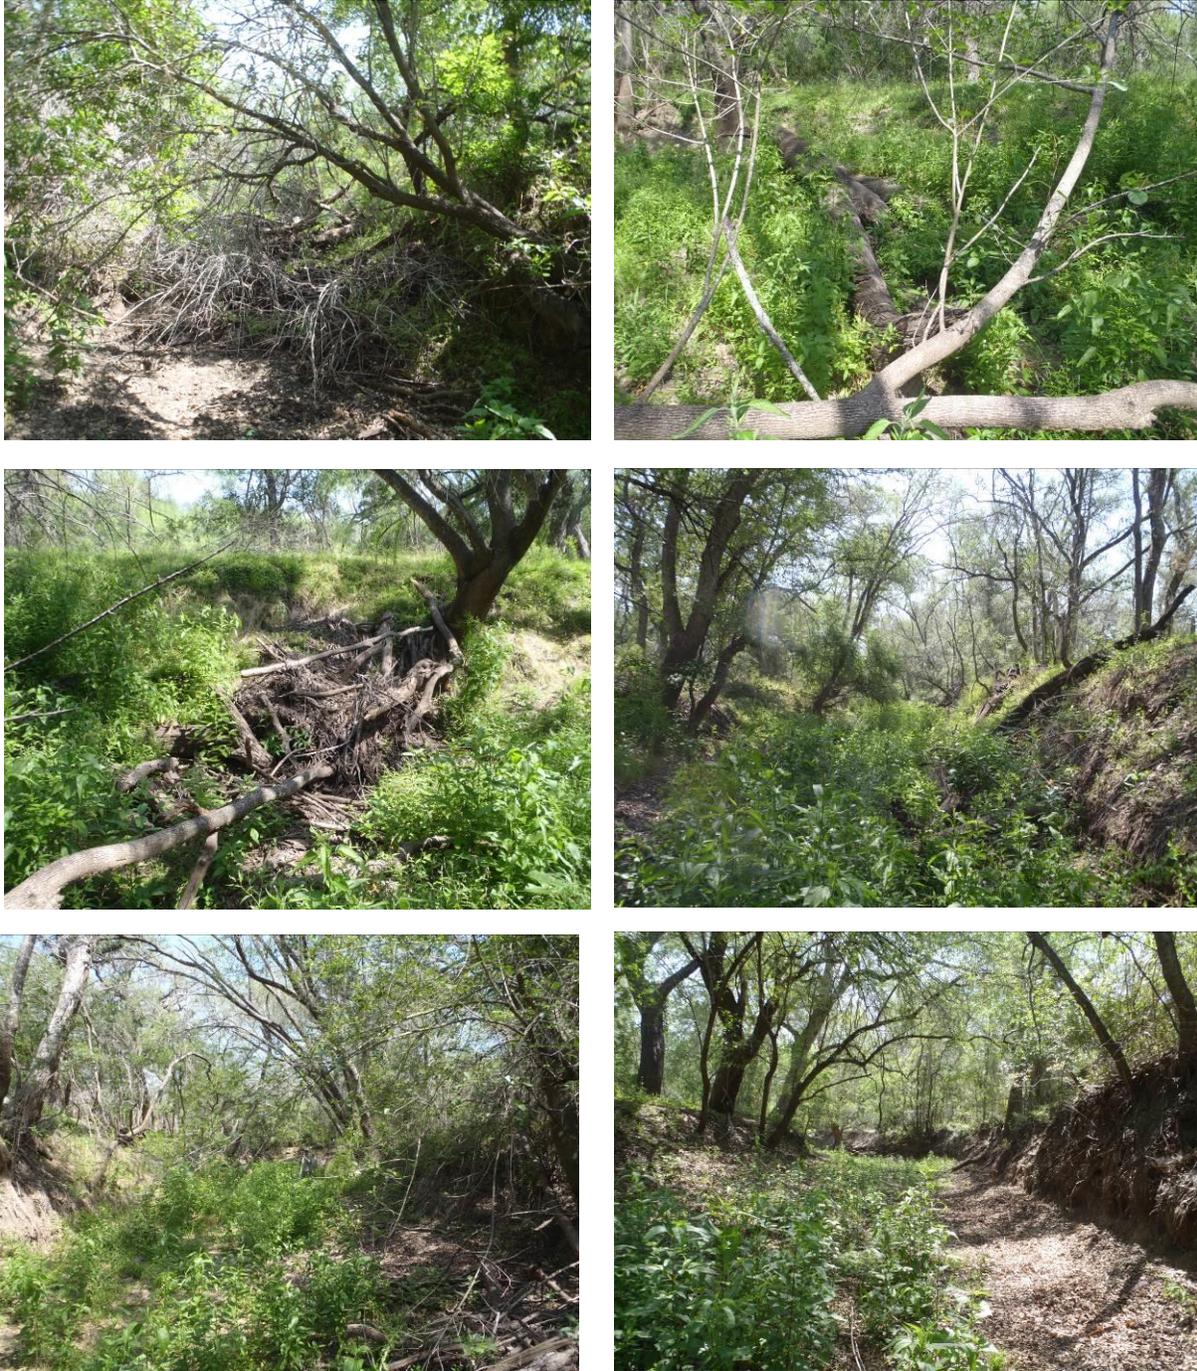
Photogroup 4-14 Leona River Site AU01_05 depicting obstructions and stream vegetation. (All individuals pictured are TIAER staff.) Top Left – obstruction 2, May 2012; Top Right – obstruction 3, May 2012; Middle Left – obstruction 4, May 2012; Middle Right – 0-m transect downstream view, May 2012; Bottom Left – 0-m transect upstream view, May 2012; Bottom Right – 300-m downstream view, May 2012.

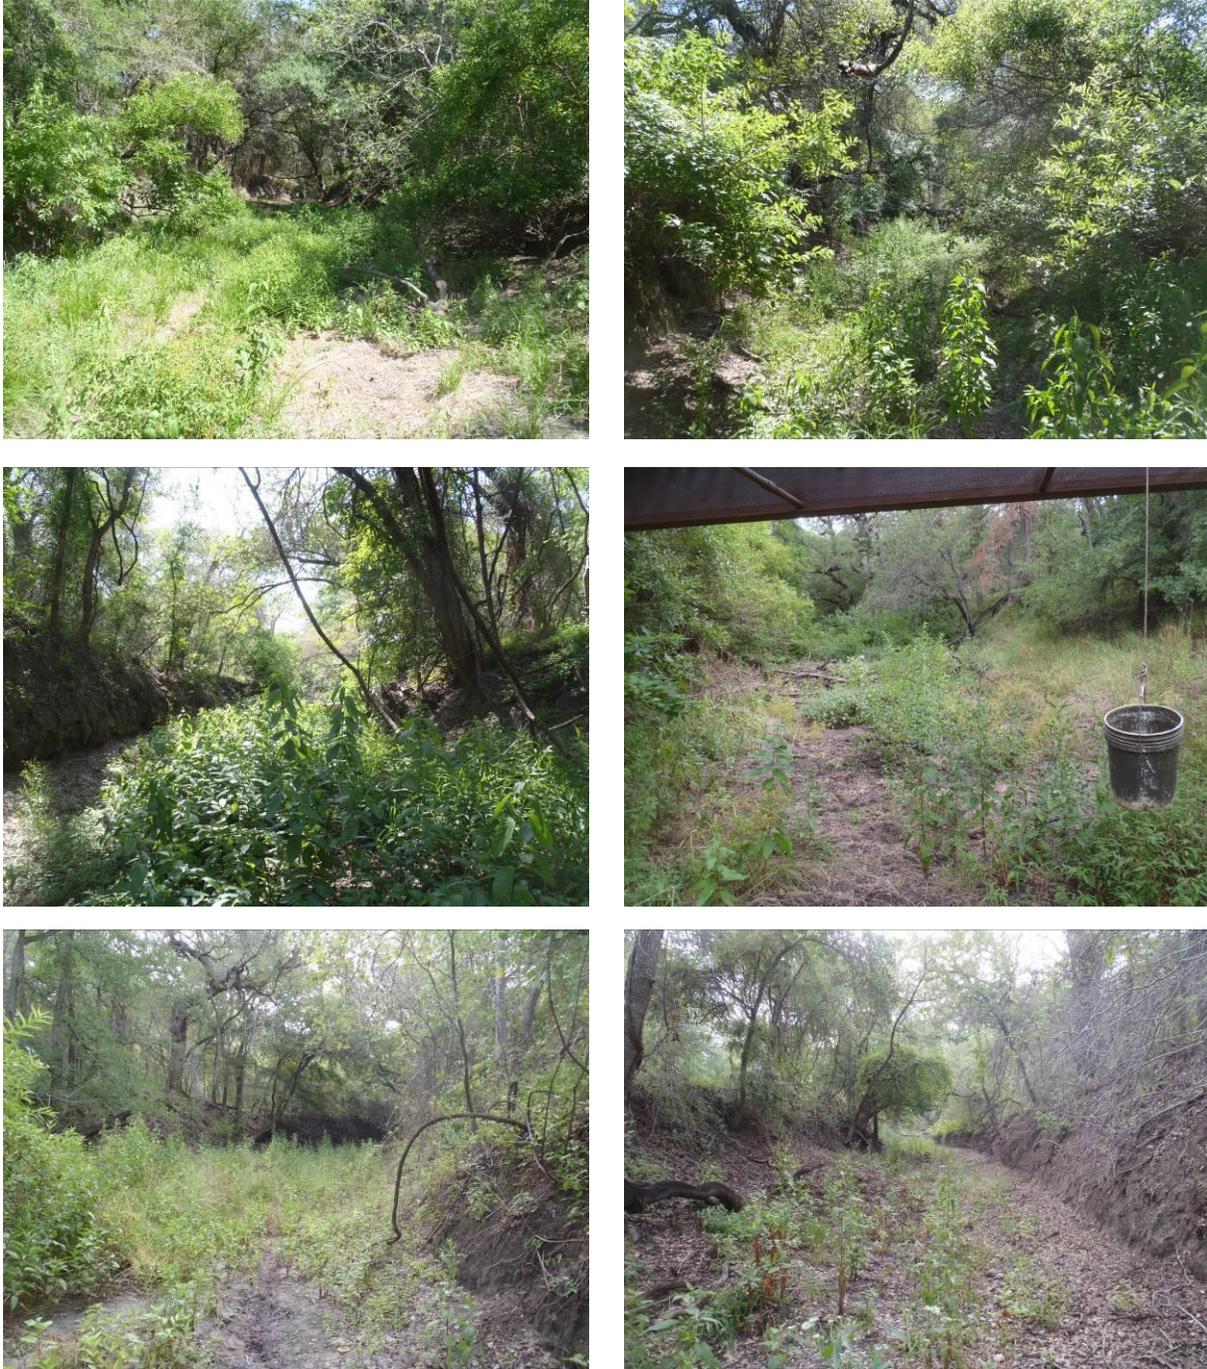
Photogroup 4-15 Leona River Site AU01_06 depicting the general appearance of the stream channel. (All individuals pictured are TIAER staff.) Top Left – 0-m transect downstream view, May 2012; Top Right – 150-m transect upstream view, May 2012; Middle Left – 300-m transect upstream view, May 2012; Middle Right – 0-m transect upstream view, July 2012; Bottom Left – 150-m transect downstream view, July 2012; Bottom Right – 300-m downstream view, July 2012.

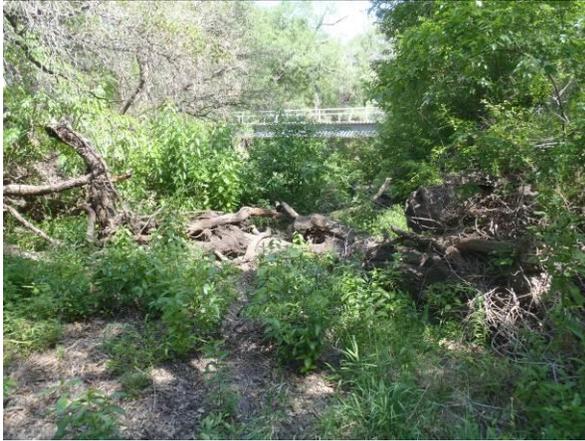
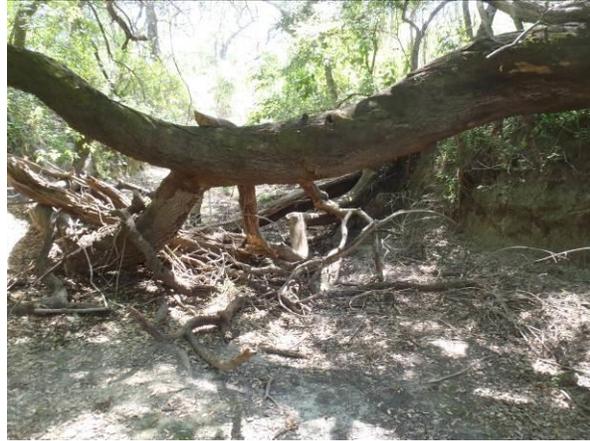
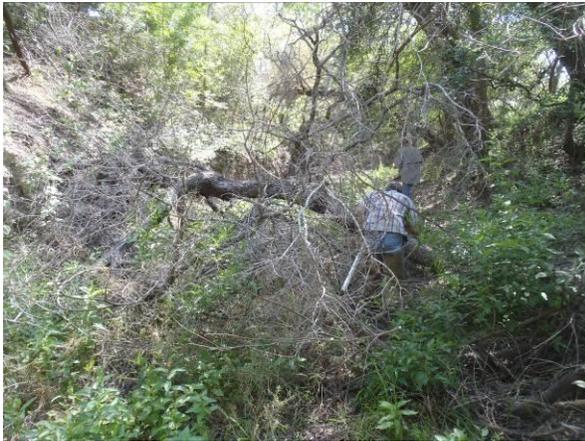
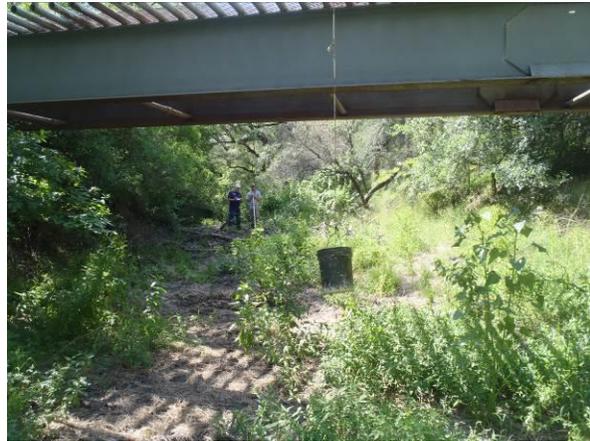
Photogroup 4-16 Leona River Site AU01_06 depicting obstructions and bridge with hanging deer feeder. (All individuals pictured are TIAER staff.) Top Left – obstruction 1, May 2012; Top Right – obstruction 3, May 2012; Bottom Left – obstruction 4, May 2012; Bottom Right – 0-m transect upstream, May 2012.
