**Leona River
Recreational Use Attainability Analysis**

**Texas State Soil and Water Conservation Board
Project 11-50**

**Texas Institute for Applied Environmental Research
Tarleton State University
Stephenville, Texas**

June 2013

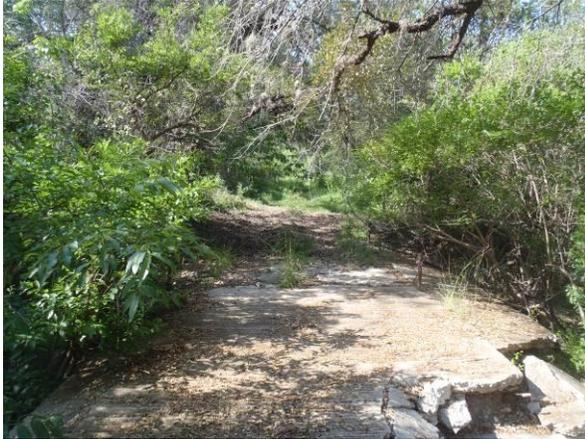
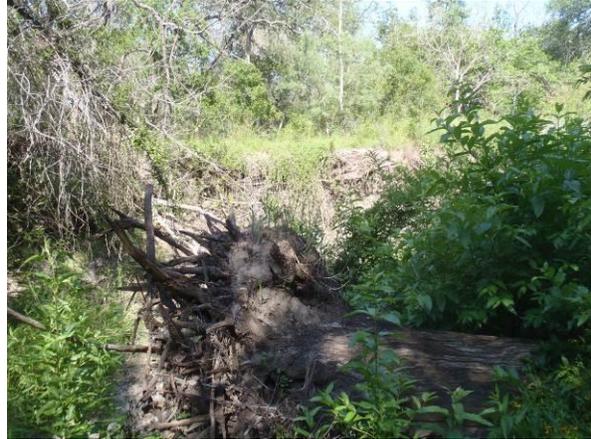
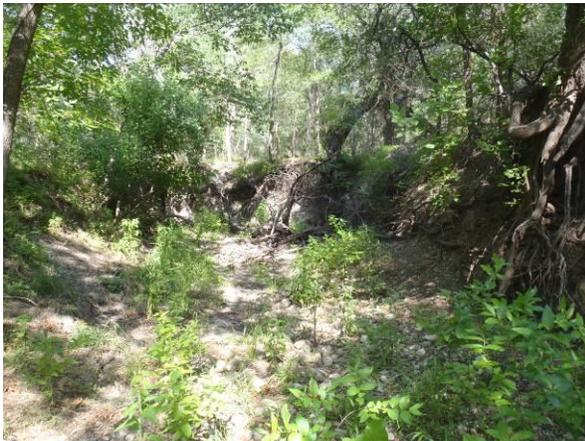
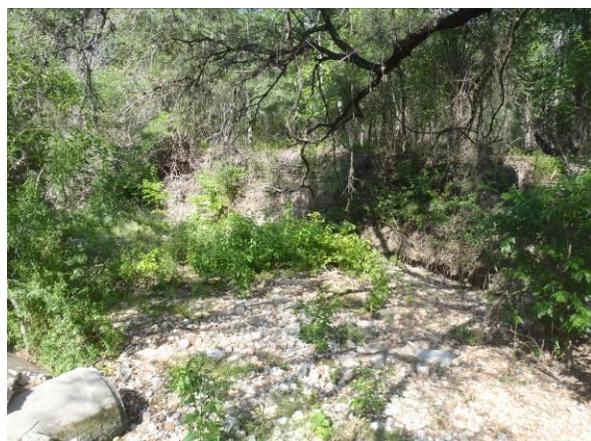
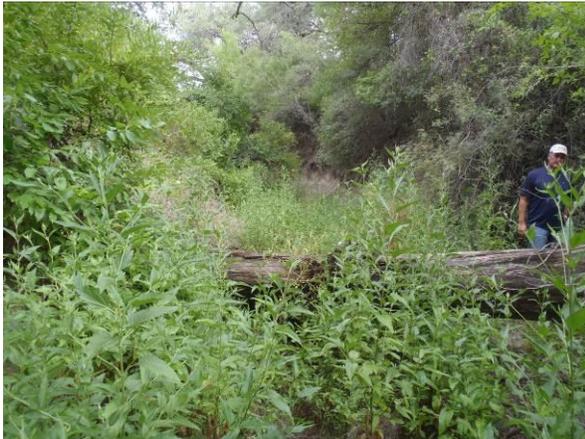
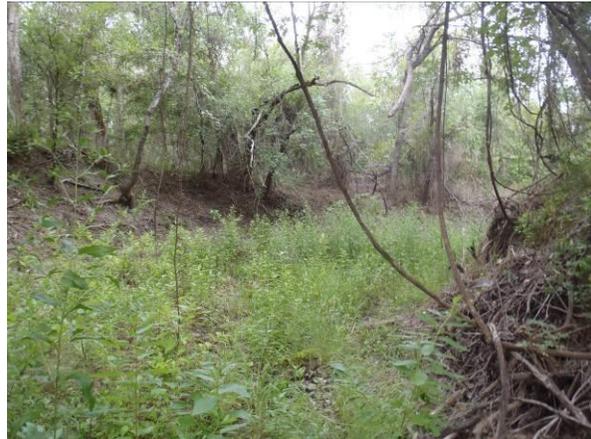
Photogroup 4-17 Leona River Site AU01_07 depicting access at low water crossing and general appearance of stream. (All individuals pictured are TIAER staff.) Top Left – 300-m transect left bank view, May 2012; Top Right – 0-m transect downstream view, May 2012; Middle Left – 150-m transect downstream view, May 2012; Middle Right – 300-m transect downstream view, May 2012; Bottom Left – 0-m transect upstream view, July 2012; Bottom Right – 150-m upstream view, July 2012.

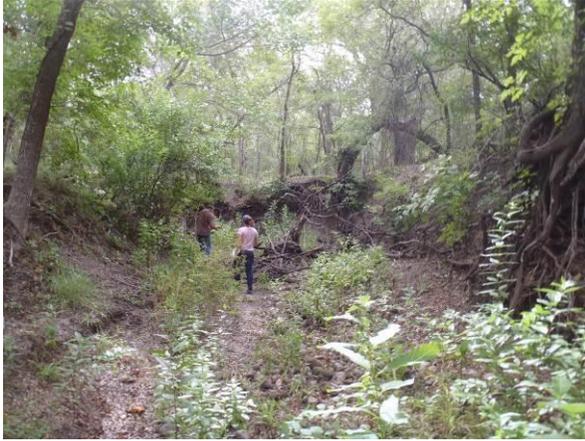
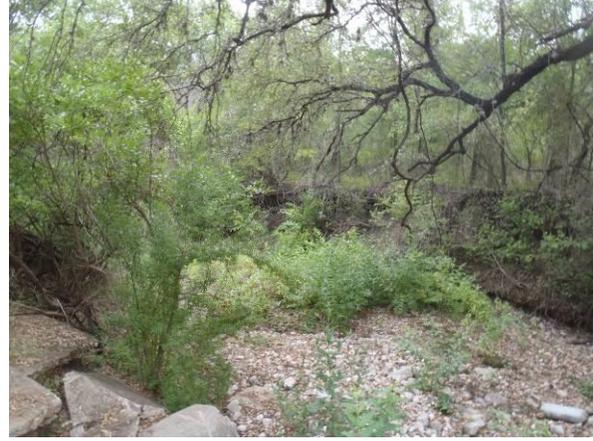
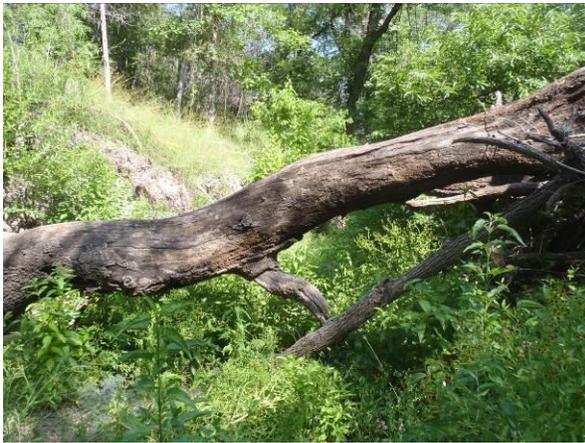
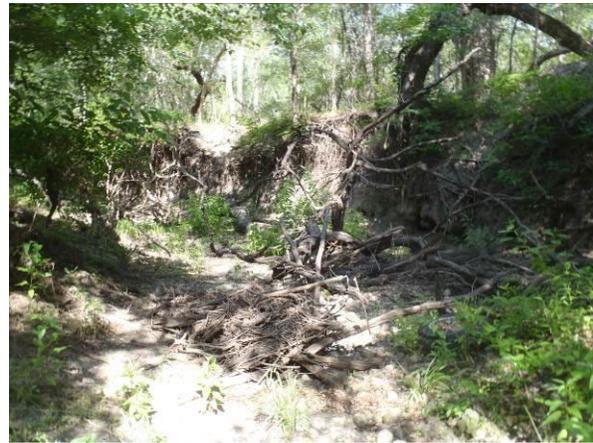
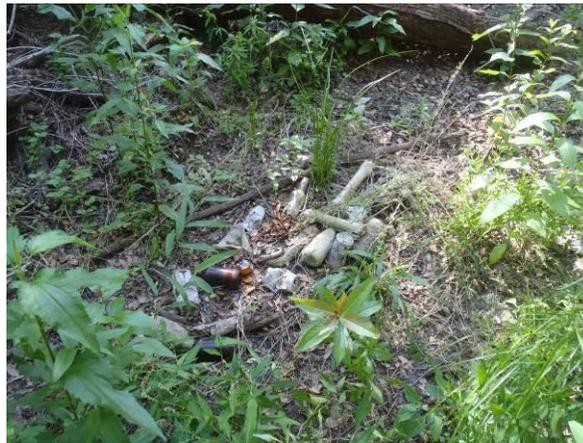
Photogroup 4-18 Leona River Site AU01_07 depicting the cobble bottom, obstructions, and trash within the channel. (All individuals pictured are TIAER staff.) Top Left – 150-m transect downstream view, July 2012; Top Right – 300-m transect downstream view, July 2012; Middle Left – obstruction 1, May 2012; Middle Right – obstruction 2, May 2012; Bottom Center – trash pile, May 2012.

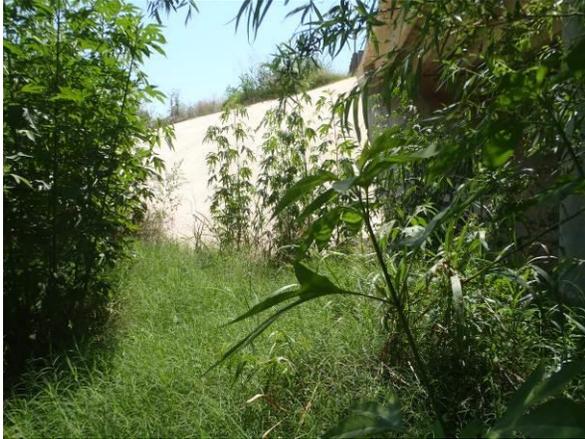
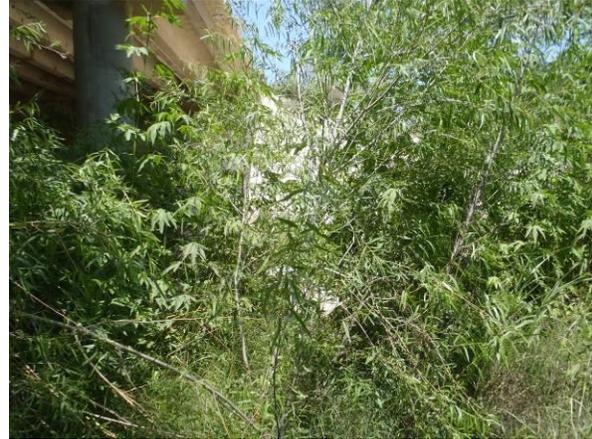
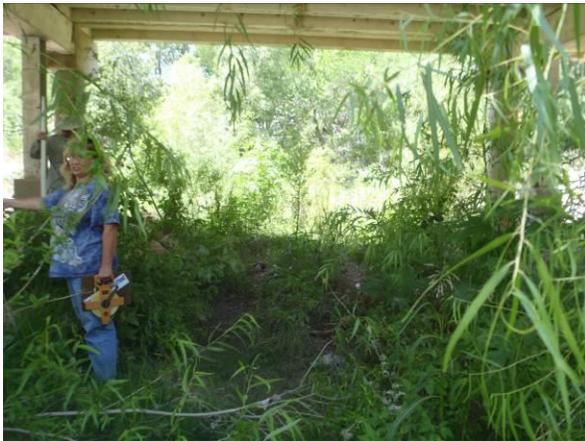
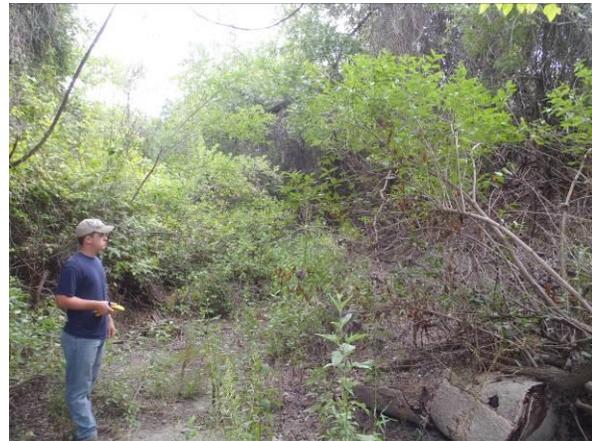
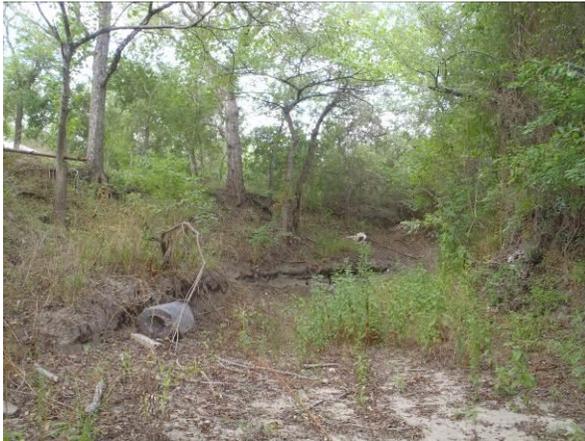
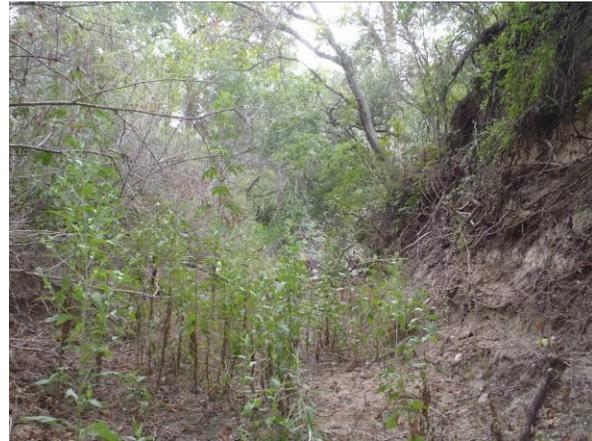
Photogroup 4-19 Leona River Site AU01_08 depicting a view from the FM 1581 bridge and the general appearance of the river. (All individuals pictured are TIAER staff.) Top Left – 300-m transect right bank view, May 2012; Top Right – 300-m transect left bank view, May 2012; Middle Left – 300-m transect upstream view, May 2012; Middle Right – 0-m transect downstream view, July 2012; Bottom Left – 0-m transect upstream view, July 2012; Bottom Right – 150-m downstream view, July 2012.

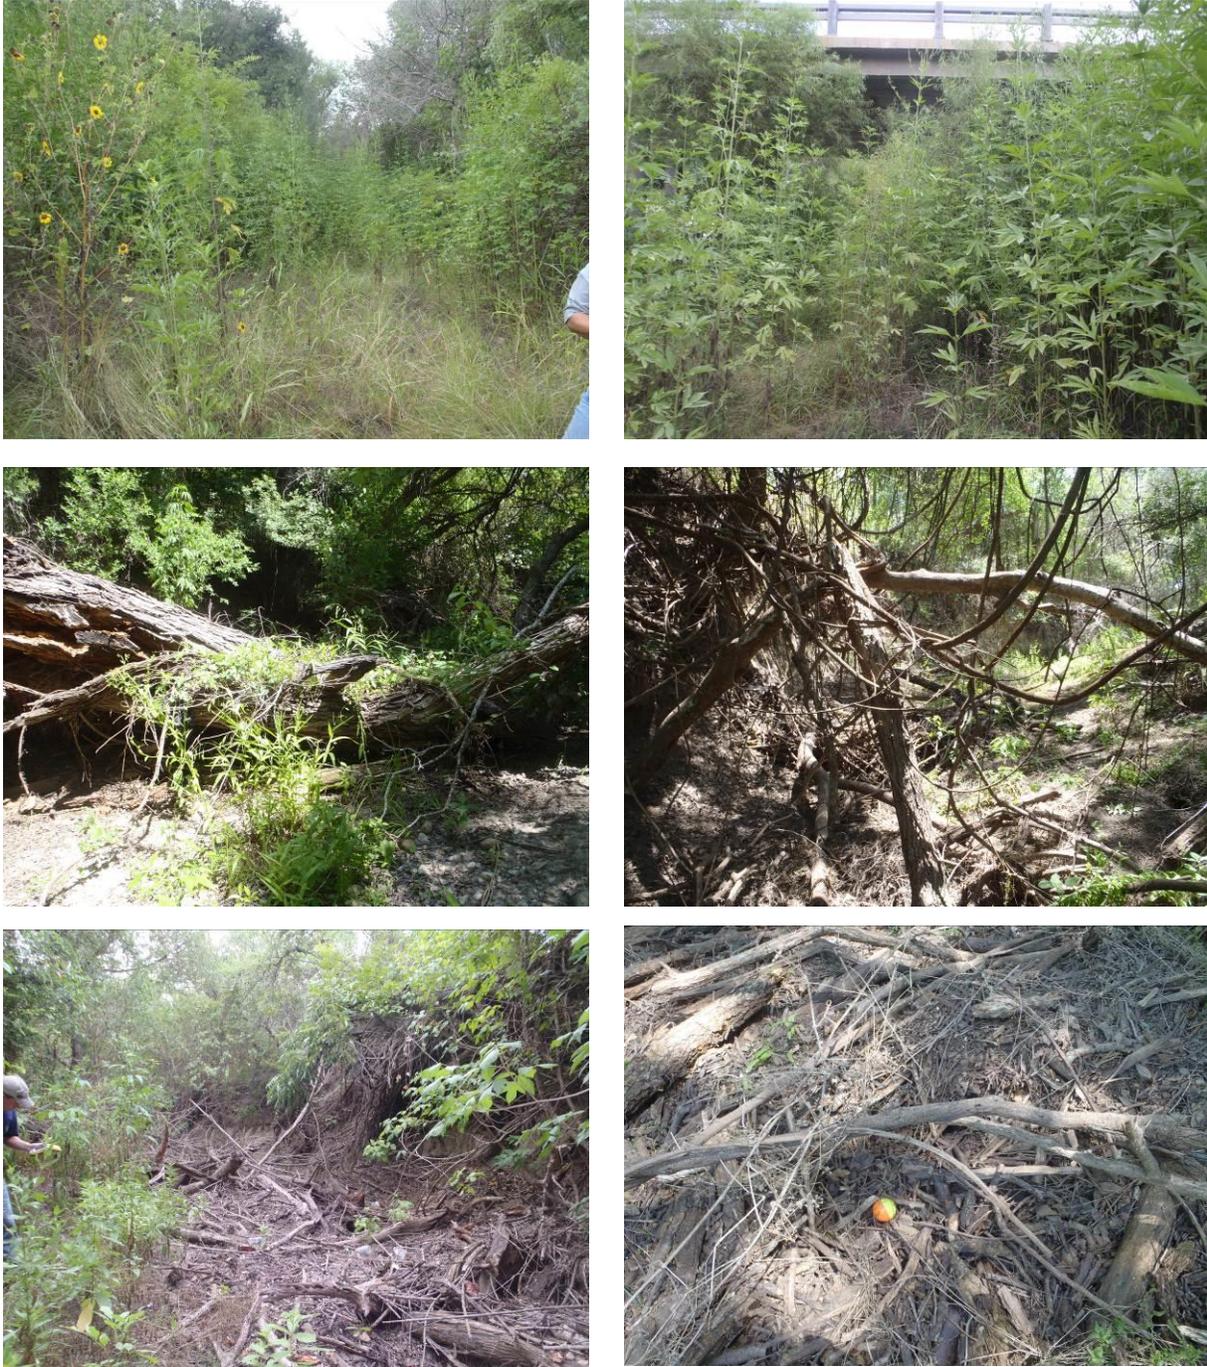
Photogroup 4-20 Leona River Site AU01_08 depicting dense vegetation, obstructions encountered, and fishing bobber. (All individuals pictured are TIAER staff.) Top Left – 300-m transect downstream view, July 2012; Top Right – 300-m transect upstream view, July 2012; Middle Left – obstruction 1, May 2012; Middle Right – obstruction 2, May 2012; Bottom Left – 168-m obstruction May 2012; Bottom Right – bobber in brush pile, May 2012.

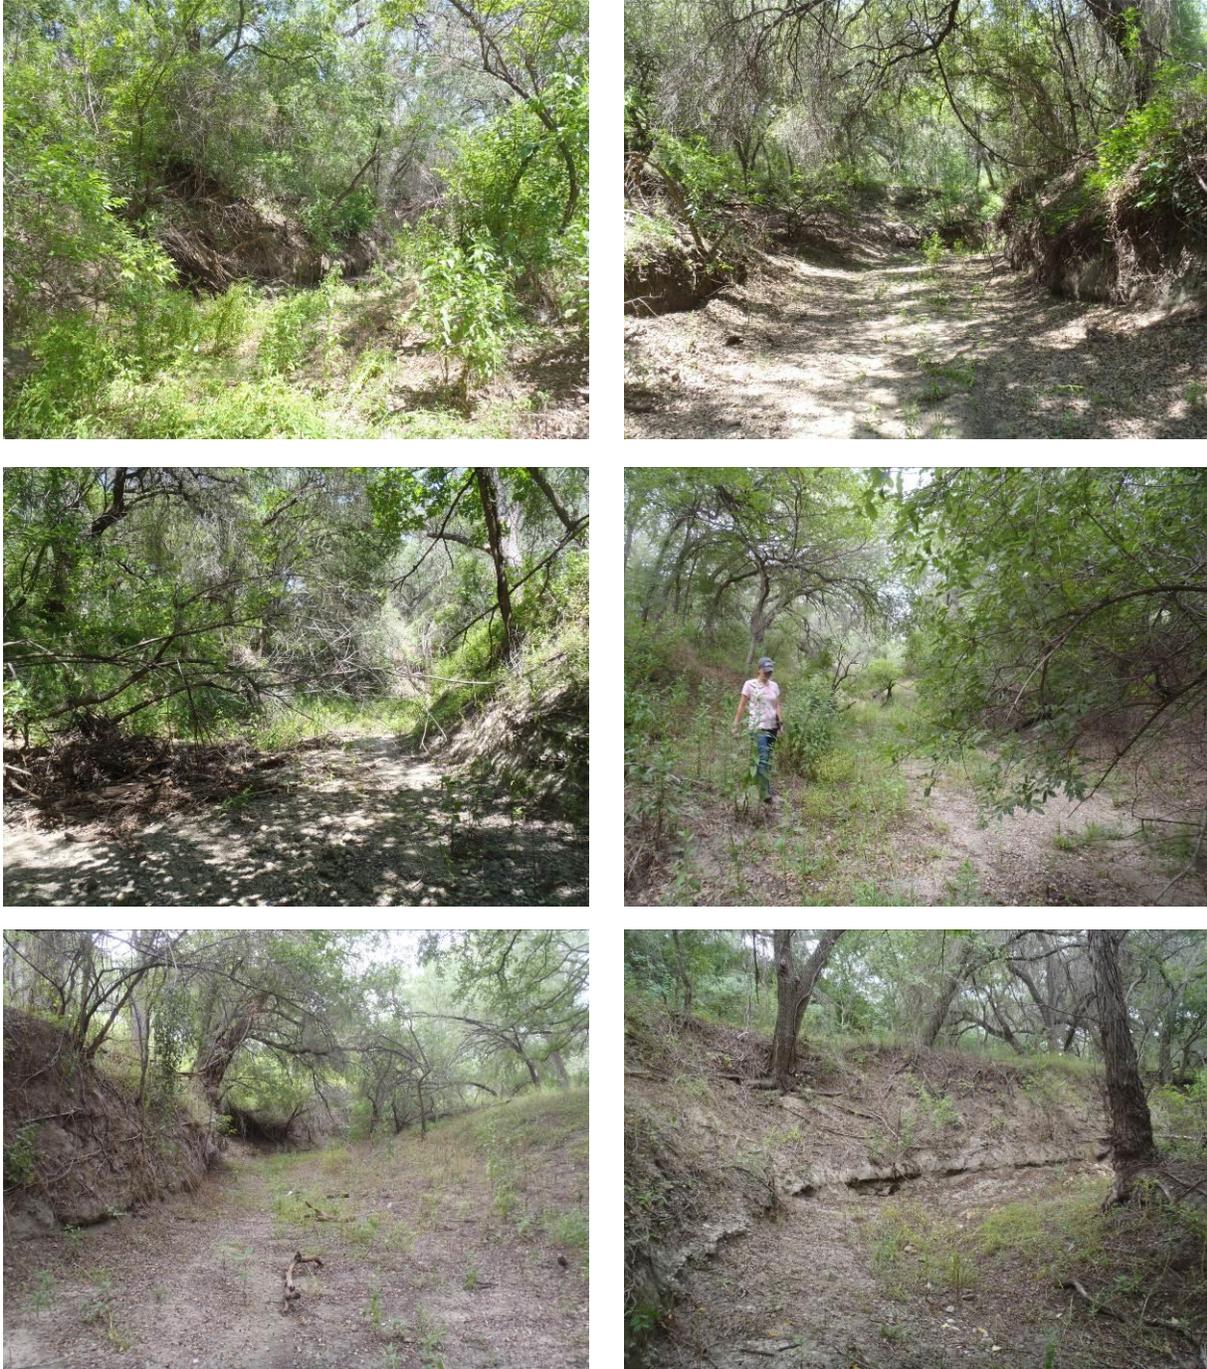
Photogroup 4-21 Leona River Site AU01_09 depicting the general appearance of the stream. (All individuals pictured are TIAER staff.) Top Left – 0-m transect downstream view, May 2012; Top Right – 150-m transect downstream view, May 2012; Middle Left – 300-m transect downstream view, May 2012; Middle Right – 0-m transect upstream view, July 2012; Bottom Left – 150-m transect upstream view, July 2012; Bottom Right – 300-m upstream view, July 2012.

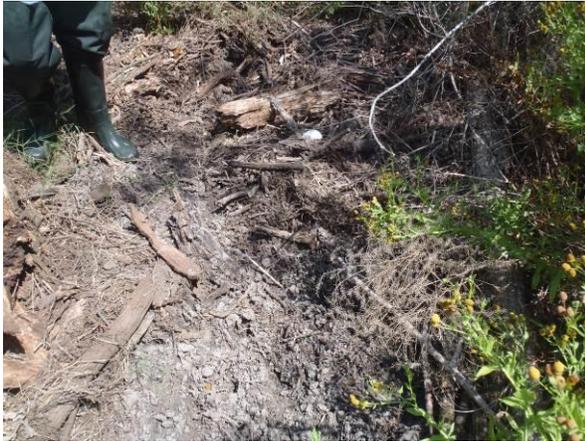
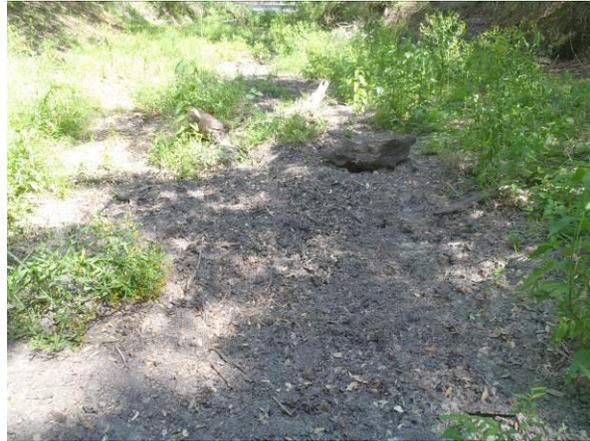
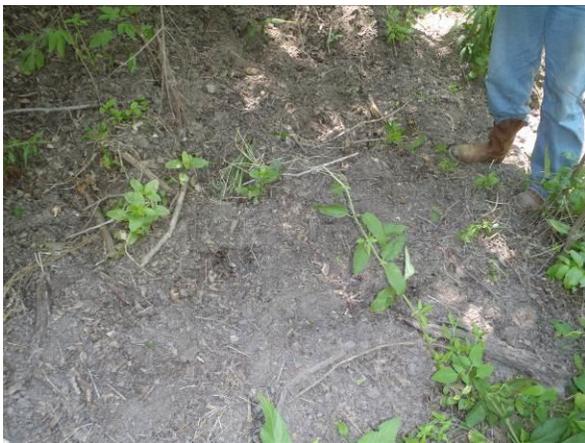
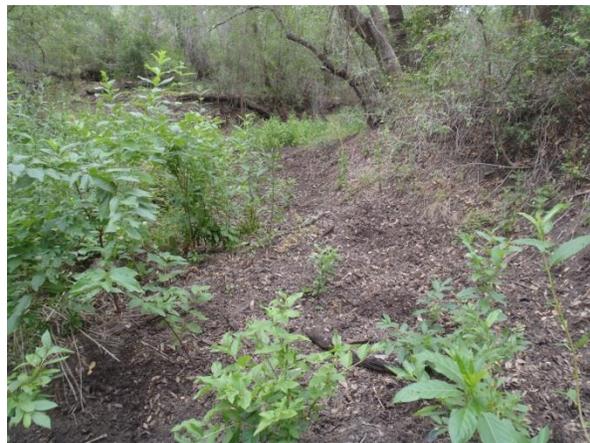
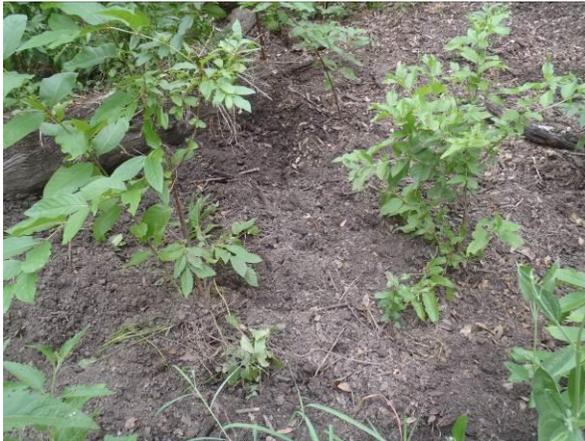
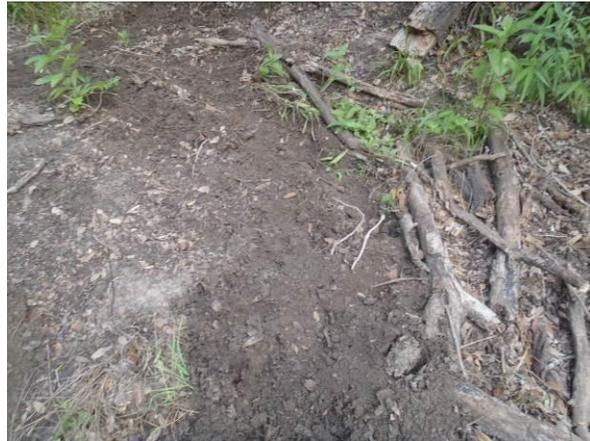
Photogroup 4-22 Hog wallows and trails as signs of wildlife found along AU 2109_01. (All individuals pictured are TIAER staff.) Top Left – Site AU01_02, May 2012; Top Right – Site AU01_06, May 2012; Middle Left – Site AU01_08, May 2012; Middle Right – Site AU01_05, July 2012; Bottom Left – Site AU01_05, July 2012; Bottom Right – Site AU01_06, July 2012.

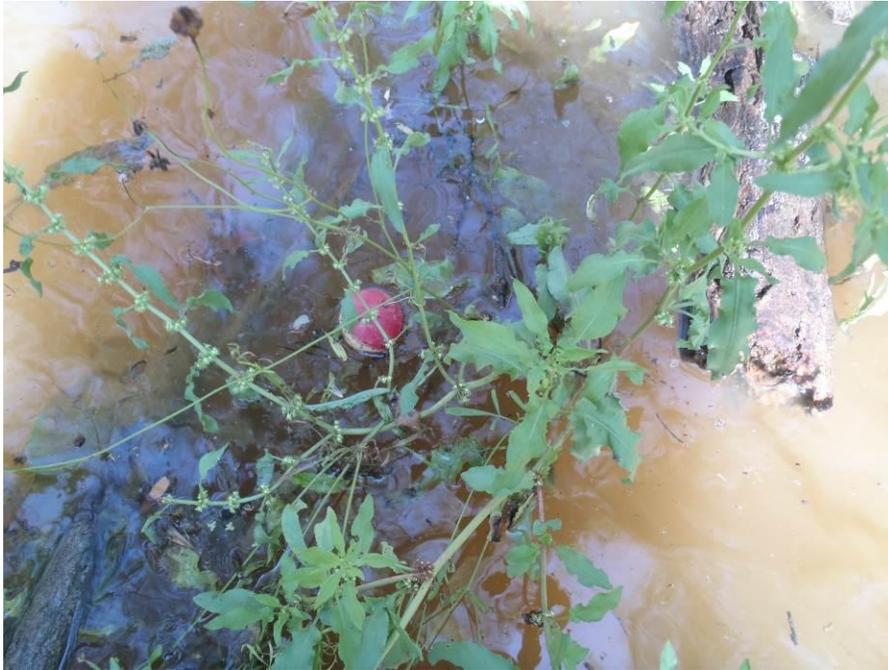
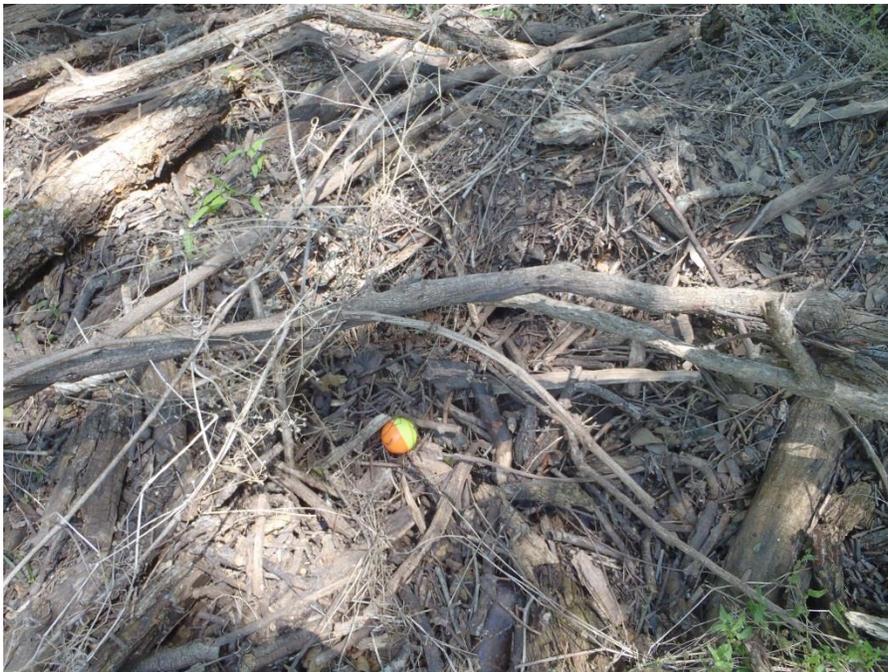
Photogroup 4-23 Bobbers as signs of recreation found along AU 2109_01. (All individuals pictured are TIAER staff.) Top – Site AU01_01, May 2012; Bottom – Site AU01_08, July 2012.

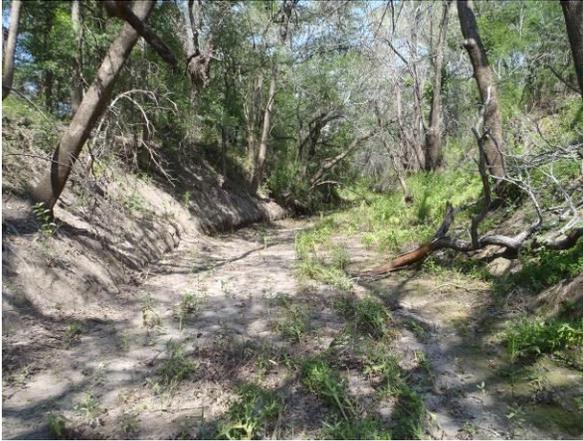
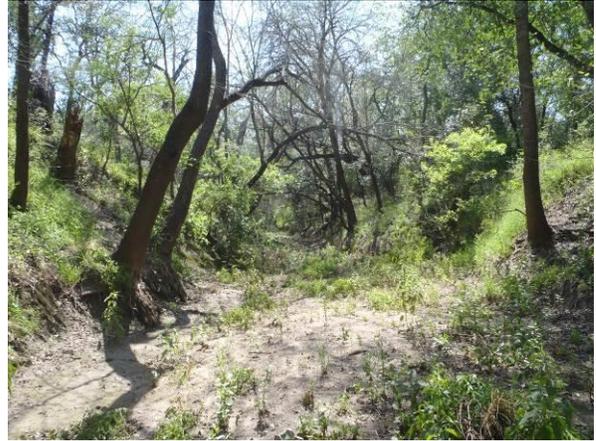
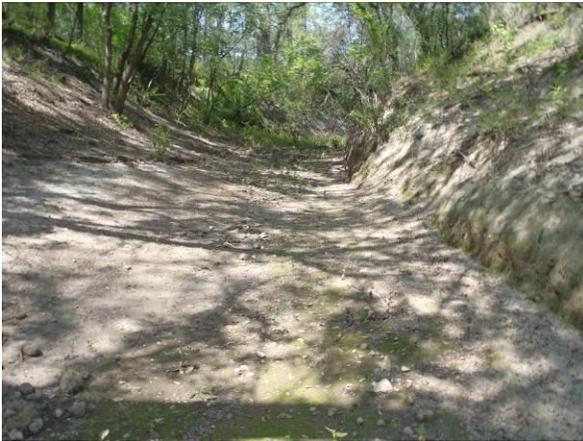
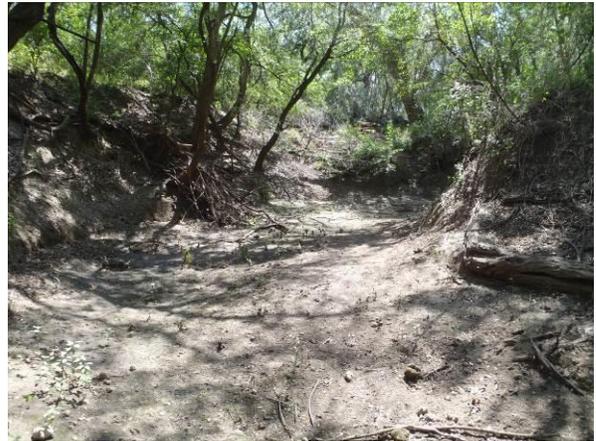
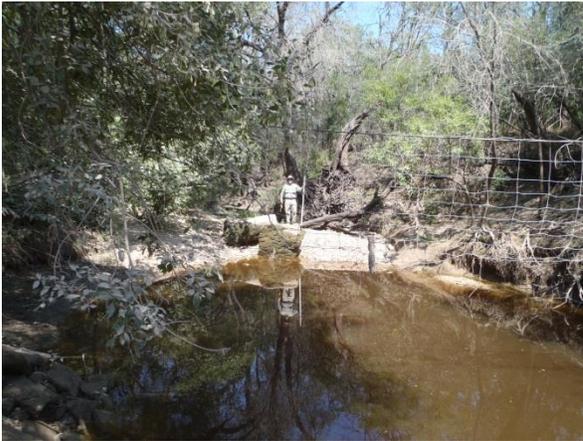
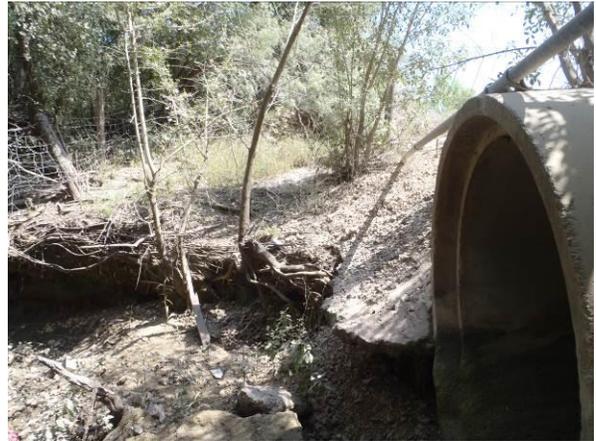
Photogroup 5-1 Leona River Site AU02_01 depicting access and the general appearance of the stream. (All individuals pictured are TIAER staff.) Top Left - 0-m transect downstream view, May 2012; Top Right - 0-m transect upstream view, May 2012; Middle Left - 150-m transect downstream view, May 2012; Middle Right - 150-m transect upstream view, May 2012; Bottom Left - 300-m transect downstream view, May 2012; Bottom Right - 300-m transect right bank, May 2012.

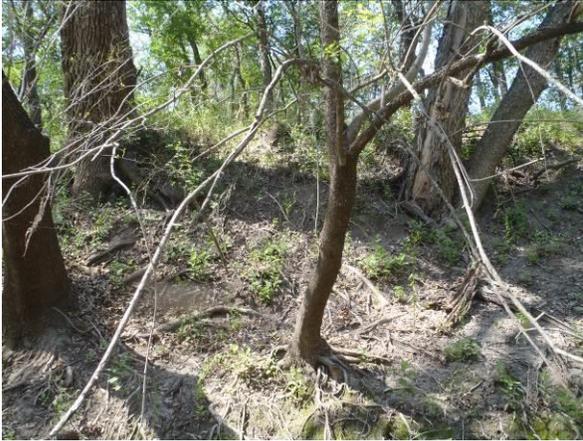
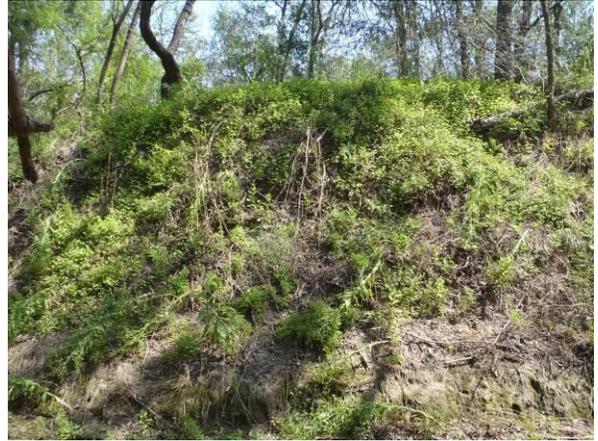
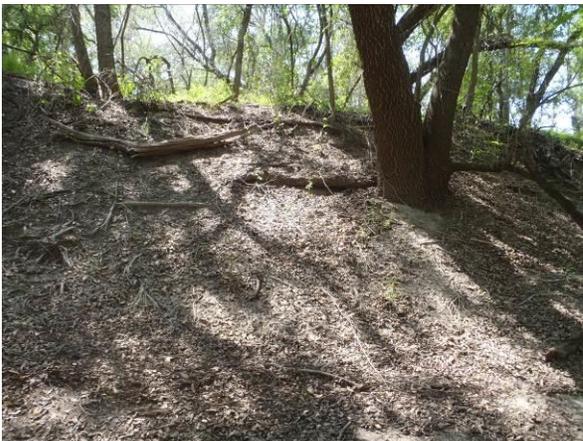
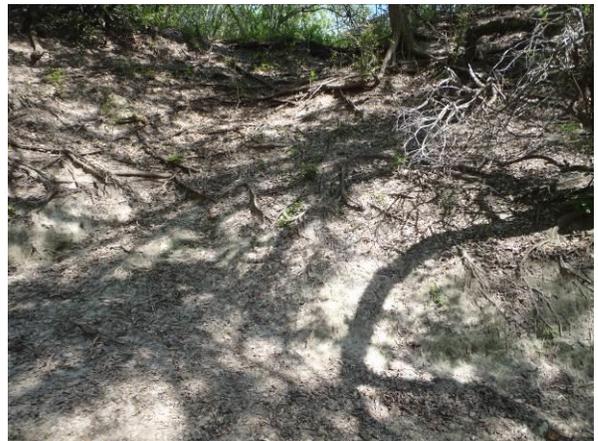
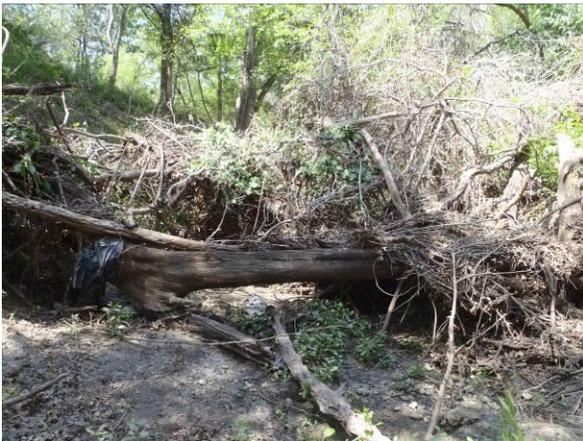
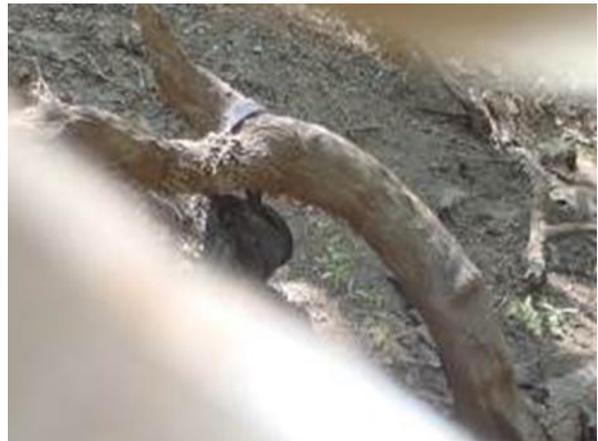
Photogroup 5-2 Leona River Site AU02_01 depicting stream banks, obstruction and a backpack encountered (All individuals pictured are TIAER staff.) Top Left – 0-m transect left bank, May 2012; Top Right – 0-m transect right bank, May 2012; Middle Left – 150-m transect left bank view, May 2012; Middle Right – 150-m transect right bank view, May 2012; Bottom Left – obstruction, May 2012; Bottom Right – backpack tied to log, May 2012.

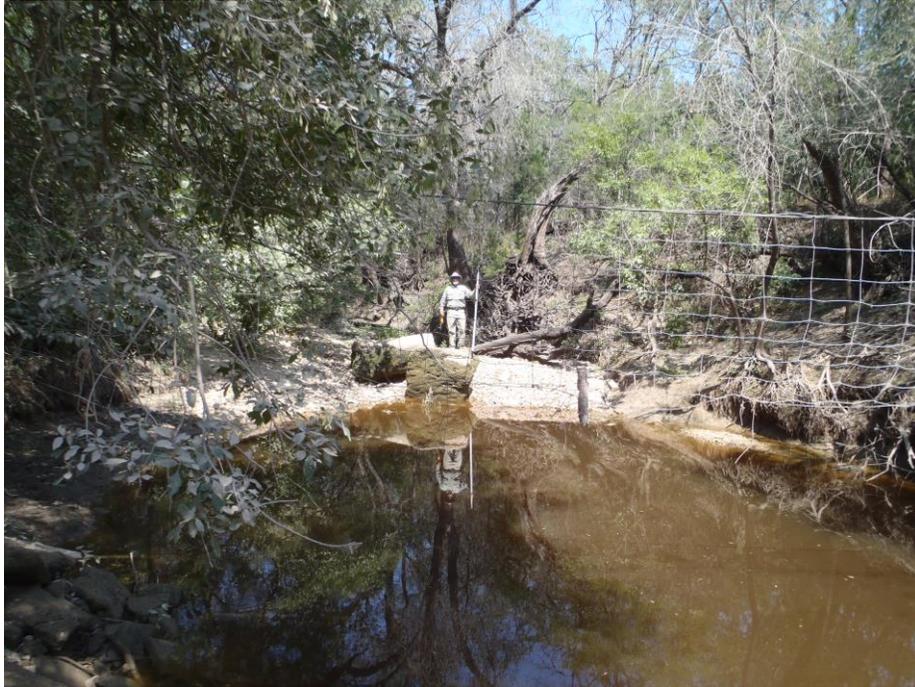
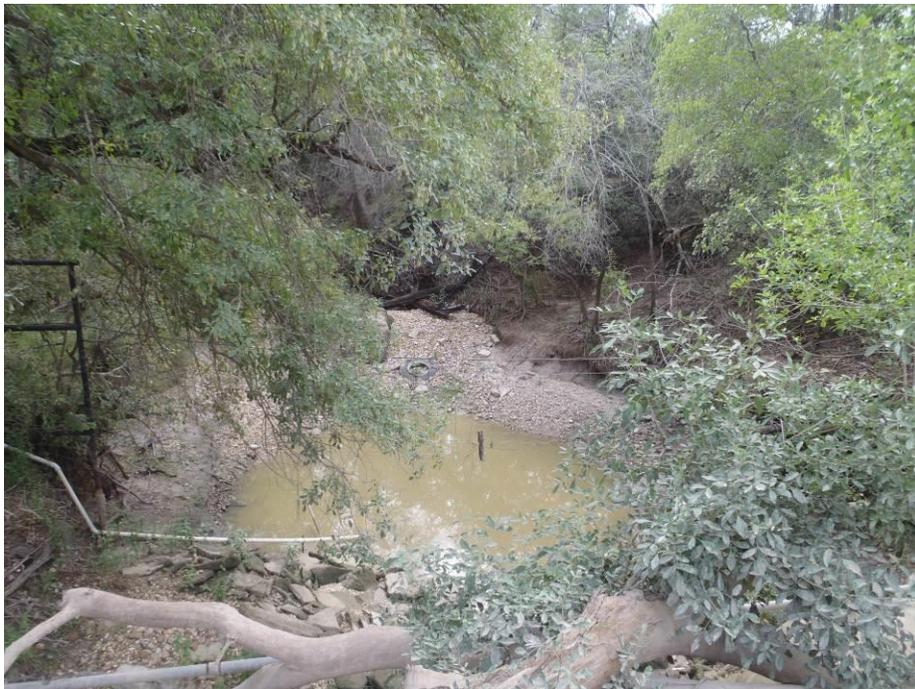
Photogroup 5-3 Leona River Site AU02_01 illustrating pool conditions in May and July 2012. (All individuals pictured are TIAER staff.) Top – 300-m transect downstream view, May 2012; Bottom – 300-m transect location downstream view, July 2012.

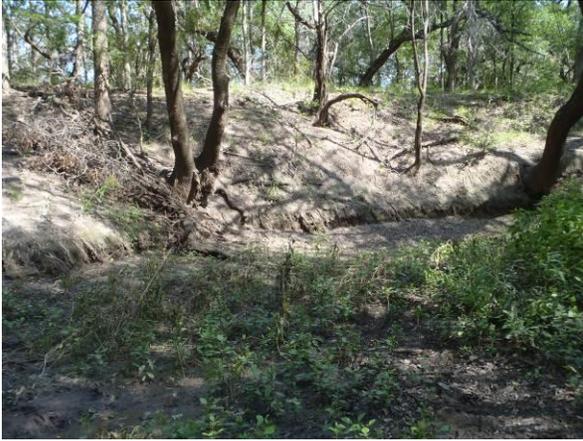
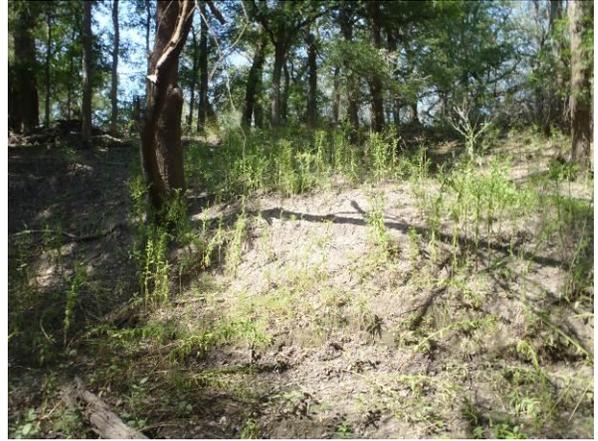
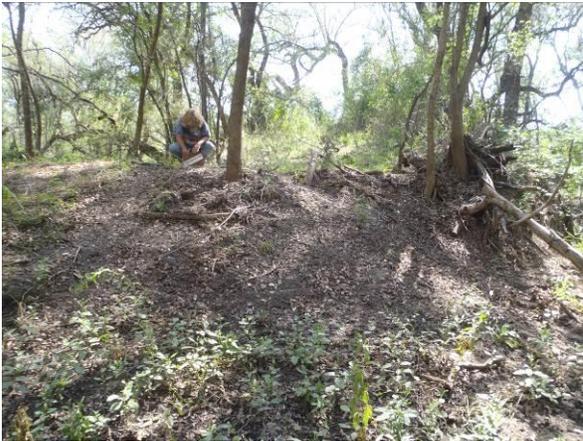
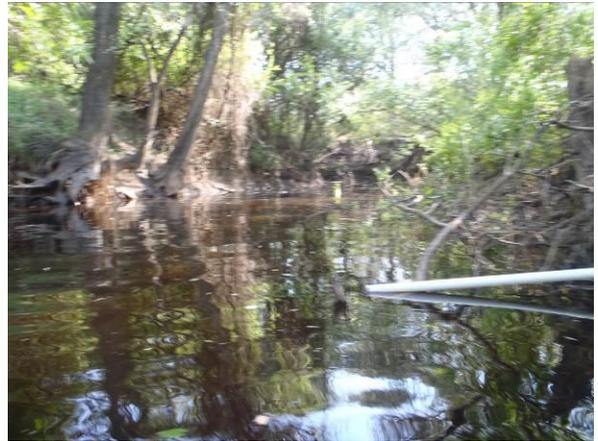
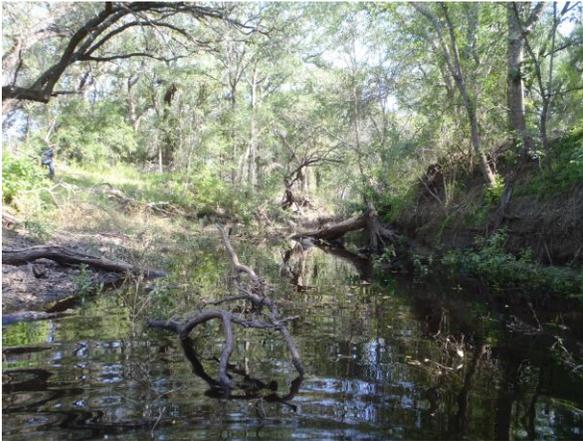
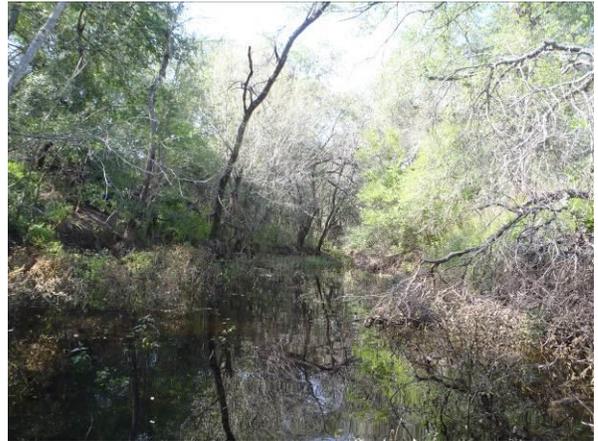
Photogroup 5-4 Leona River Site AU02_02 depicting the general appearance of the stream. Top Left - 0-m transect downstream view, May 2012; Top Right - 0-m transect left bank view, May 2012; Middle Left – 0-m transect right bank view, May 2012; Middle Right – 150-m transect downstream view, May 2012; Bottom Left – 300-m transect downstream view, May 2012; Bottom Right – 300-m transect upstream view, May 2012.

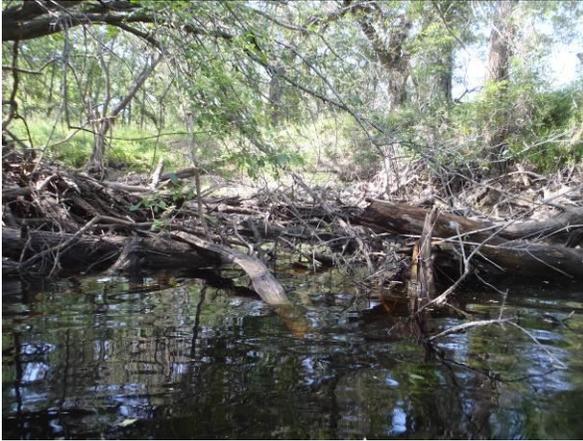
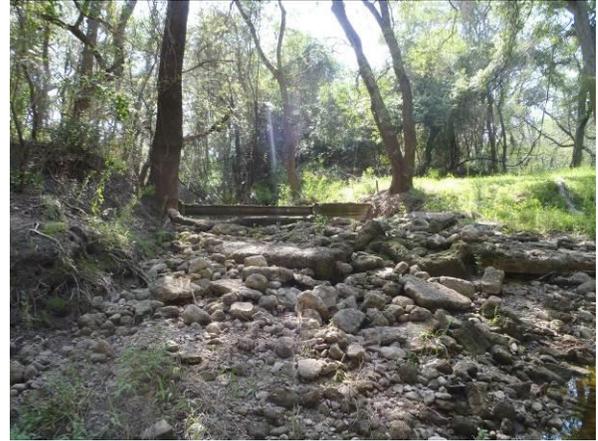
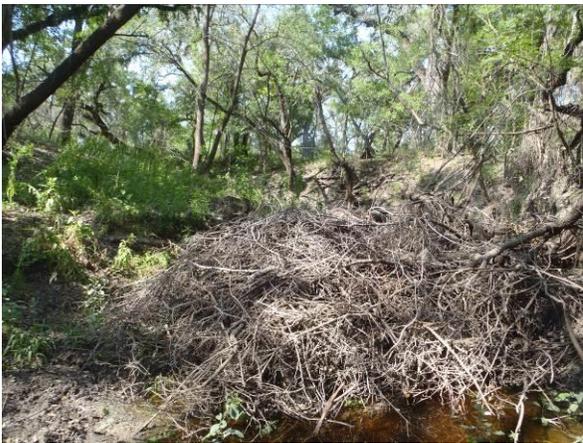
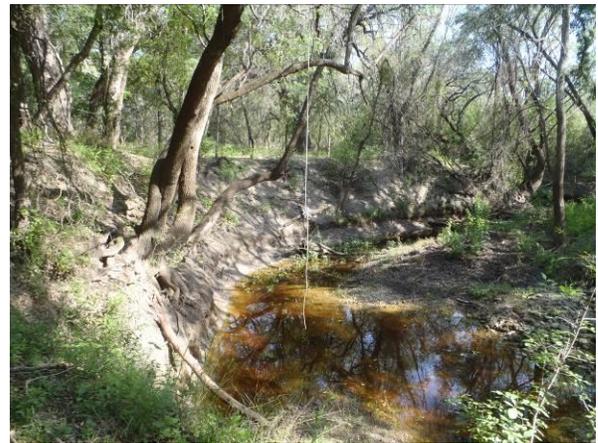
Photogroup 5-5 Leona River Site AU02_02 depicting obstructions and rope swing encountered. Top Left - 150-m transect upstream view, May 2012; Top Right – obstruction 2, May 2012; Bottom Left – obstruction, May 2012; Bottom Right – rope swing over shallow pool, May 2012.

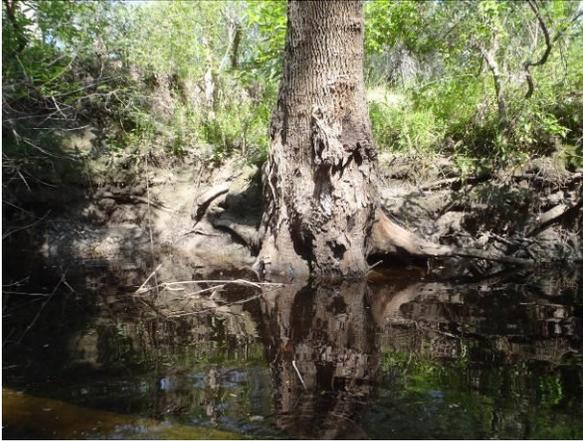
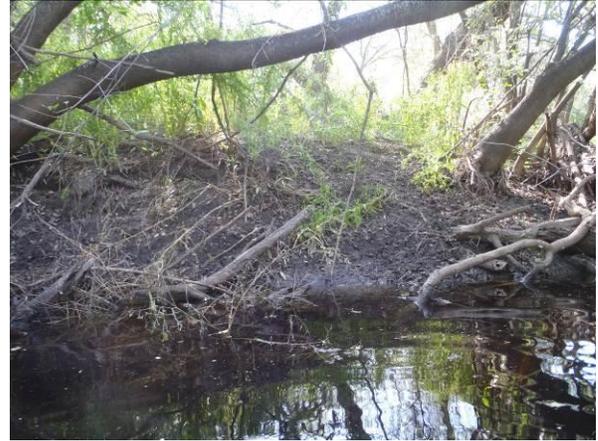
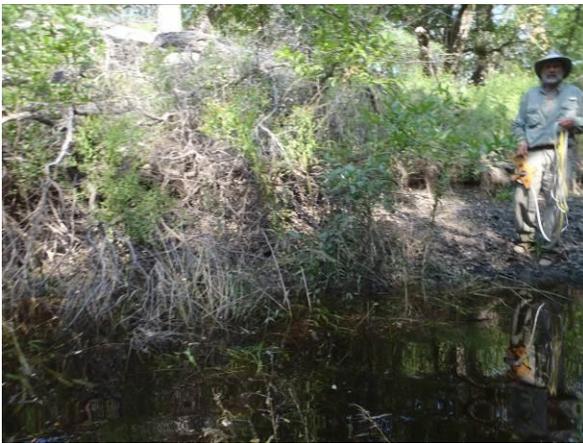
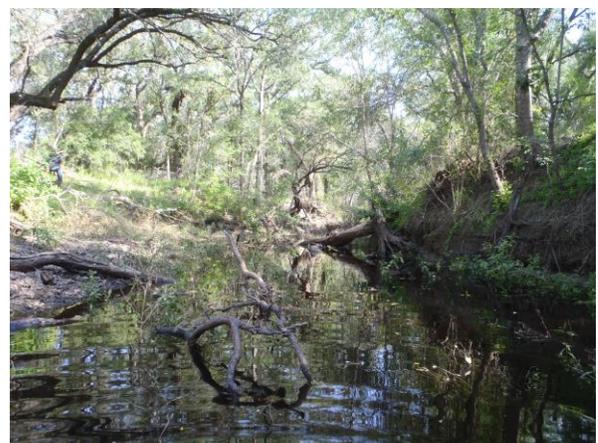
Photogroup 5-6 Leona River Site AU02_02 illustrating the water color, general appearance, and clarity of the water surface. (All individuals pictured are TIAER staff.) Top Left - 150-m transect left bank view, May 2012; Top Right - 150-m transect right bank view, May 2012; Bottom Left – 300-m transect, left bank view, May 2012; Bottom Right – 300-m transect downstream view, May 2012.

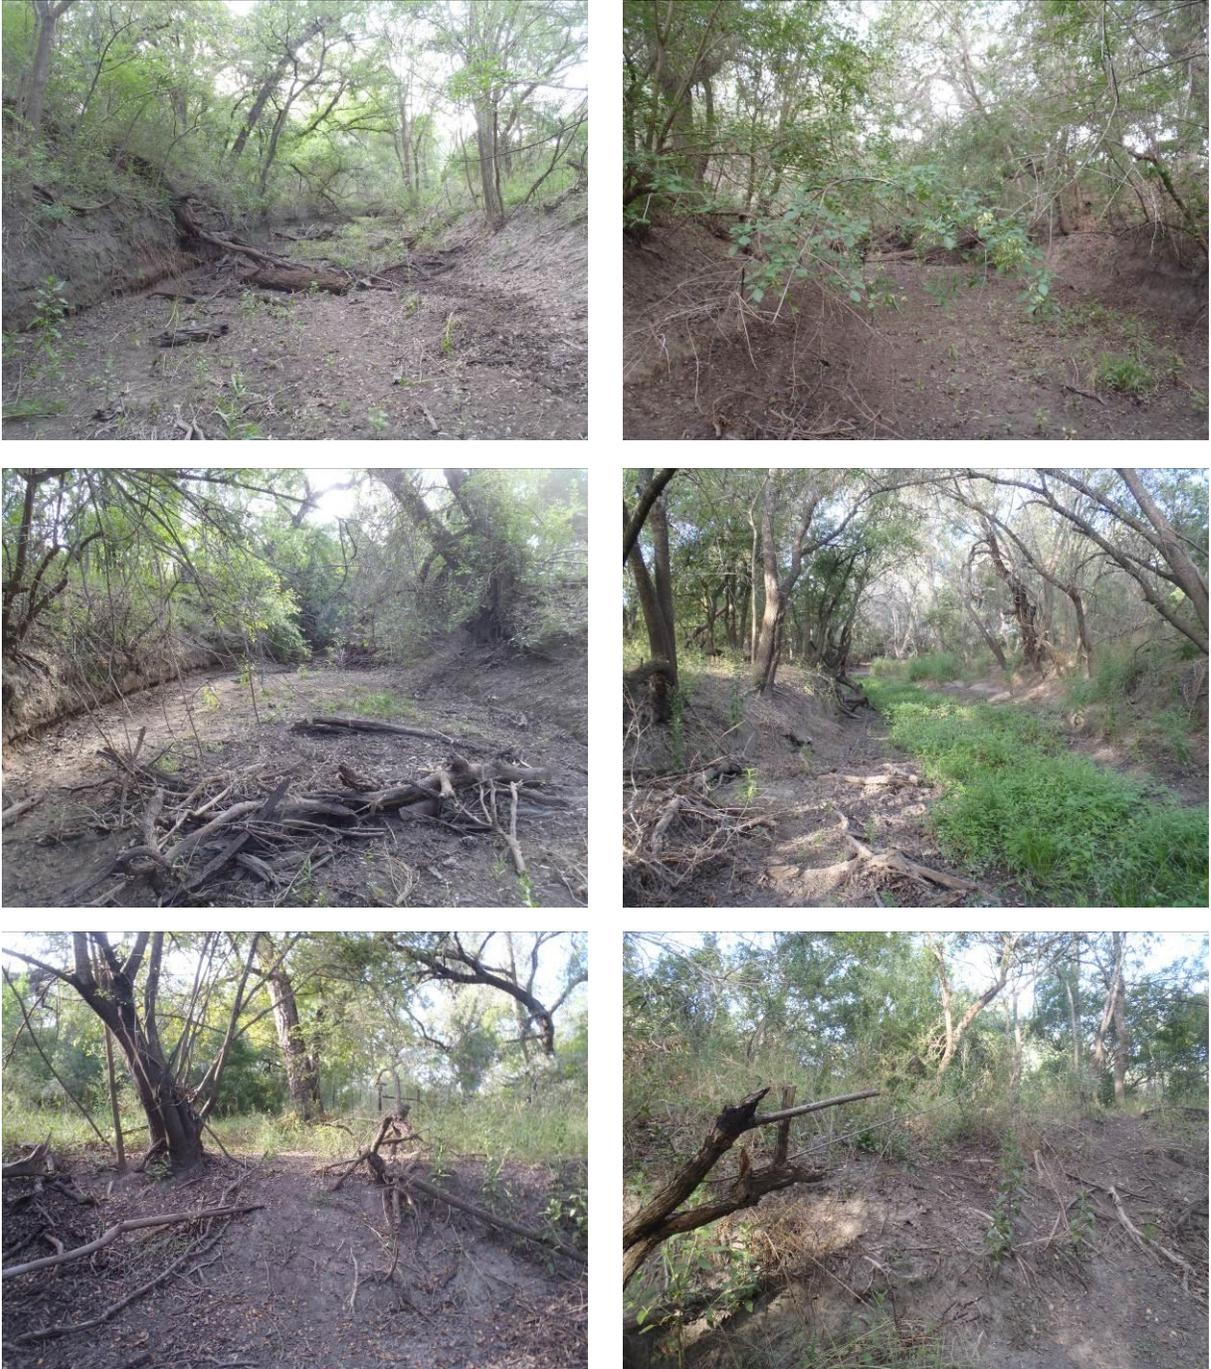
Photogroup 5-7 Leona River Site AU02_03 depicting access and the general appearance of the stream. Top Left - 150-m transect downstream view, May 2012; Top Right - 150-m transect upstream view, May 2012; Middle Left – 300-m transect downstream view, May 2012; Middle Right – 0-m transect upstream view, July 2012; Bottom Left – 0-m transect right bank view, July 2012; Bottom Right – 300-m transect left bank view, July 2012.

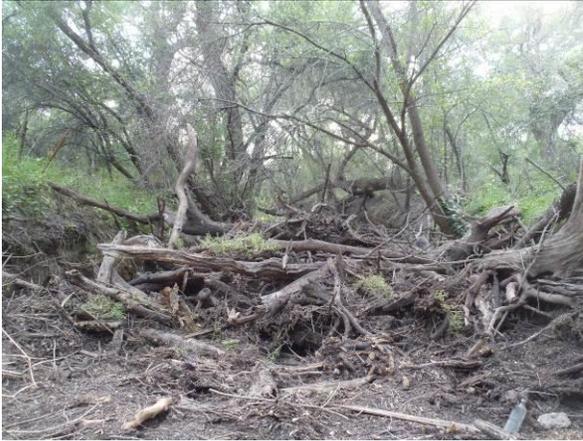
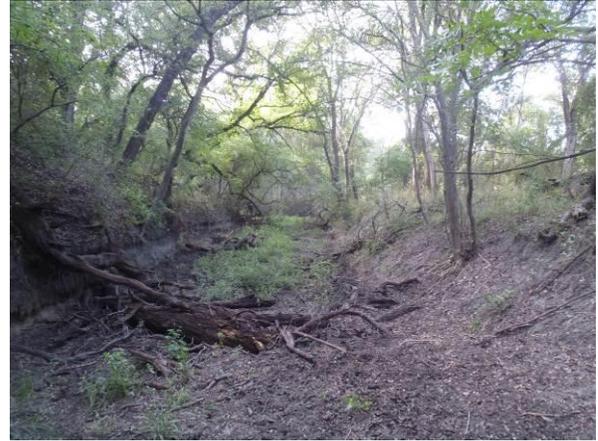
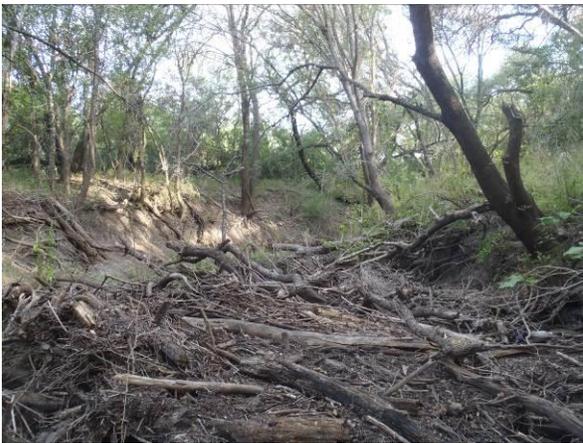
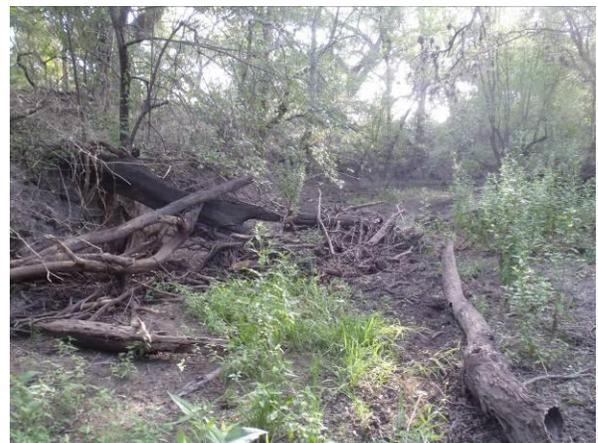
Photogroup 5-8 Leona River Site AU02_03 depicting obstructions encountered. Top Left - 0-m transect downstream view, May 2012; Top Right - 150-m transect downstream view, July 2012; Bottom Left – 300-m transect, downstream view, July 2012; Bottom Right – obstruction, July 2012.
