**Leona River
Recreational Use Attainability Analysis**

**Texas State Soil and Water Conservation Board
Project 11-50**

**Texas Institute for Applied Environmental Research
Tarleton State University
Stephenville, Texas**

June 2013

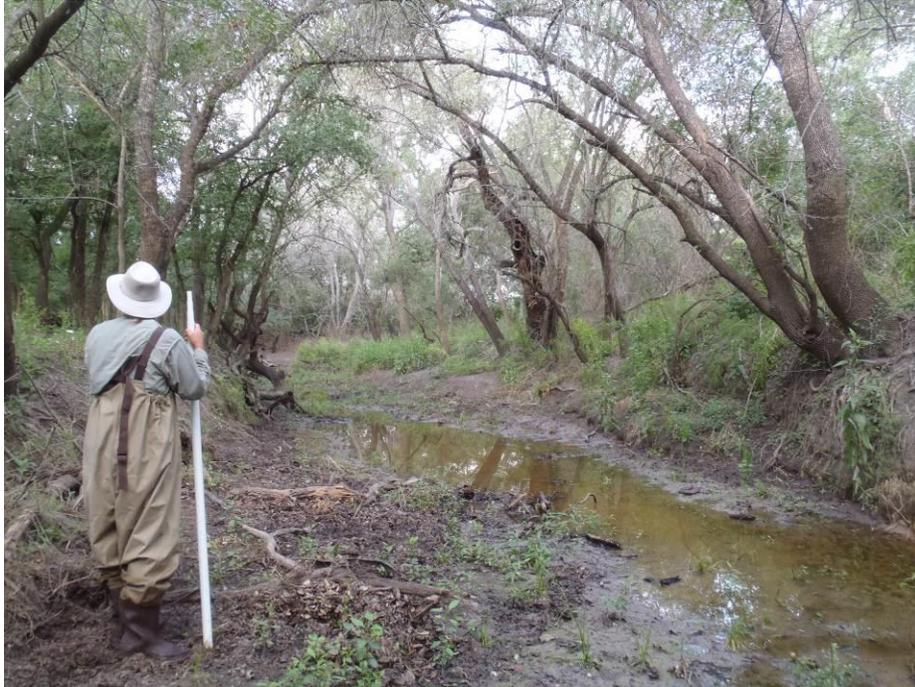
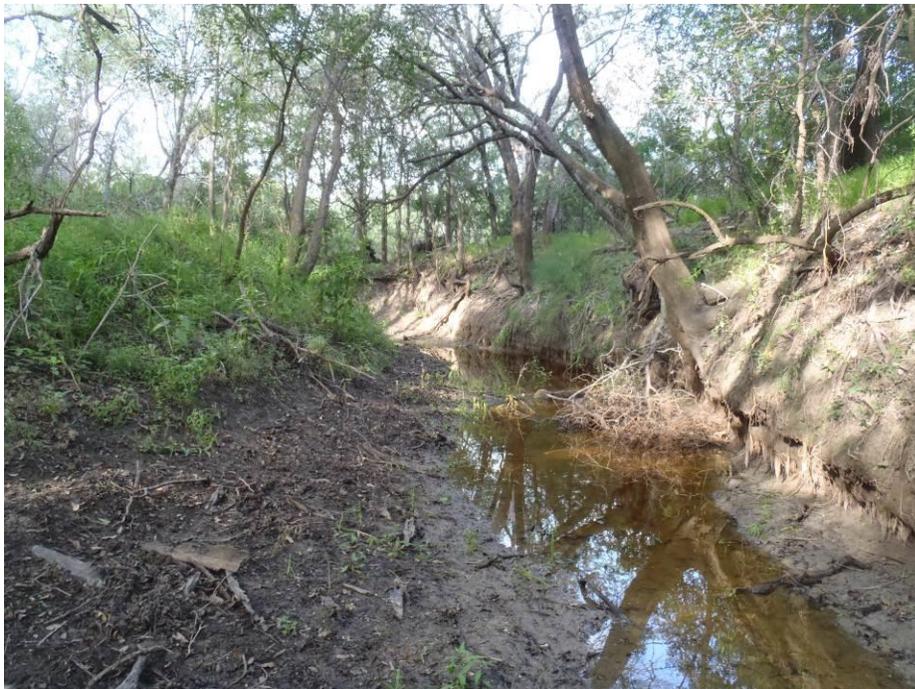
Photogroup 5-9 Leona River Site AU02_03 illustrating the water color, general appearance, and clarity of the water surface. (All individuals pictured are TIAER staff.) Top - 0-m transect upstream view, May 2012; Bottom – 300-m transect upstream view, May 2012.

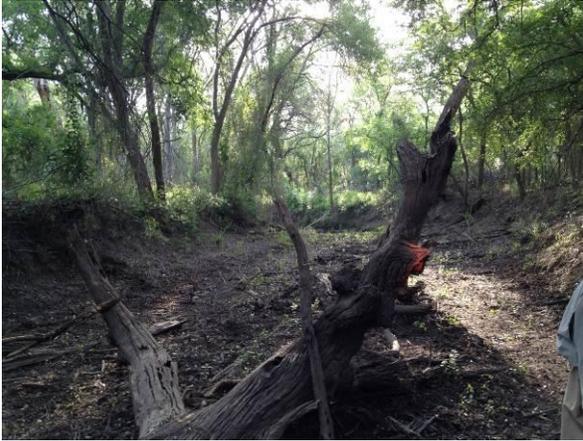
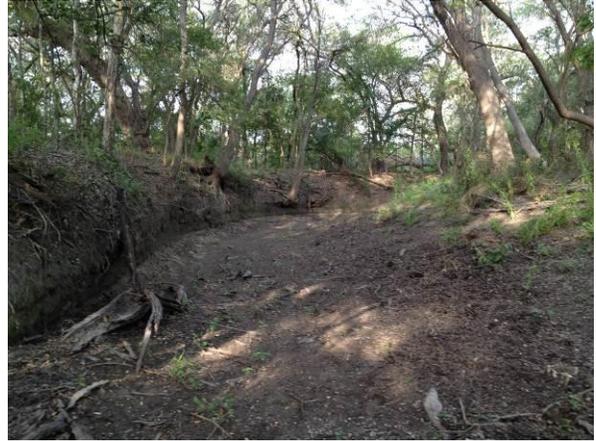
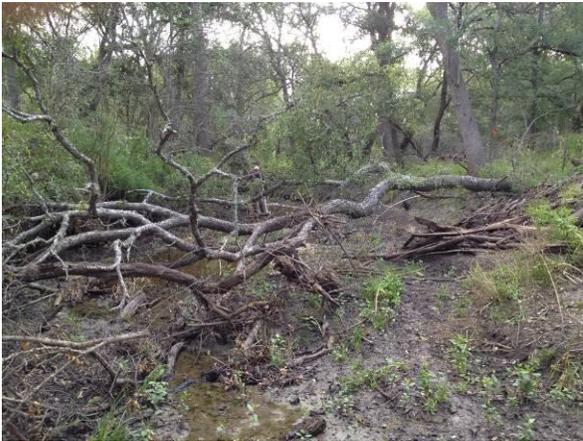
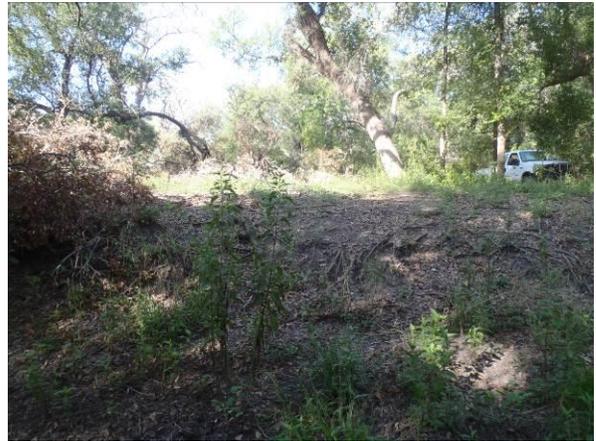
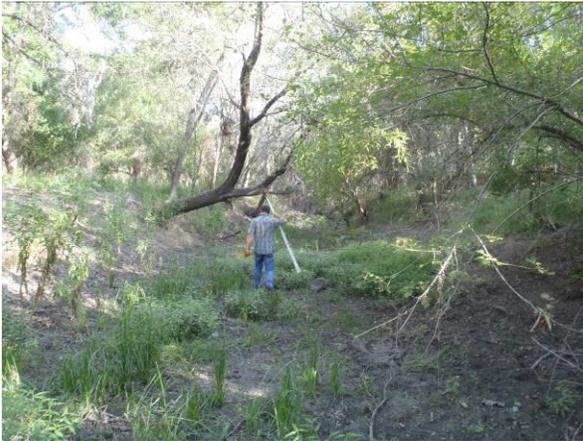
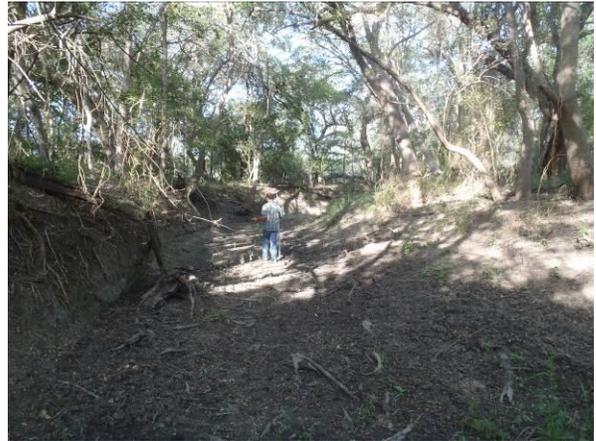
Photogroup 5-10 Leona River Site AU02_04 depicting access and the general appearance of the stream. (All individuals pictured are TIAER staff.) Top Left - 150-m transect downstream view, May 2012; Top Right - 150-m transect upstream view, May 2012; Middle Left – 300-m transect downstream view, May 2012; Middle Right – 0-m transect right bank view, July 2012; Bottom Left – 0-m transect upstream view, July 2012; Bottom Right – 300-m transect upstream view, July 2012.

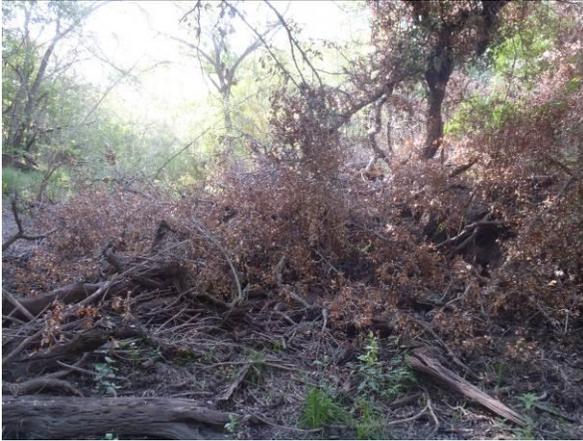
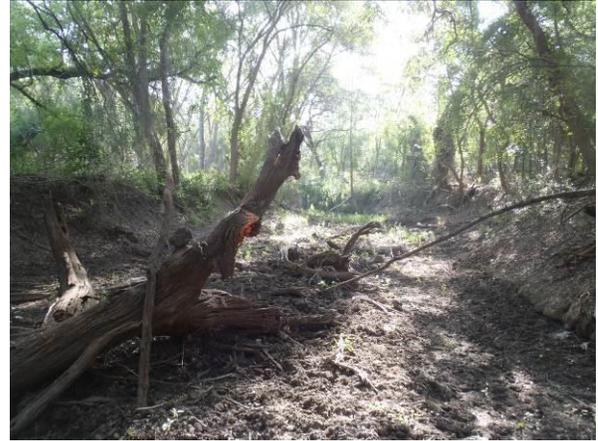
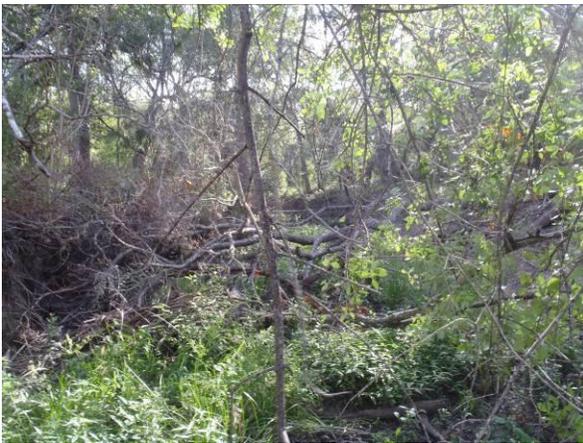
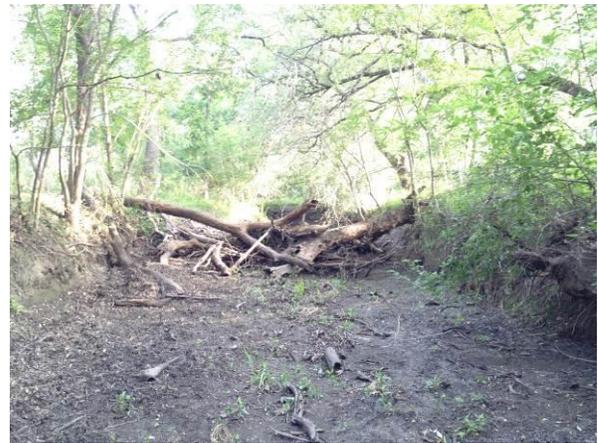
Photogroup 5-11 Leona River Site AU02_04 depicting obstructions encountered. Top Left - 0-m transect downstream view, July 2012; Top Right - 150-m transect downstream view, July 2012; Bottom Left – 300-m transect downstream view, July 2012; Bottom Right – obstruction, May 2012.

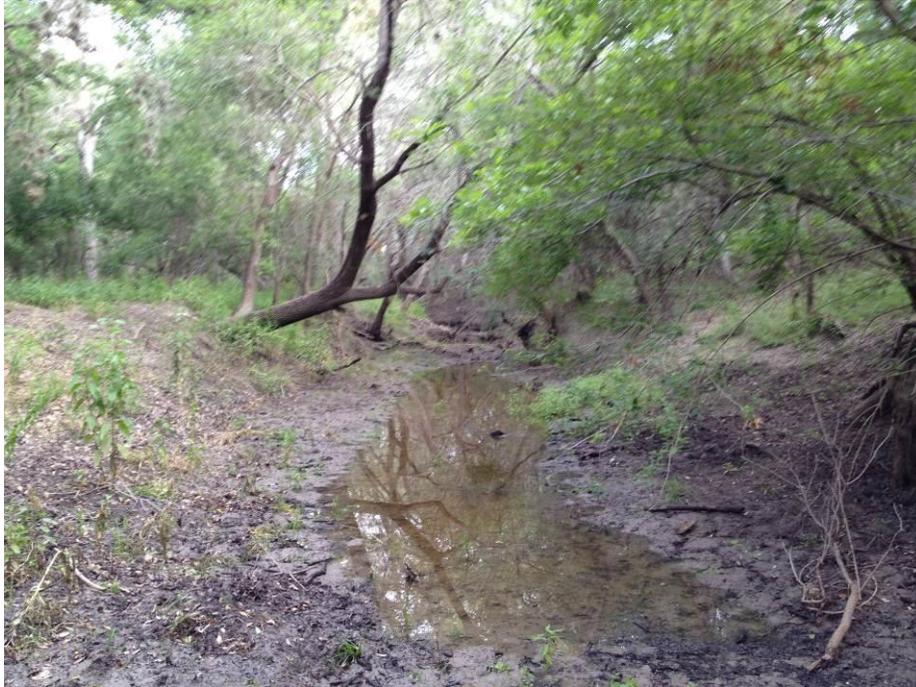
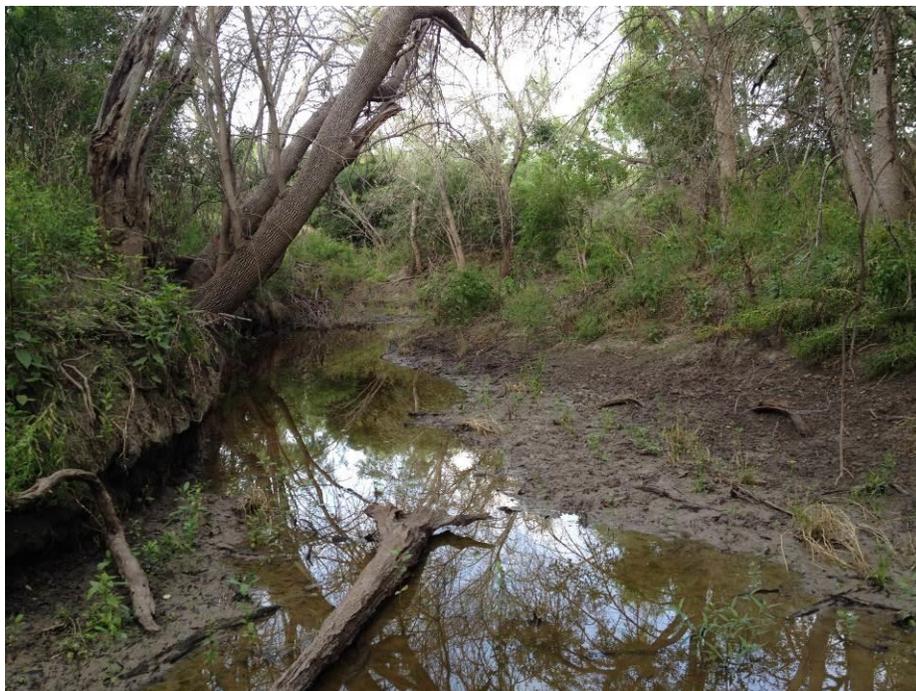
Photogroup 5-12 Leona River Site AU02_04 illustrating the water color, general appearance, and clarity of the water surface. Top - 0-m transect upstream view, May 2012; Bottom – 300-m transect upstream view, May 2012.

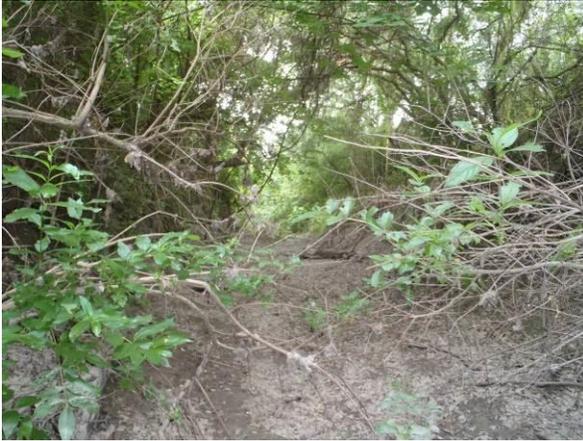
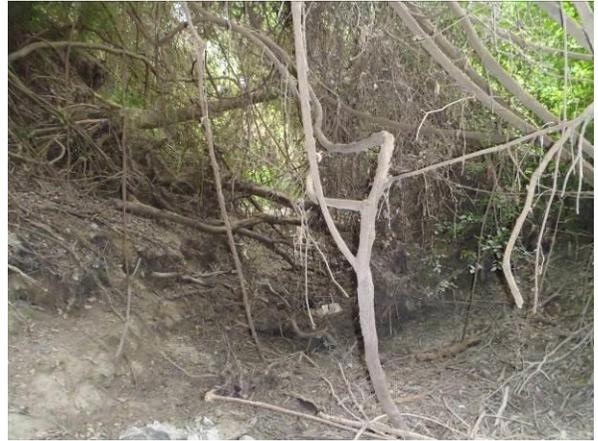
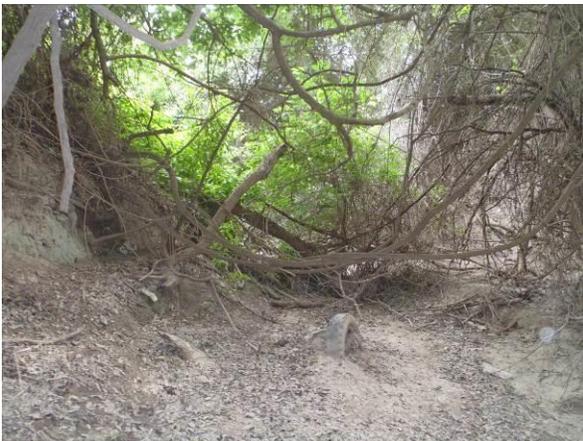
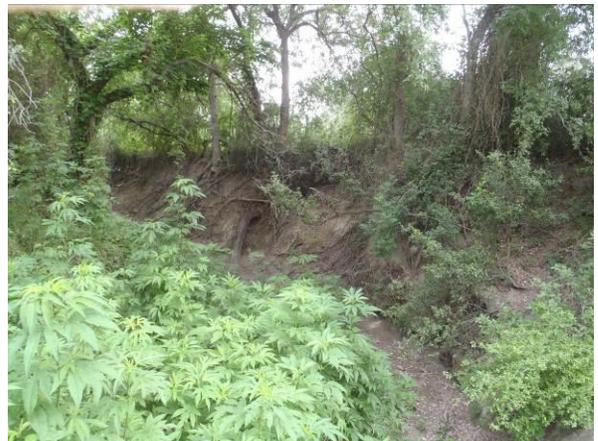
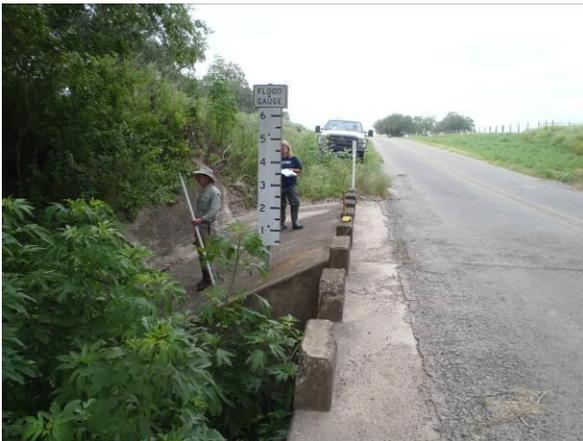
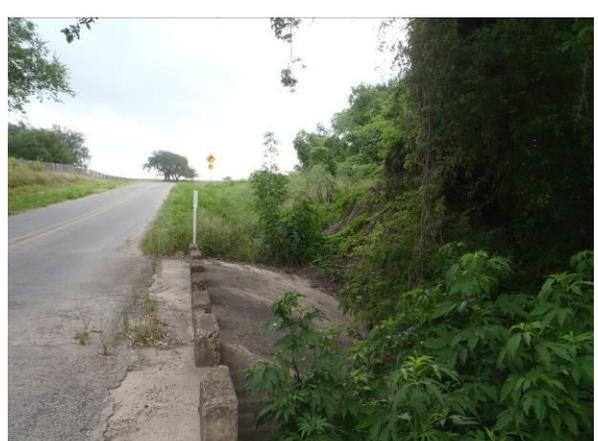
Photogroup 5-13 Leona River Site AU02_05 depicting access and the general appearance of the stream. (All individuals pictured are TIAER staff.) Top Left - 0-m transect downstream view, May 2012; Top Right - 150-m transect downstream view, May 2012; Middle Left – 150-m transect upstream view, May 2012; Middle Right – 300-m transect downstream view, May 2012; Bottom Left – 300-m right bank view, July 2012; Bottom Right – 300-m transect left bank view, July 2012.

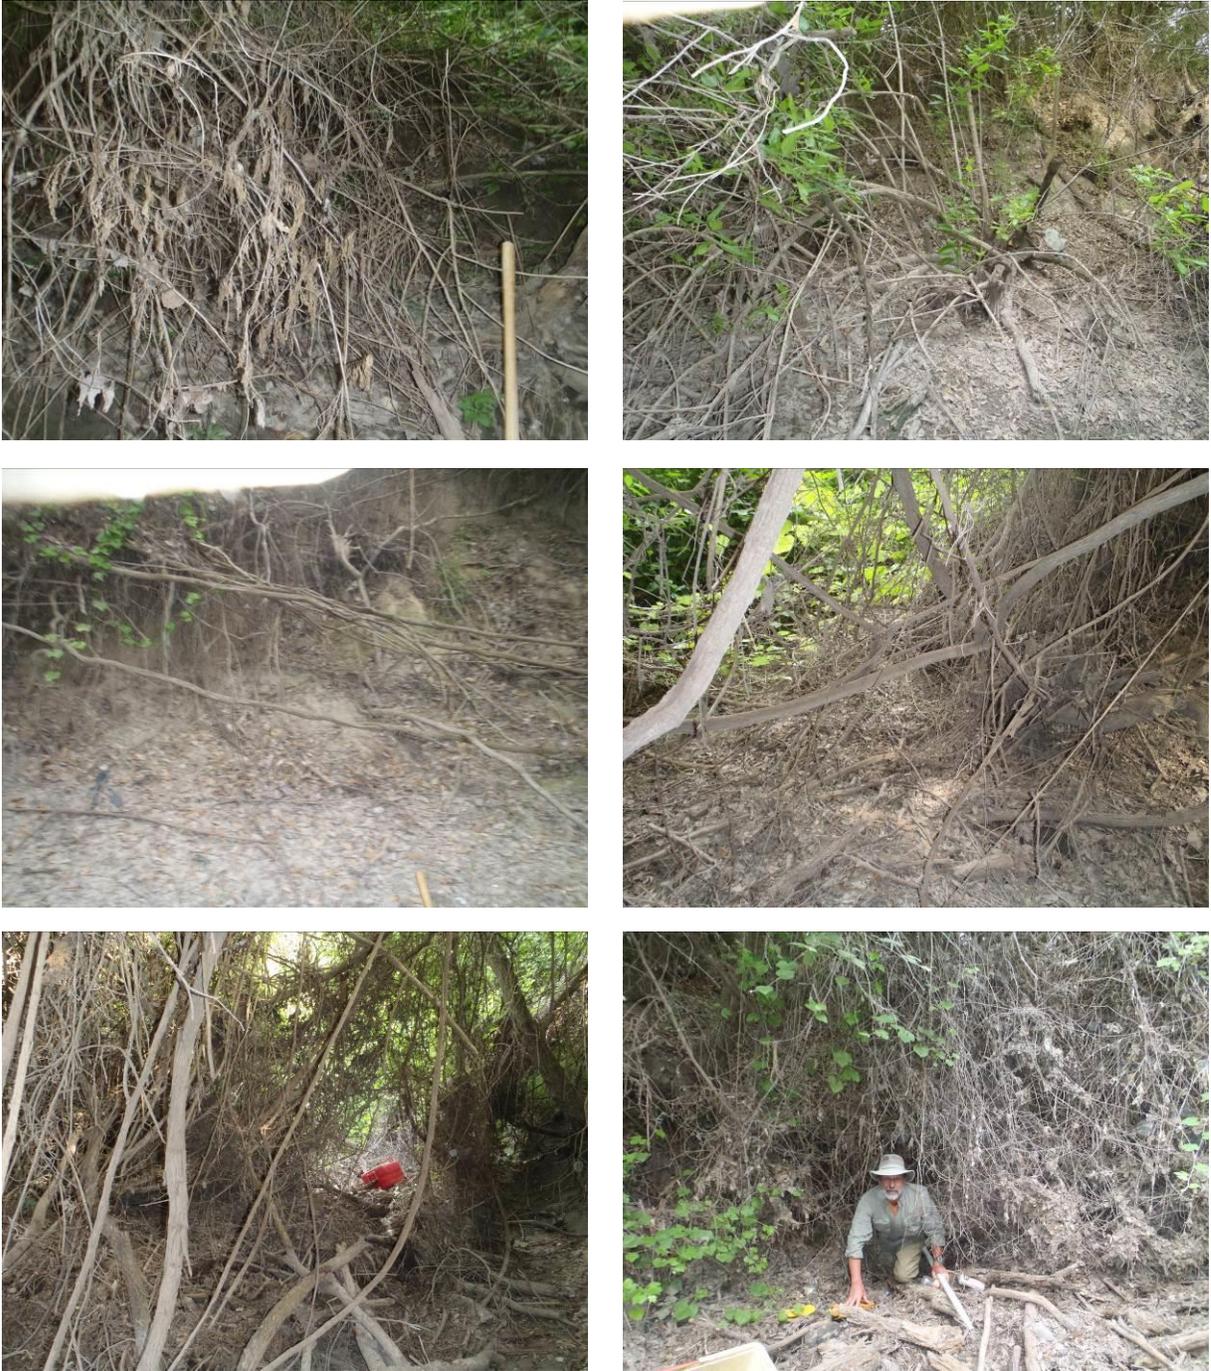
Photogroup 5-14 Leona River Site AU02_05 depicting obstructions encountered. (All individuals pictured are TIAER staff.) Top Left - 0-m transect left bank view, May 2012; Top Right - 0-m transect, right bank view, May 2012; Middle Left – 150-m transect left bank view, May 2012; Middle Right – 150-m transect right bank view, May 2012; Bottom Left – obstruction and red cooler, May 2012; Bottom Right – staff crawling through vines, May 2012.

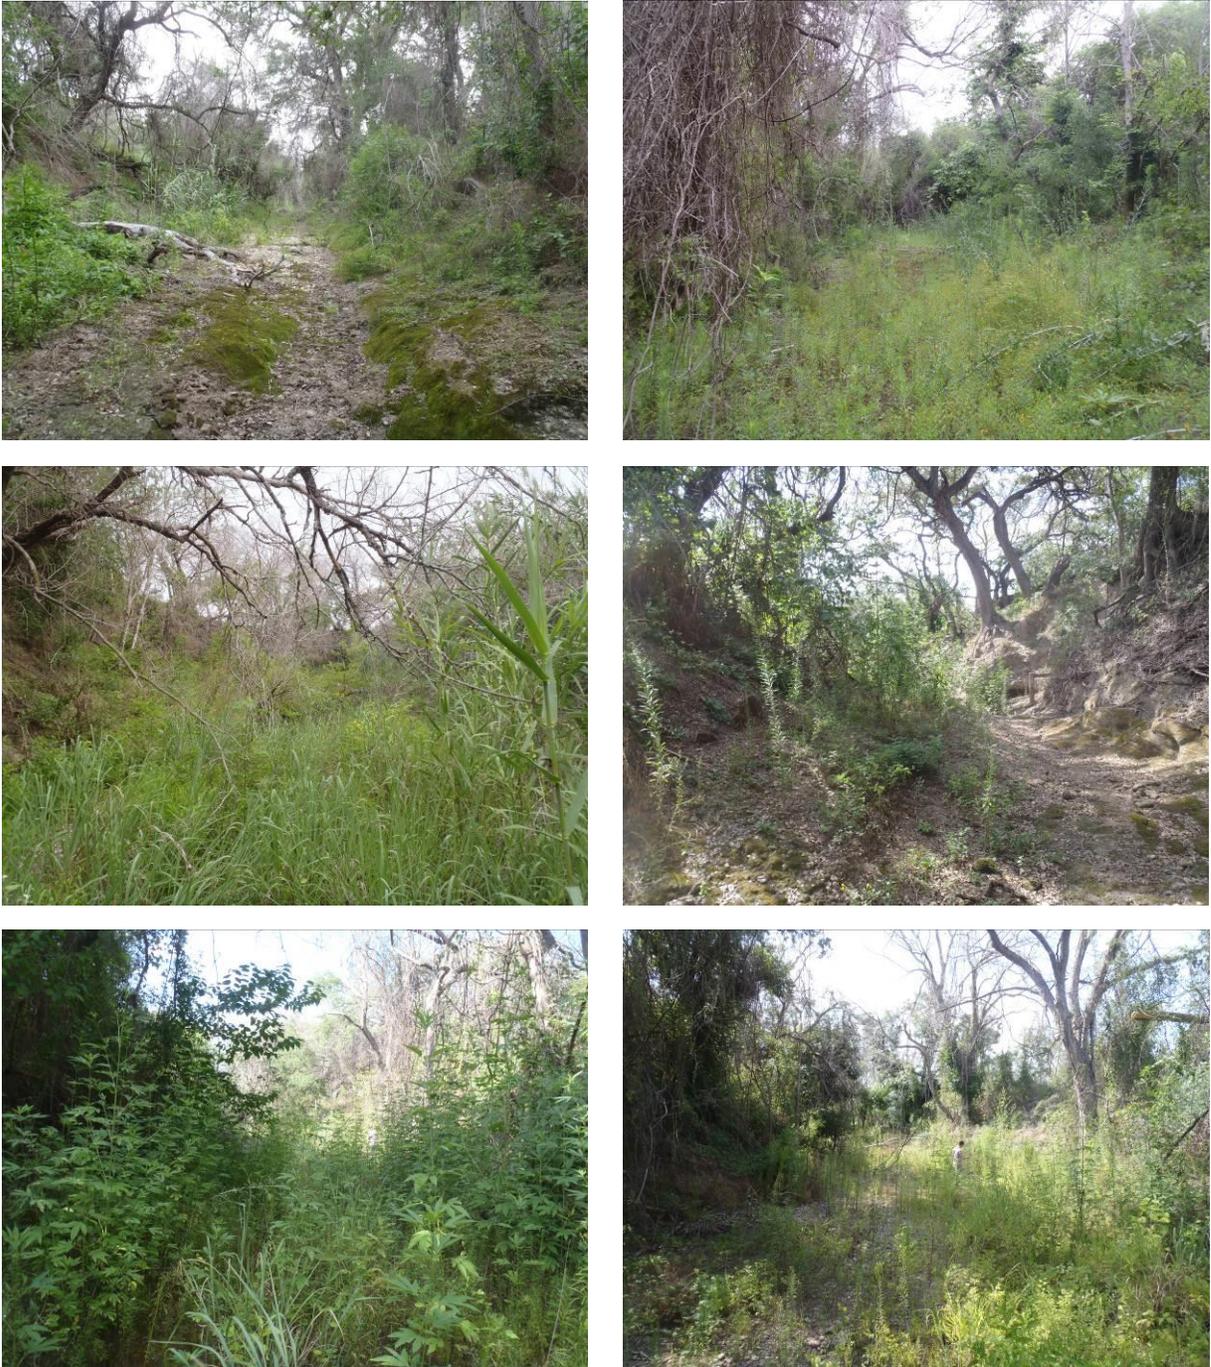
Photogroup 5-15 Leona River Site AU02_05 illustrating dense vegetation and absence of water. Top - 300-m transect downstream view, July 2012; Bottom – 300-m transect upstream view, July 2012.

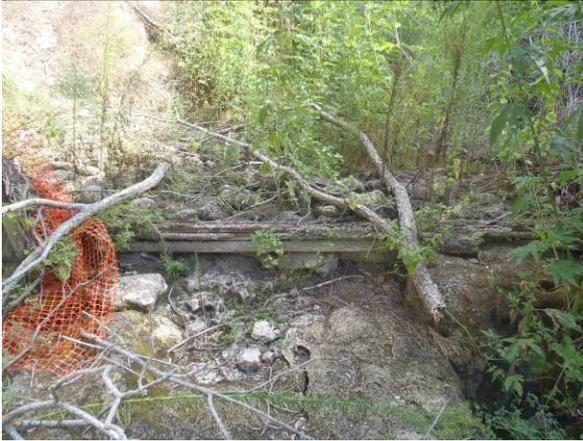
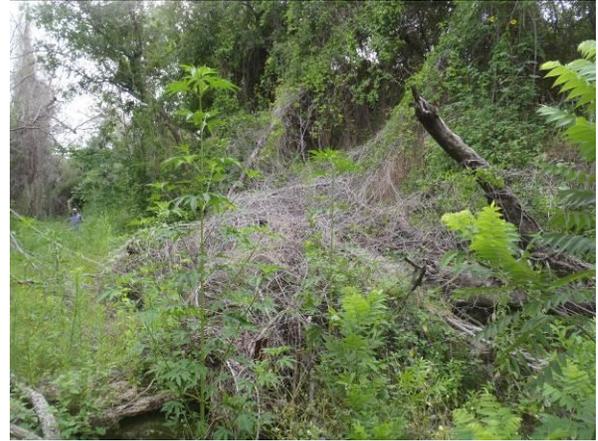
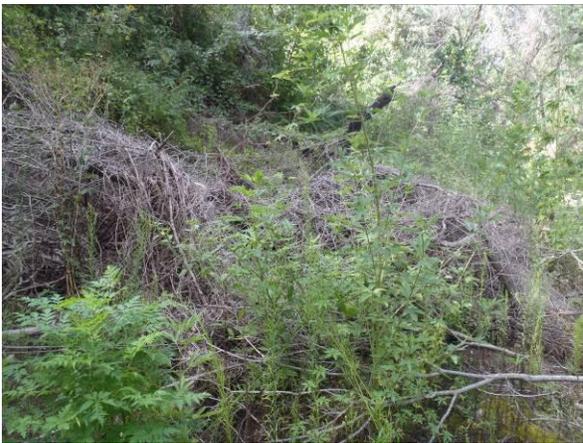
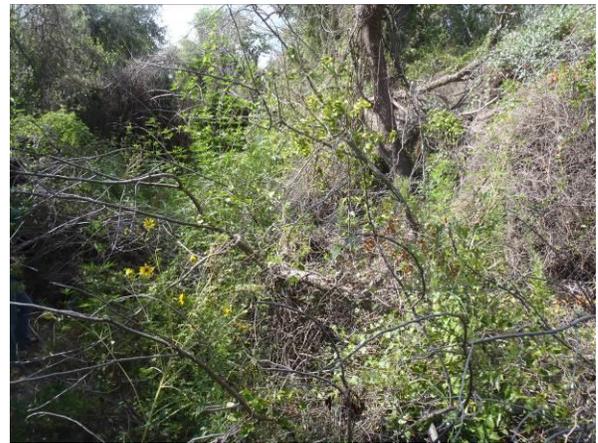
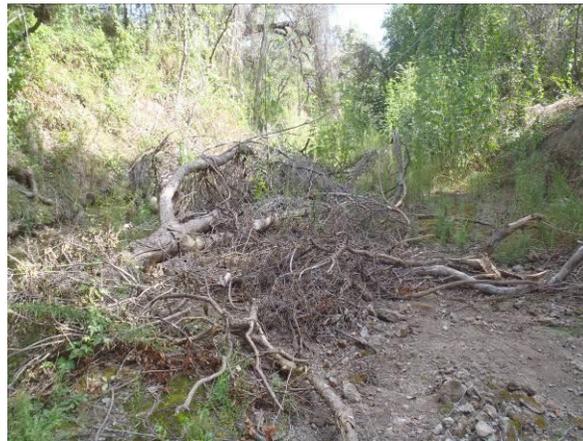
Photogroup 5-16 Leona River Site AU02_06 depicting the general appearance of the stream. (All individuals pictured are TIAER staff.) Top Left - 0-m transect upstream view, May 2012; Top Right - 150-m transect upstream view, May 2012; Middle Left – 300-m transect upstream view, May 2012; Middle Right – 0-m transect downstream view, July 2012; Bottom Left – 150-m transect downstream view, July 2012; Bottom Right – 300-m transect downstream view, July 2012.

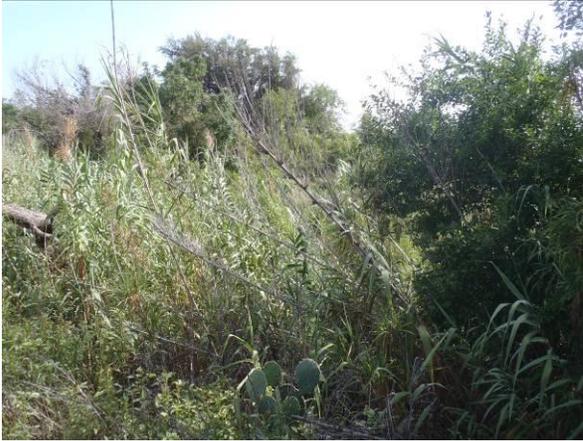
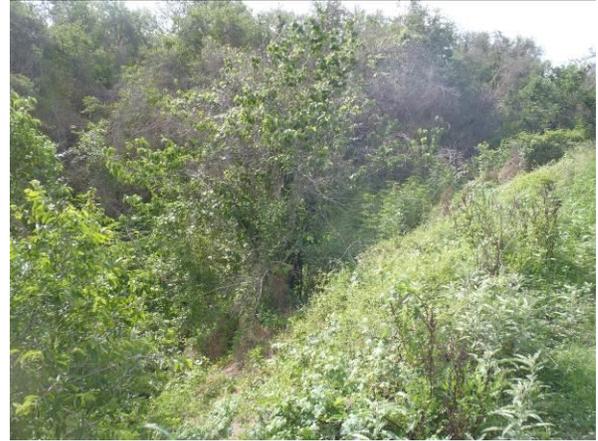
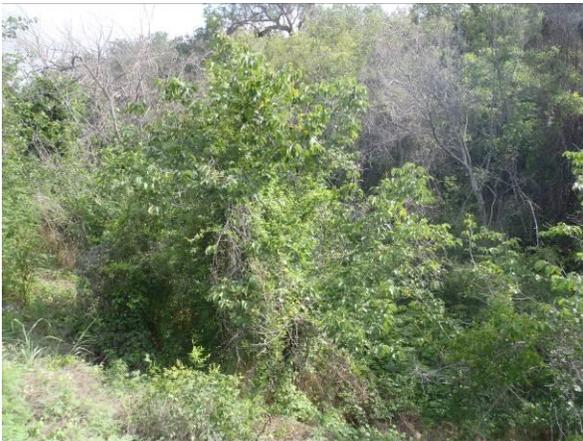
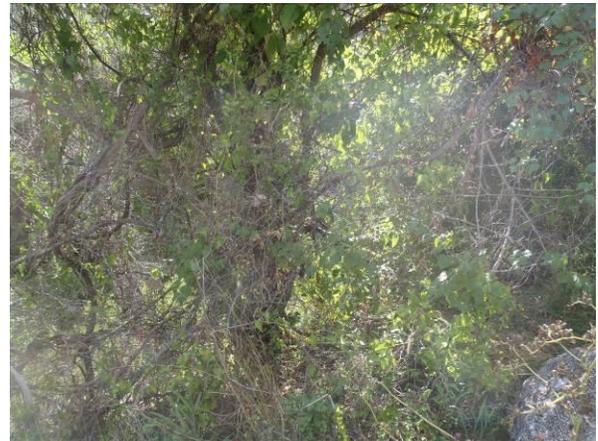
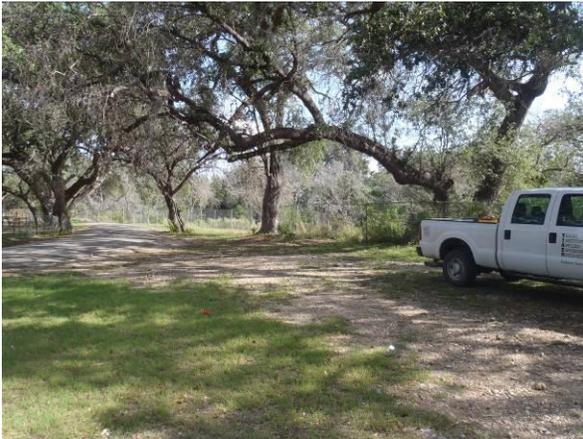
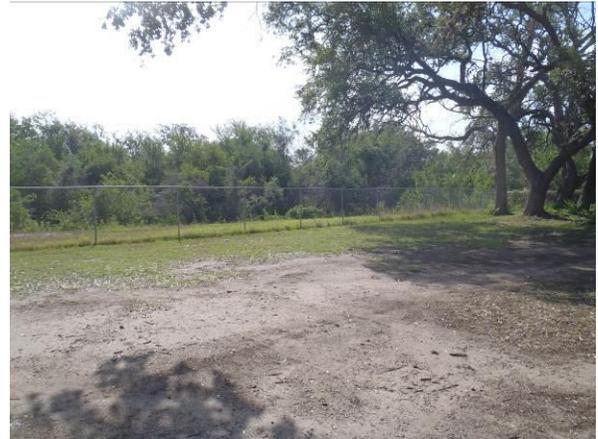
Photogroup 5-17 Leona River Site AU02_06 depicting small dam and obstructions encountered. Top Left – 135-m crude dam, July 2012; Top Right - obstruction, May 2012; Middle Left – 135-m obstruction, July 2012; Middle Right – 210-m obstruction, July 2012; Bottom – obstruction and dozer tracks, July 2012.

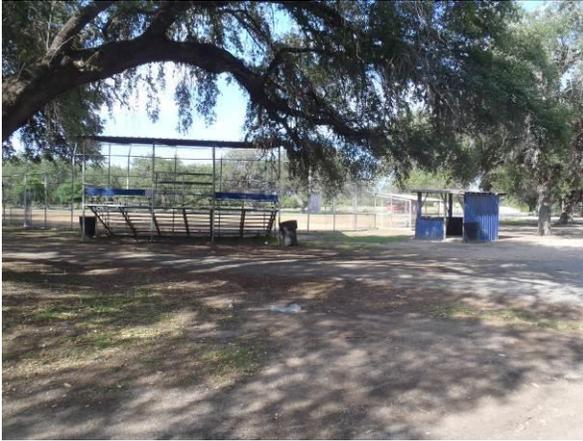
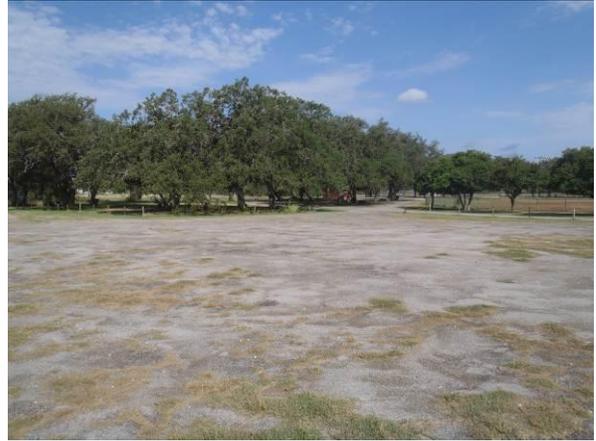
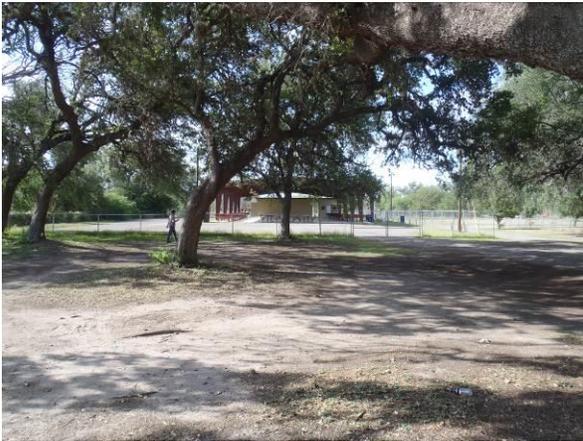
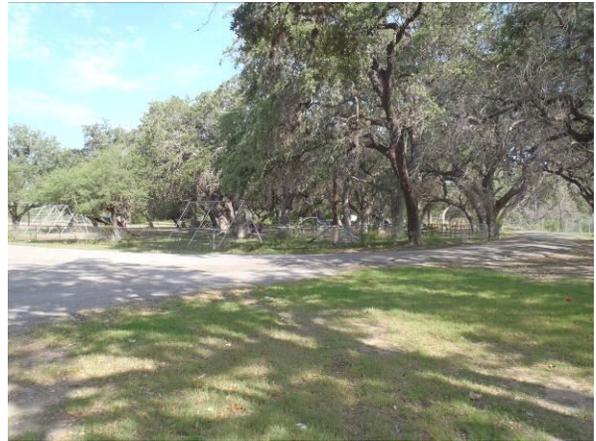
Photogroup 5-18 Leona River Site AU02_07 depicting access and the general appearance of the stream. Top Left - 0-m transect upstream view, July 2012; Top Right - 150-m transect downstream view, May 2012; Middle Left - 150-m transect upstream view, May 2012; Middle Right - 300-m transect downstream view, July 2012; Bottom Left - view of fence blocking access, July 2012; Bottom Right - second view of fence blocking access, July 2012.

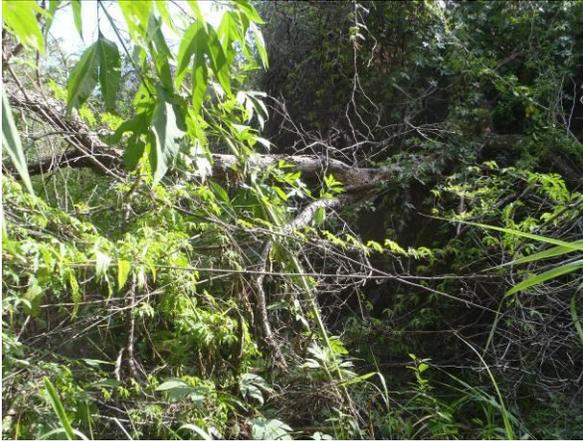
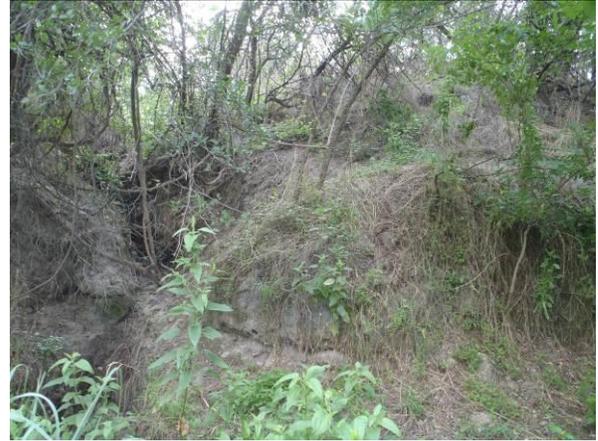
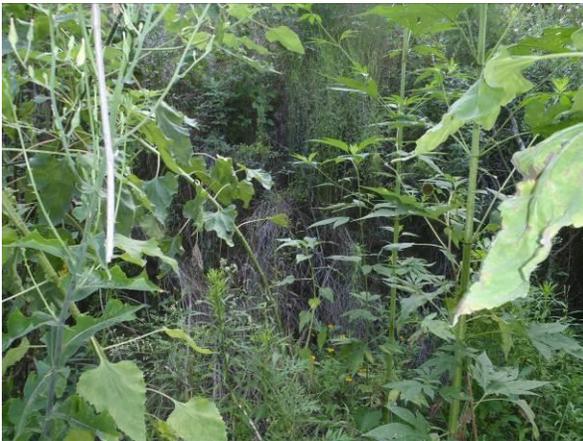
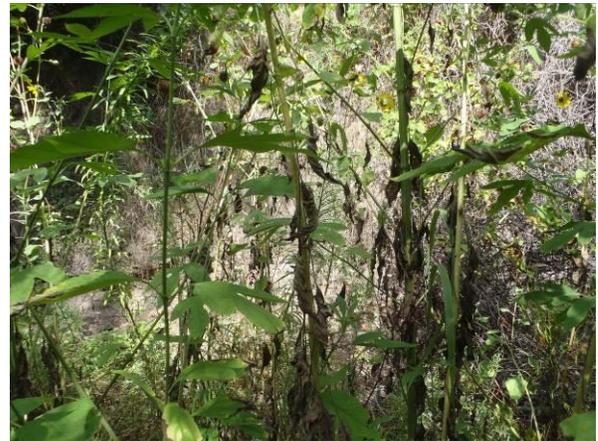
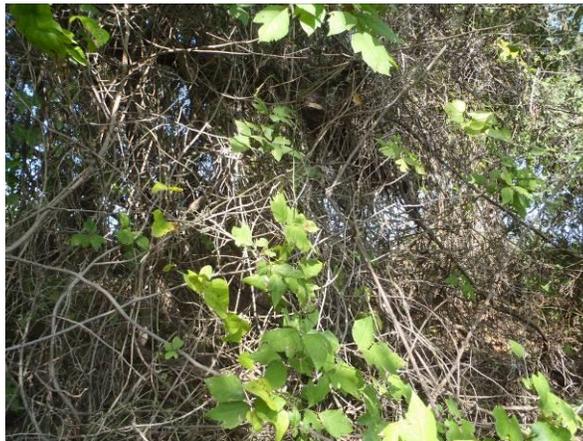
Photogroup 5-20 Leona River Site AU02_08 depicting access and the general appearance of the stream. Top Left - 0-m transect right bank view, May 2012; Top Right - 0-m transect left bank view, July 2012; Middle Left – 0-m transect downstream view, May 2012; Middle Right – 150-m transect downstream view, July 2012; Bottom Left – 150-m transect upstream view, July 2012; Bottom Right – 300-m transect downstream view, May 2012.

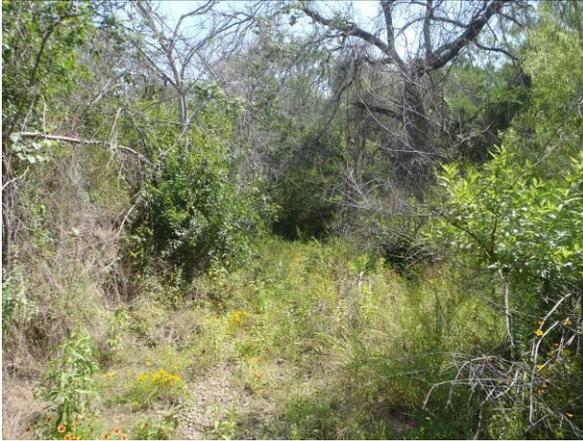
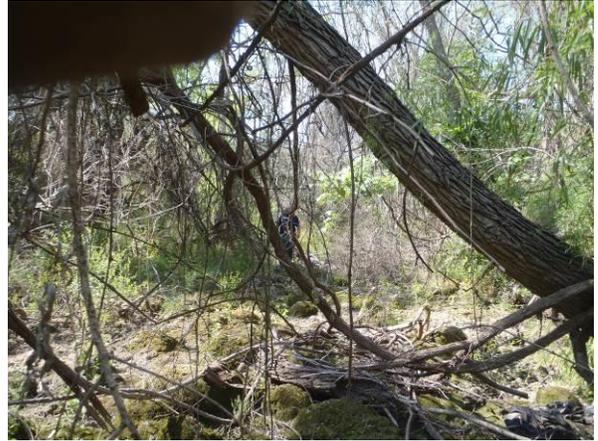
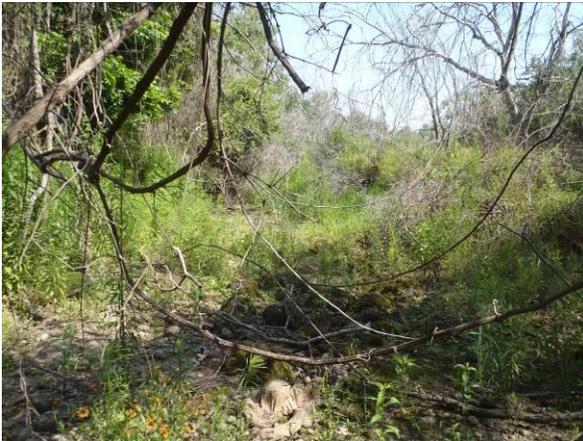
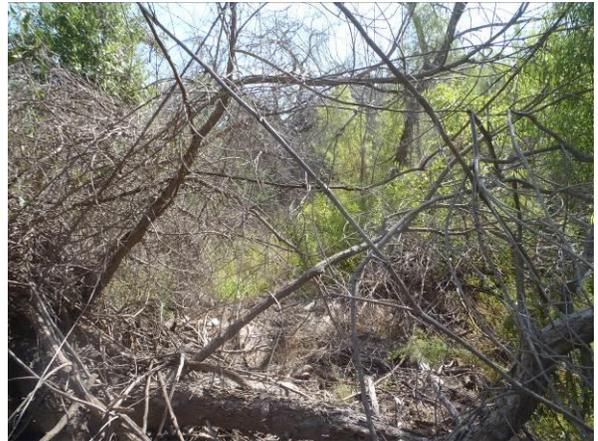
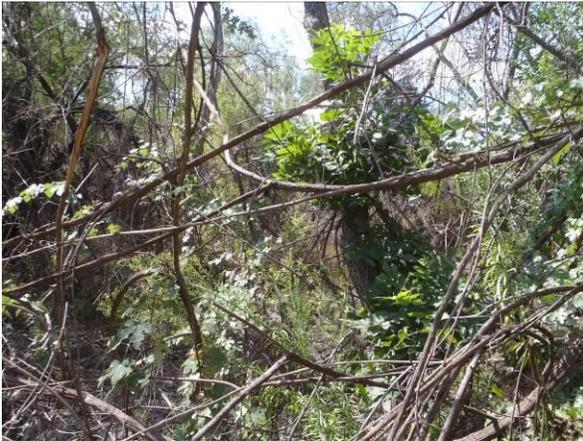
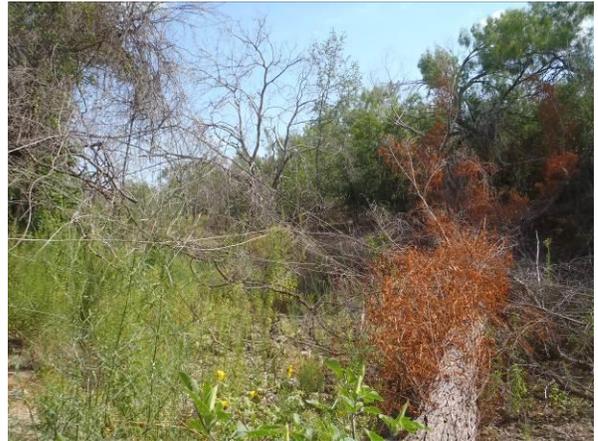
Photogroup 5-21 Leona River Site AU02_08 depicting obstruction and dense vegetation encountered. Top Left – 245-m obstruction, July 2012; Top Right - 150-m transect left bank view, May 2012; Middle Left – 300-m transect left bank view, May 2012; Middle Right – 300-m transect right bank view, July 2012; Bottom – 150-m transect right bank view, July 2012.

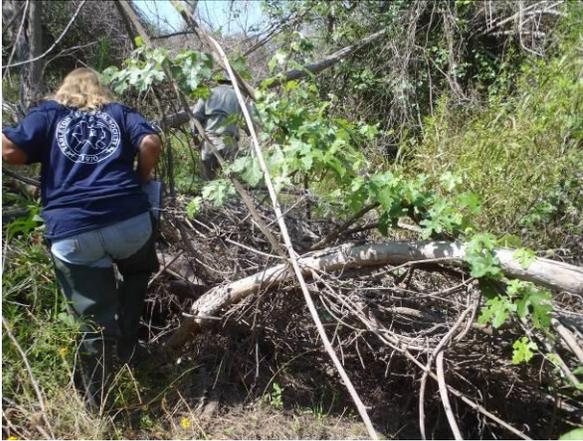
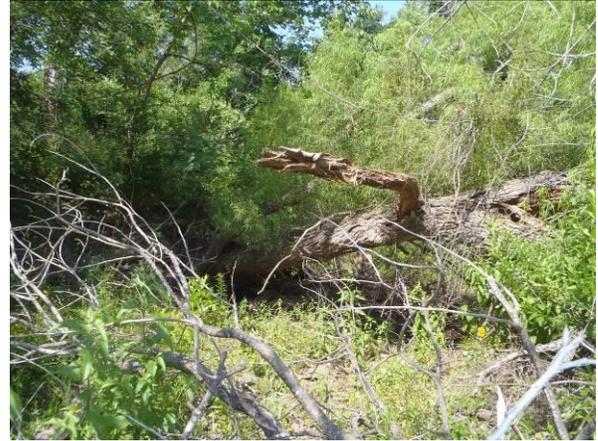
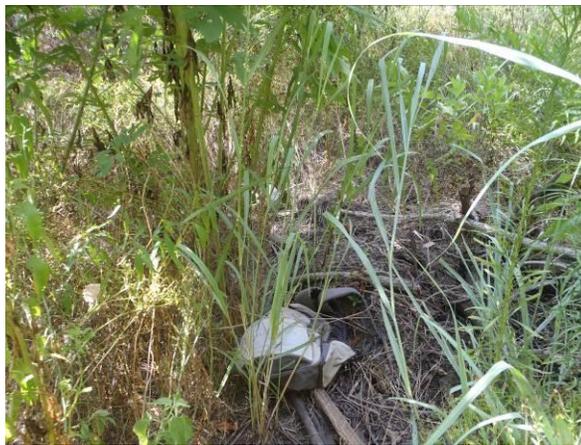
Photogroup 5-22 Leona River Site AU02_09 depicting the general appearance of the stream. Top Left - 0-m transect upstream view, May 2012; Top Right - 300-m transect downstream view, May 2012; Middle Left – 300-m transect upstream view, May 2012; Middle Right – 0-m transect upstream view, July 2012; Bottom Left – 300-m transect downstream view, July 2012; Bottom Right – 300-m transect upstream view, July 2012.

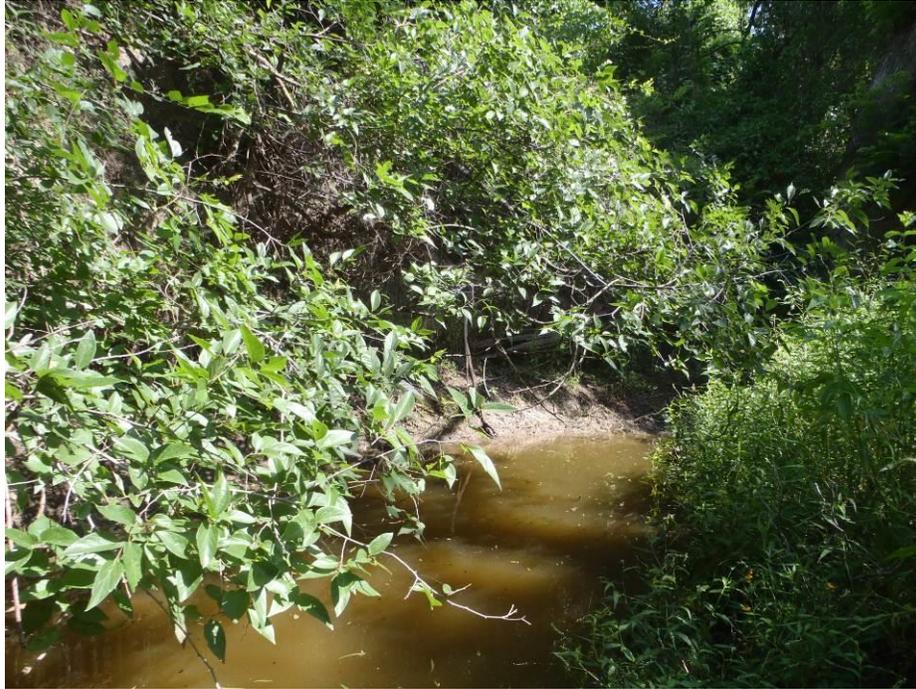
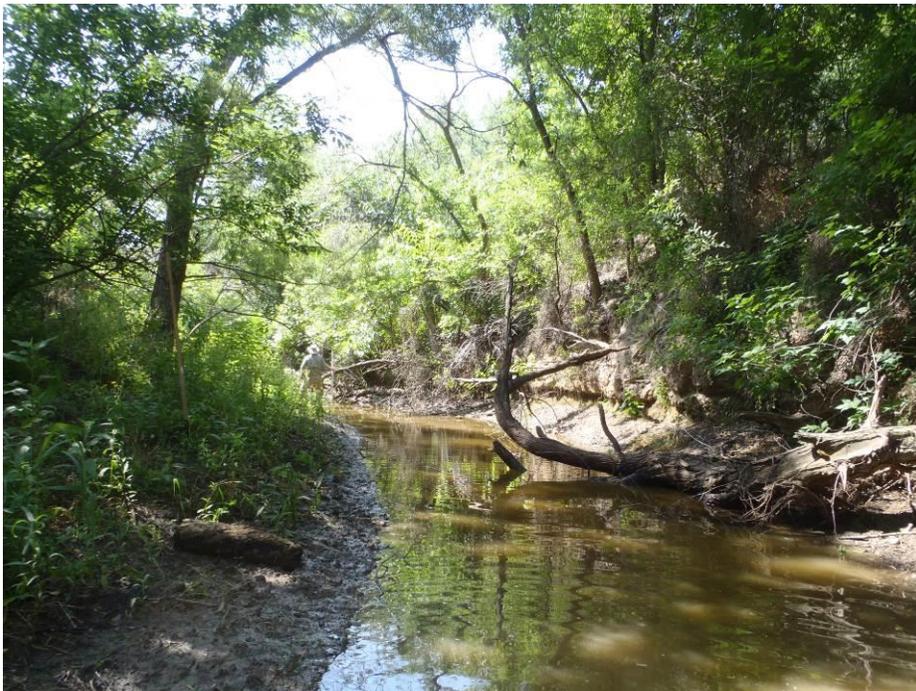
Photogroup 5-23 Leona River Site AU02_09 depicting obstructions and backpack encountered. (All individuals pictured are TIAER staff.) Top Left – obstruction 1, May 2012; Top Right – obstruction 2, May 2012; Middle – backpack, July 2012.

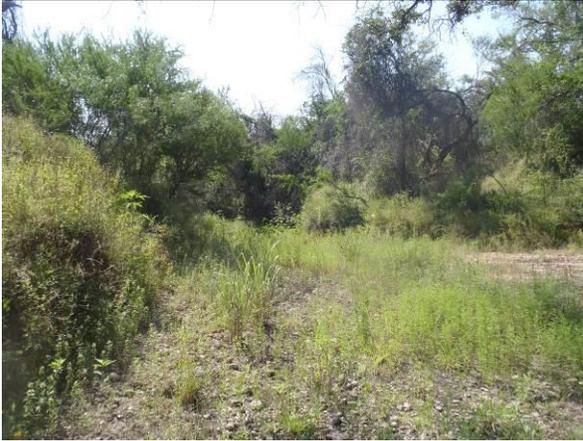
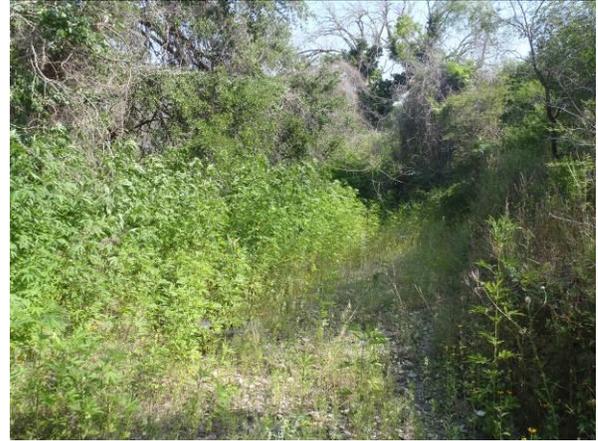
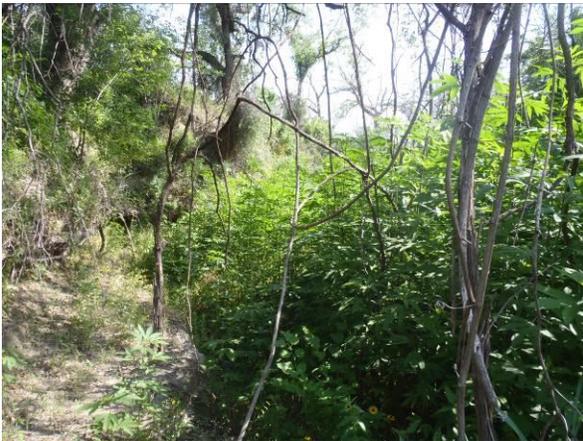
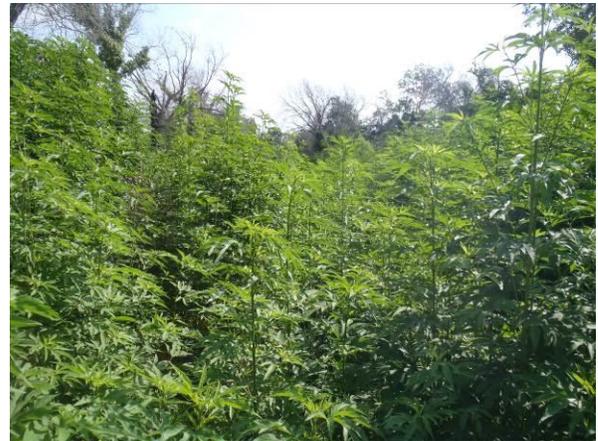
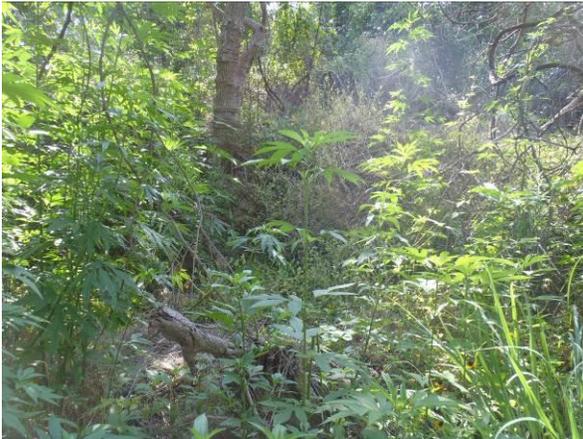
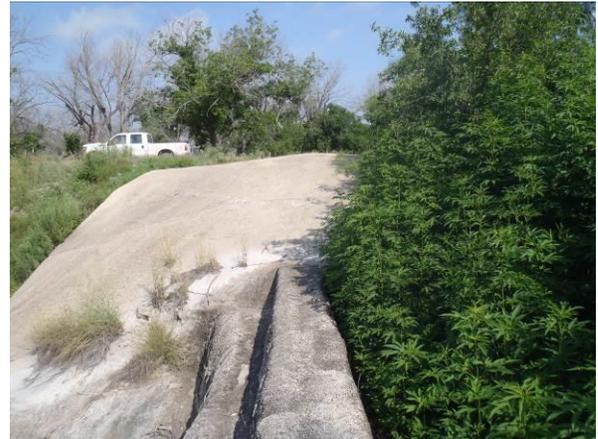
Photogroup 5-25 Leona River Site AU02_10 depicting the general appearance of the stream and dam. (All individuals pictured are TIAER staff.) Top Left - 0-m transect downstream view, May 2012; Top Right - 0-m transect upstream view, May 2012; Middle Left – 150-m transect upstream view, May 2012; Middle Right – 300-m transect upstream view, May 2012; Bottom Left – 150-m transect left bank view, May 2012; Bottom Right – 300-m right bank view, May 2012.
