**Leona River
Recreational Use Attainability Analysis**

**Texas State Soil and Water Conservation Board
Project 11-50**

**Texas Institute for Applied Environmental Research
Tarleton State University
Stephenville, Texas**

June 2013

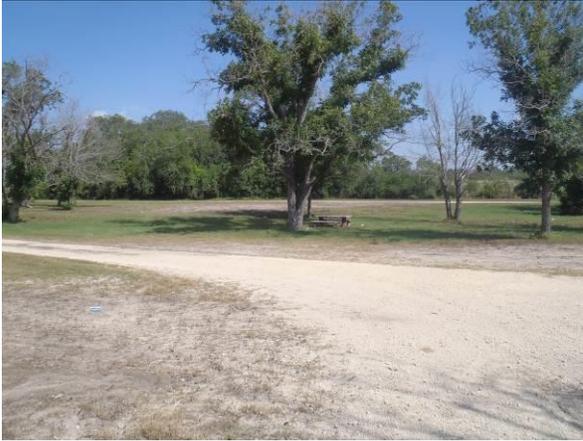
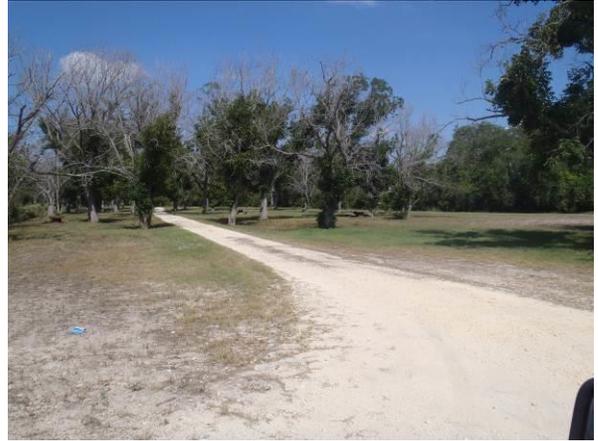
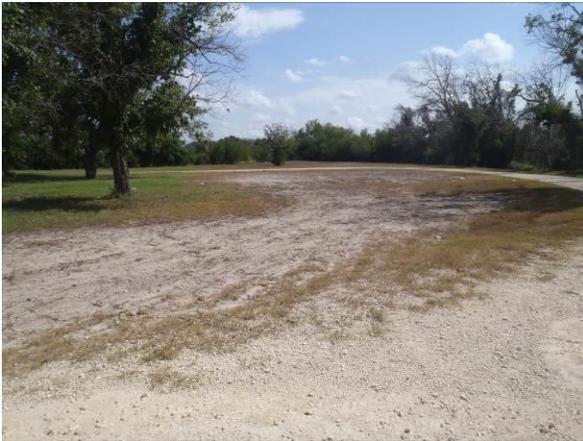
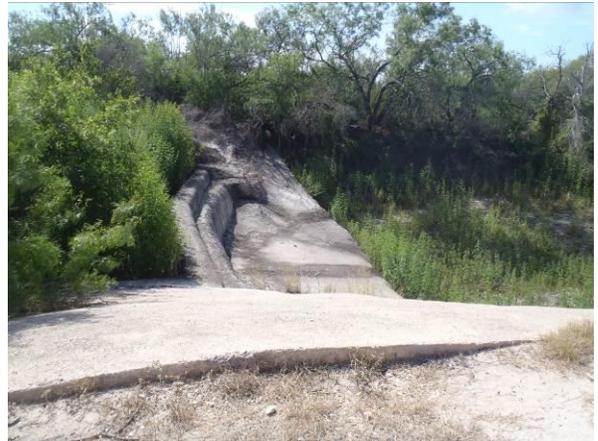
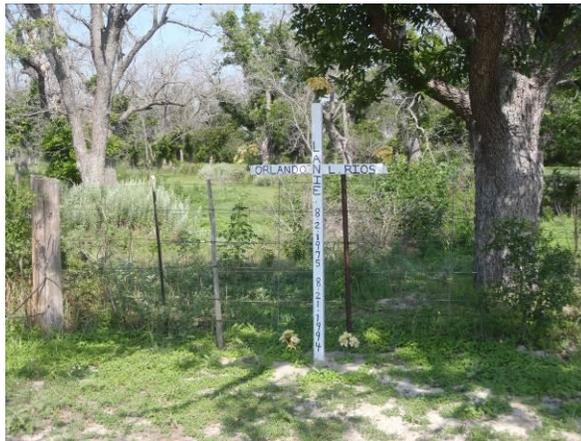
Photogroup 5-26 Leona River Site AU02_10 depicting nearby park area, dam, and memorial cross. Top Left – view 1 park area, July 2012; Top Right – view 2 park area, July 2012; Middle Left – view 3 park area, July 2012; Middle Right – view dam within channel, July 2012; Bottom – cross noting drowning, July 2012.

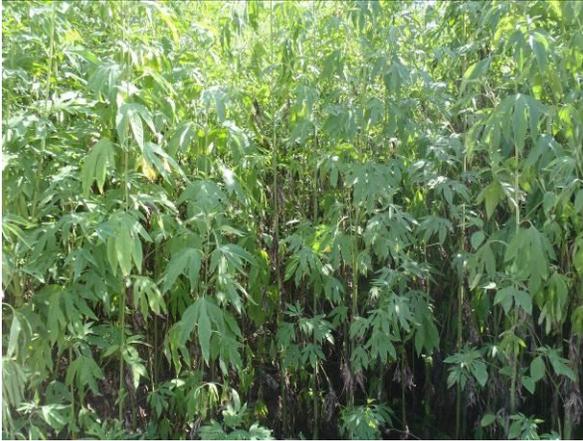
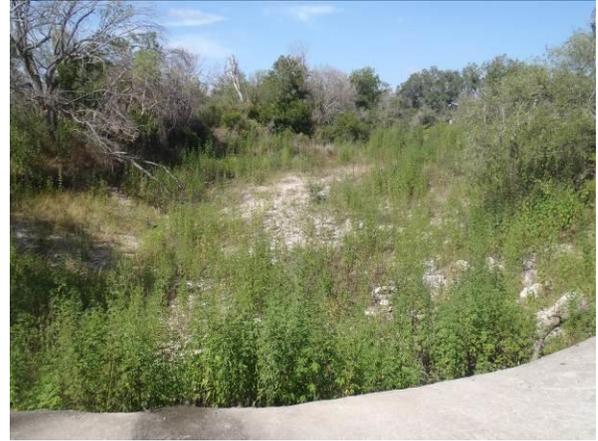
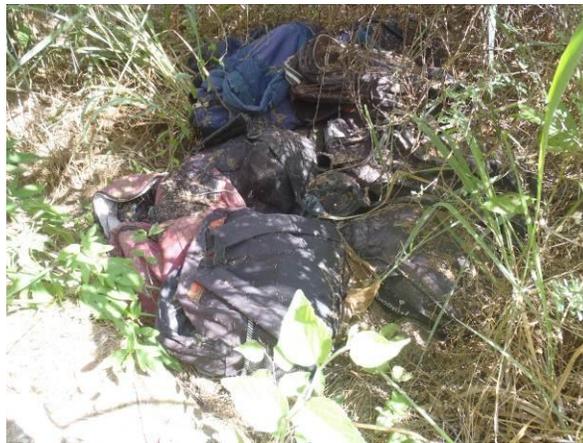
Photogroup 5-27 Leona River Site AU02_10 dry conditions and backpacks observed in July 2012. Top Left - 300-m transect upstream view, July 2012; Top Right - 300-m transect, downstream view, July 2012; Middle – backpacks stowed in stream, July 2012.

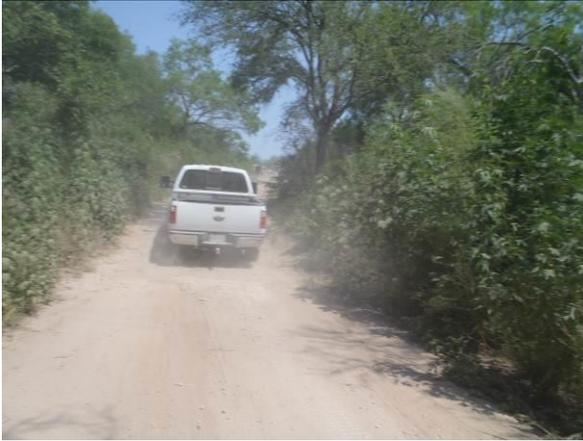
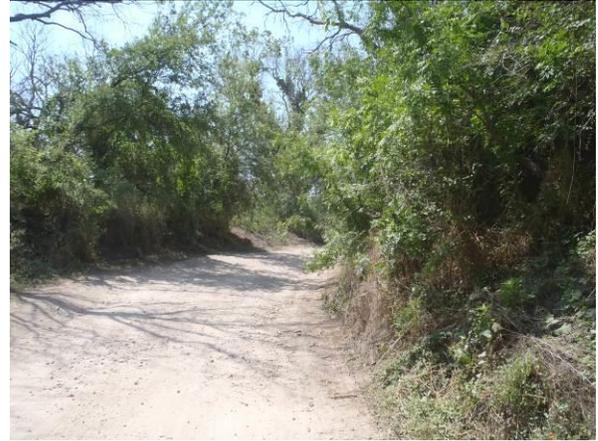
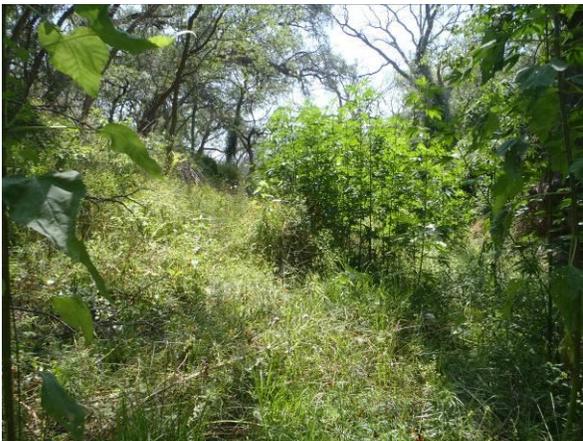
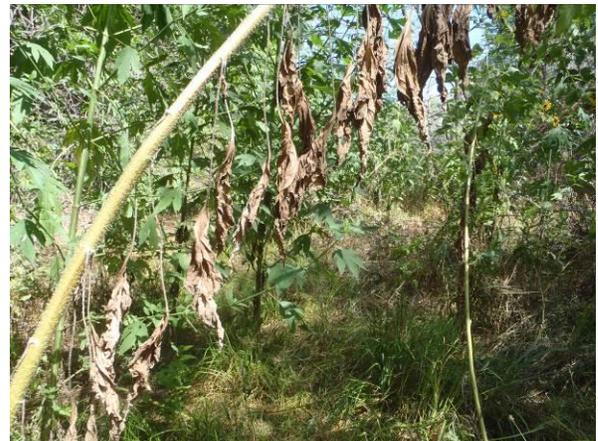
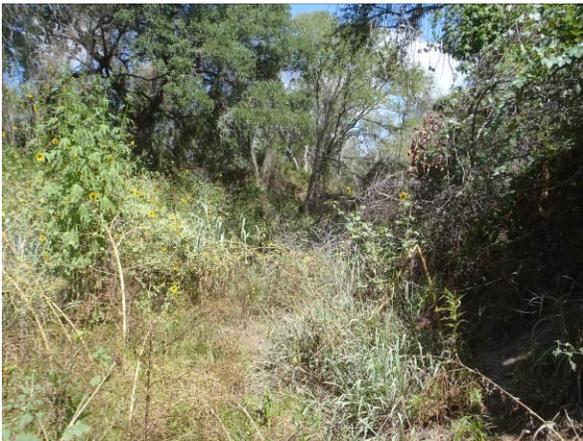
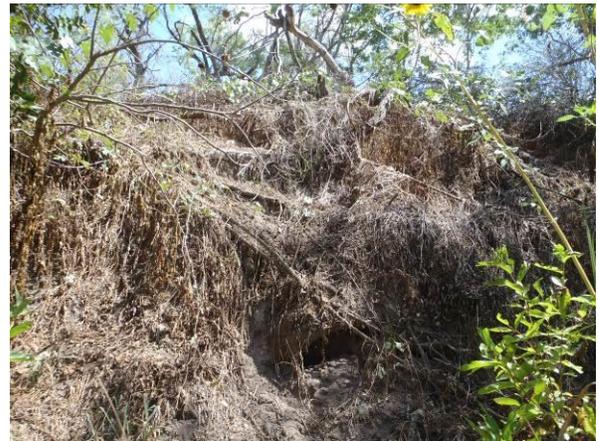
Photogroup 5-28 Leona River Site AU02_11 depicting access and the general appearance of the stream. (All individuals pictured are TIAER staff.) Top Left - 150-m transect left bank view, May 2012; Top Right - 150-m transect right bank view, May 2012; Middle Left - 0-m transect downstream view, May 2012; Middle Right - 0-m transect upstream view, July 2012; Bottom Left - 300-m transect, upstream view, July 2012; Bottom Right - 300-m transect left bank view, July 2012.

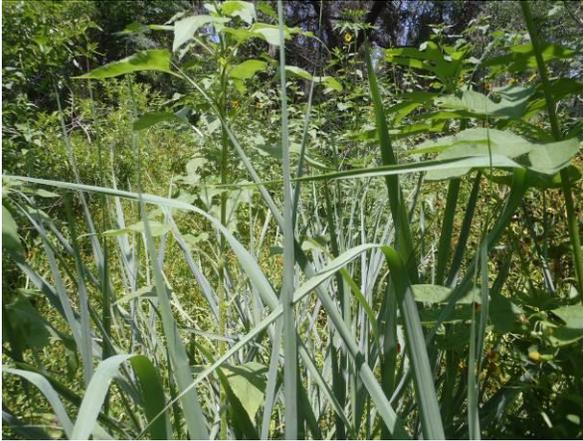
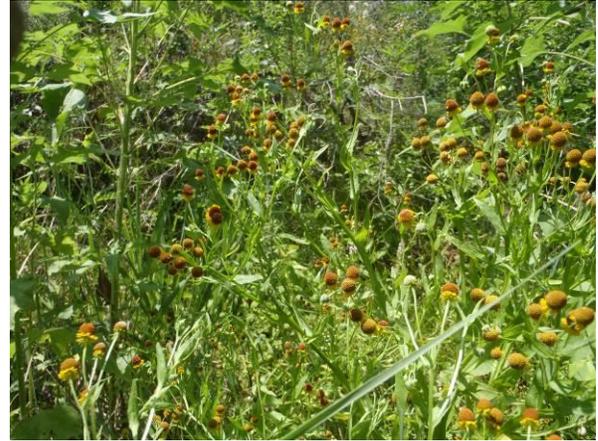
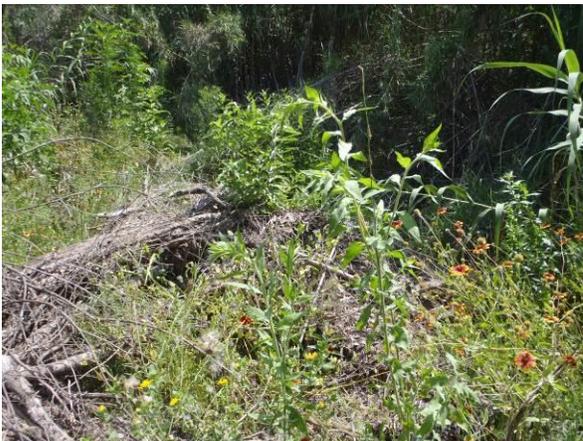
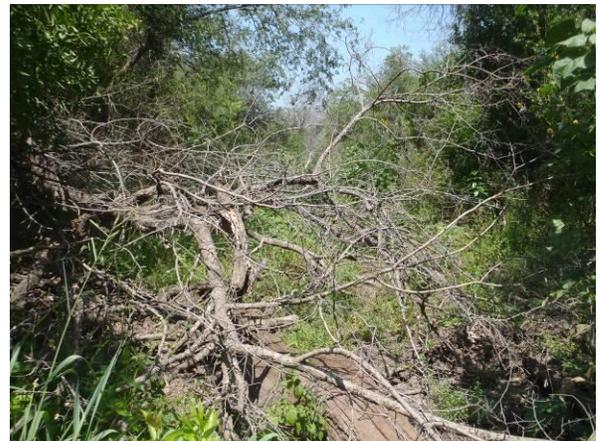
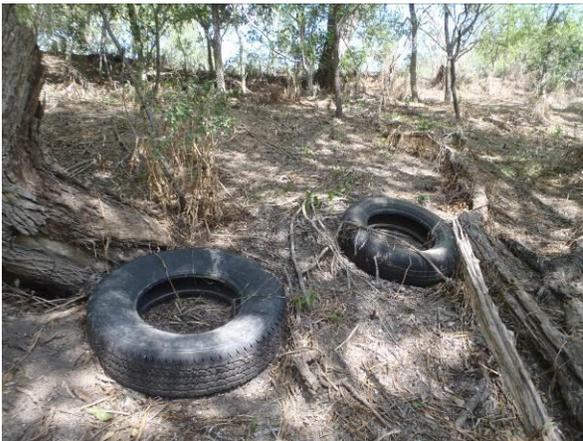
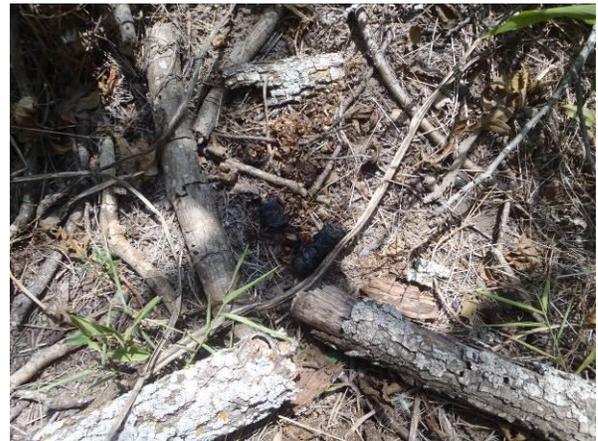
Photogroup 5-29 Leona River Site AU02_11 depicting dense vegetation, log jam obstructions, tires, hog feces. Top Left - 300-m transect upstream view, May 2012; Top Right - 300-m transect right bank view, May 2012; Middle Left – obstruction 1, May 2012; Middle Right – obstruction 2, May 2012; Bottom Left – tires, July 2012; Bottom Right – feral hog feces, July 2012.

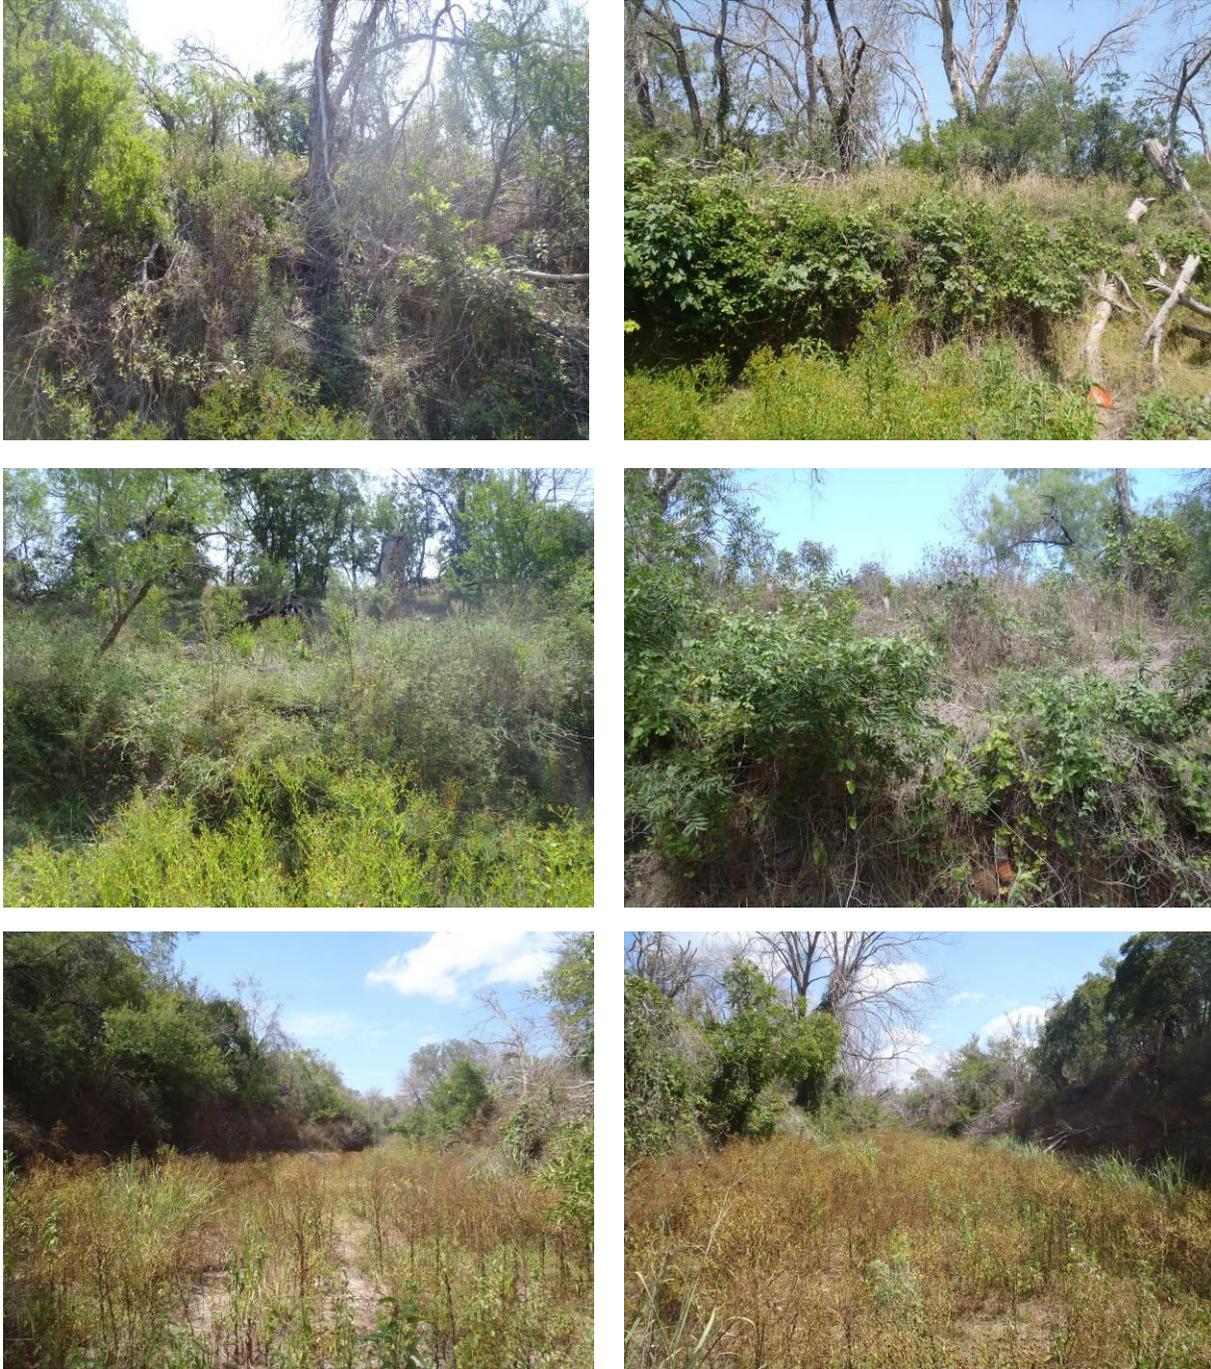
Photogroup 6-1 Leona River Site AU03_01 depicting the general appearance of the stream. Top Left - 0-m transect left bank view, May 2012; Top Right - 0-m transect right bank view, May 2012; Middle Left – 150-m transect left bank view, May 2012; Middle Right – 300-m transect right bank view, July 2012; Bottom Left – 0-m transect downstream view, July 2012; Bottom Right – 0-m transect upstream view, July 2012.

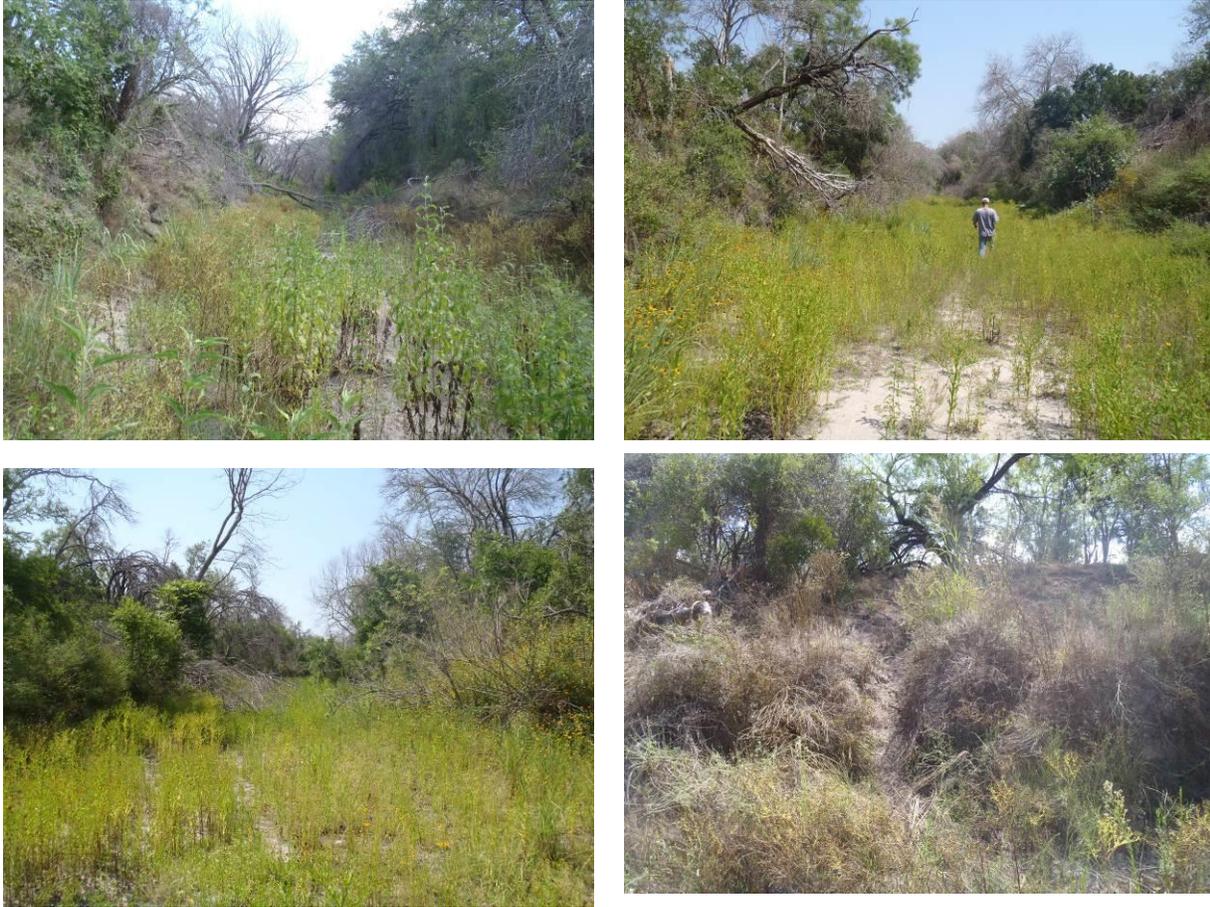
Photogroup 6-2 Leona River Site AU03_01 depicting vegetation in streambed, fallen tree, and wildlife trail. (All individuals pictured are TIAER staff.) Top Left - 300-m transect upstream view, July 2012; Top Right - 150-m transect upstream view, May 2012; Bottom Left – 150-m transect downstream view, May 2012; Bottom Right – wildlife trail, July 2012.

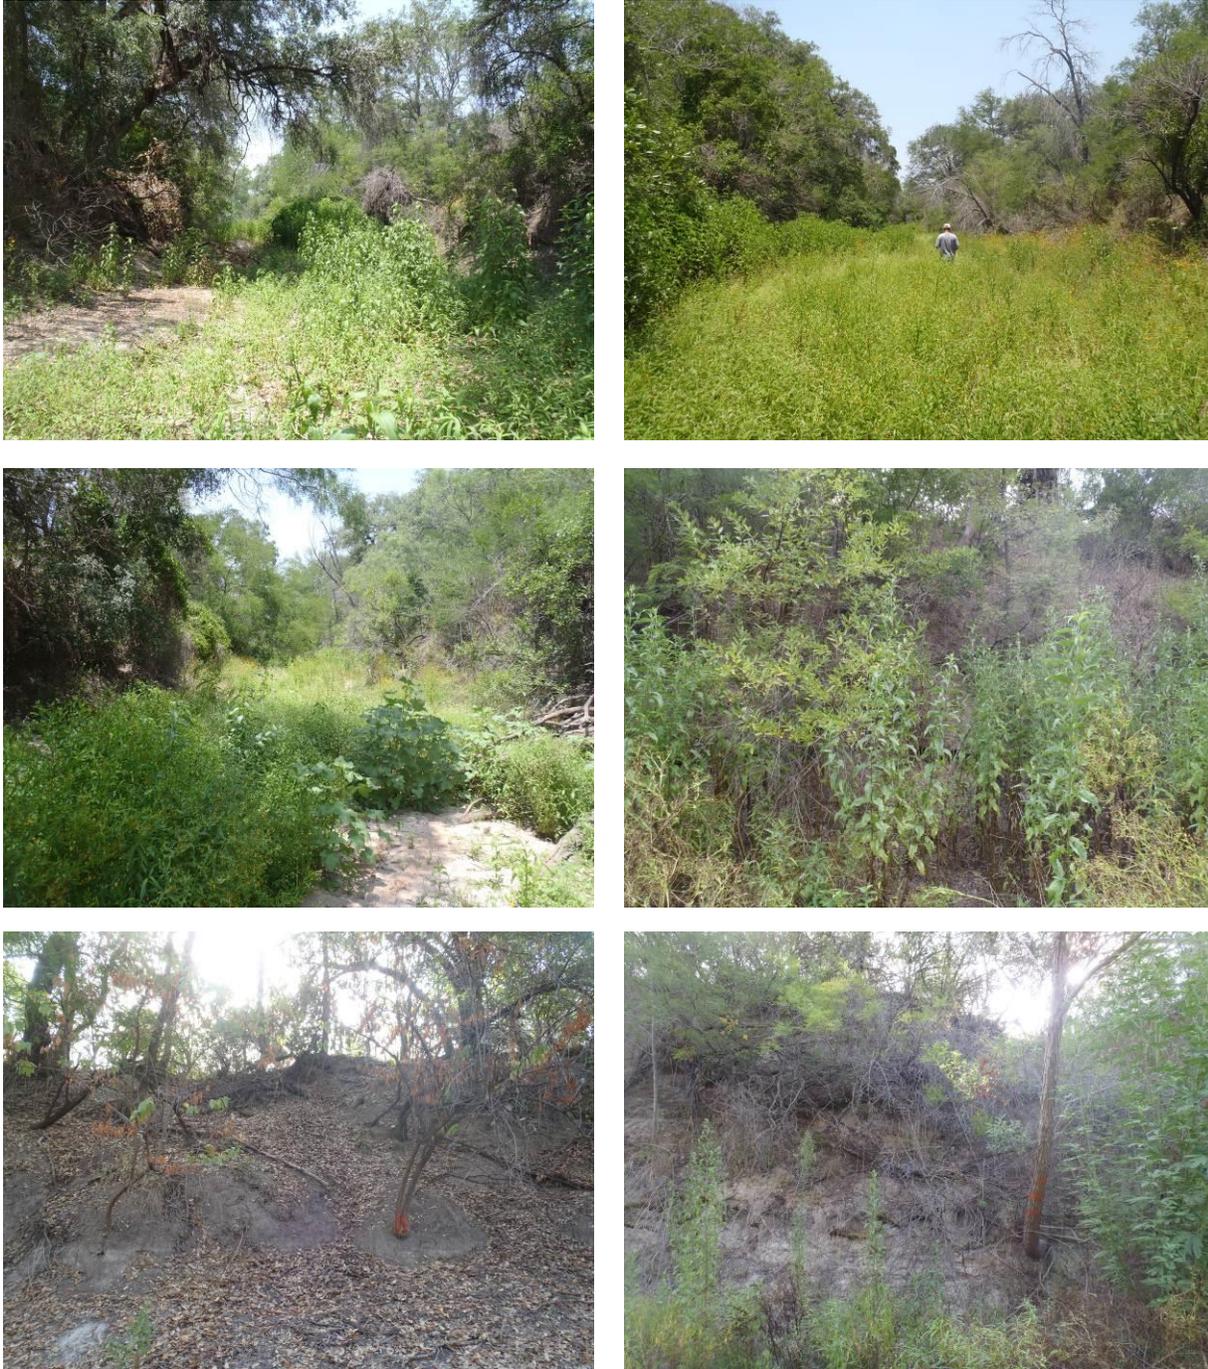
Photogroup 6-3 Leona River Site AU03_02 depicting access and the general appearance of the stream. (All individuals pictured are TIAER staff.) Top Left - 0-m transect upstream view, May 2012; Top Right - 150-m transect upstream view, May 2012; Middle Left – 300-m transect upstream view, May 2012; Middle Right – 150-m transect left bank view, July 2012; Bottom Left – 0-m transect left bank view, July 2012; Bottom Right – 300-m transect left bank view, July 2012.

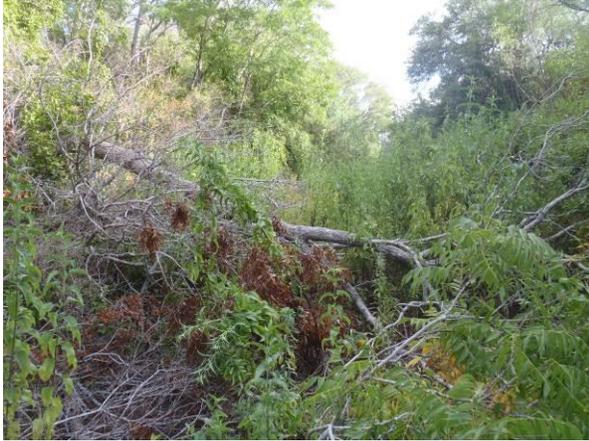
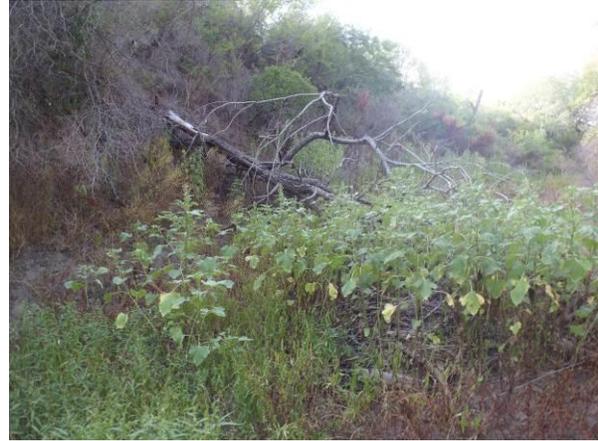
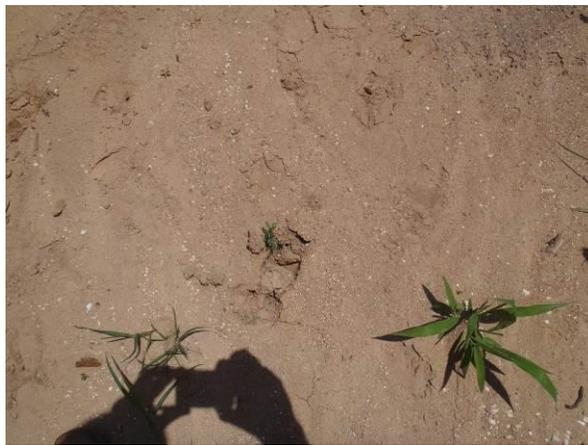
Photogroup 6-4 Leona River Site AU03_02 illustrating obstructions and signs of wildlife. (All individuals pictured are TIAER staff.) Top Left - 65-m obstruction, July 2012; Top Right - 270-m obstruction, July 2012; Bottom – hog tracks, May 2012.

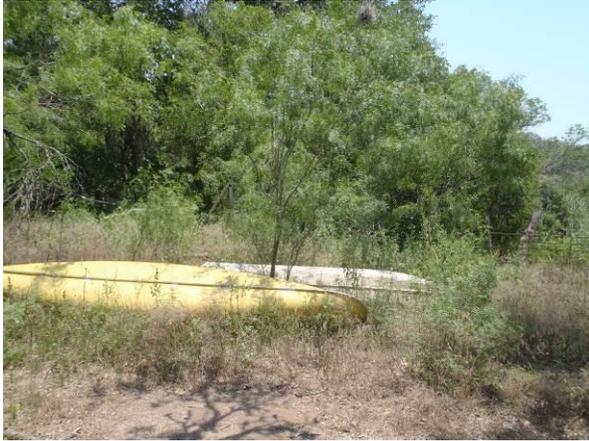
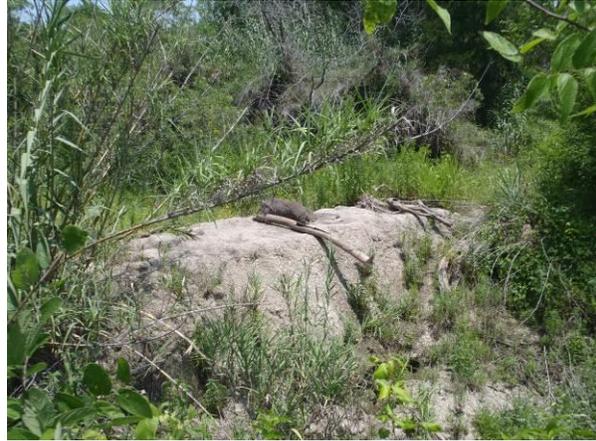
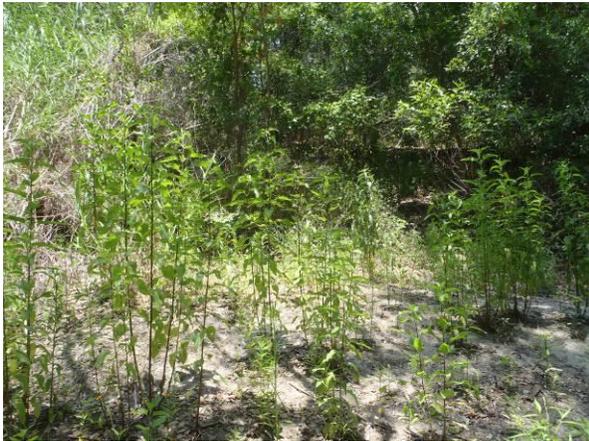
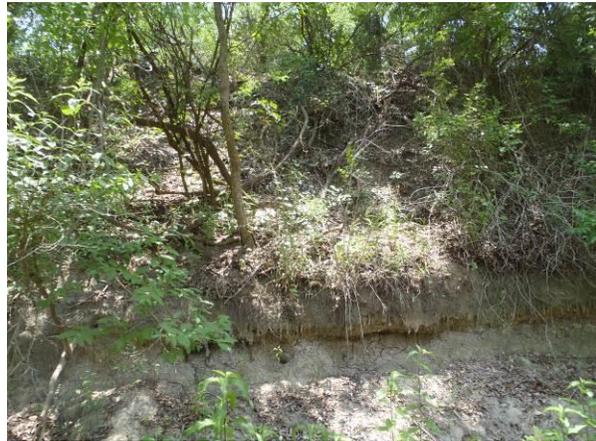
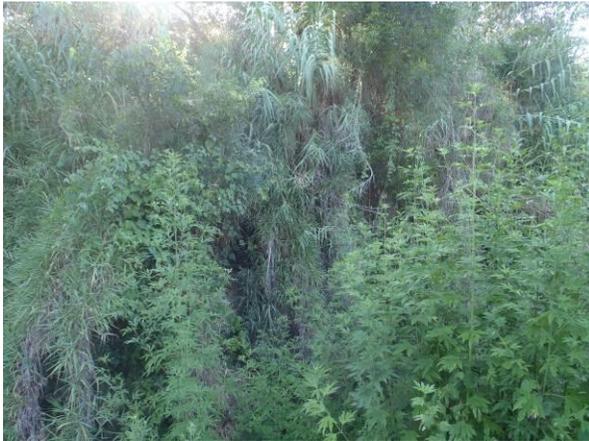
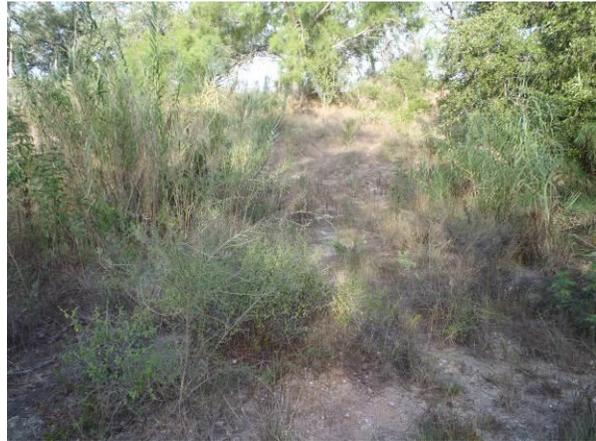
Photogroup 6-5 Leona River Site AU03_03 depicting boats, dam, and stream banks. Top Left – canoes on stream bank view, May 2012; Top Right - 300-m transect upstream view, May 2012; Middle Left – 150-m transect left bank view, May 2012; Middle Right – 150-m transect right bank view, May 2012; Bottom Left – 300-m transect left bank view, July 2012; Bottom Right – 300-m transect right bank view, July 2012.

Evidence of potential contact recreation was observed at some sites in the segment. A canoe and flat bottom boat were observed lying next to a fence at Site AU03_03. According to the landowner, the boats were used in the past to boat in the river. Fishing bobbers, lures and a broken fishing pole were observed at Site AU03_07, at Fort Inge.

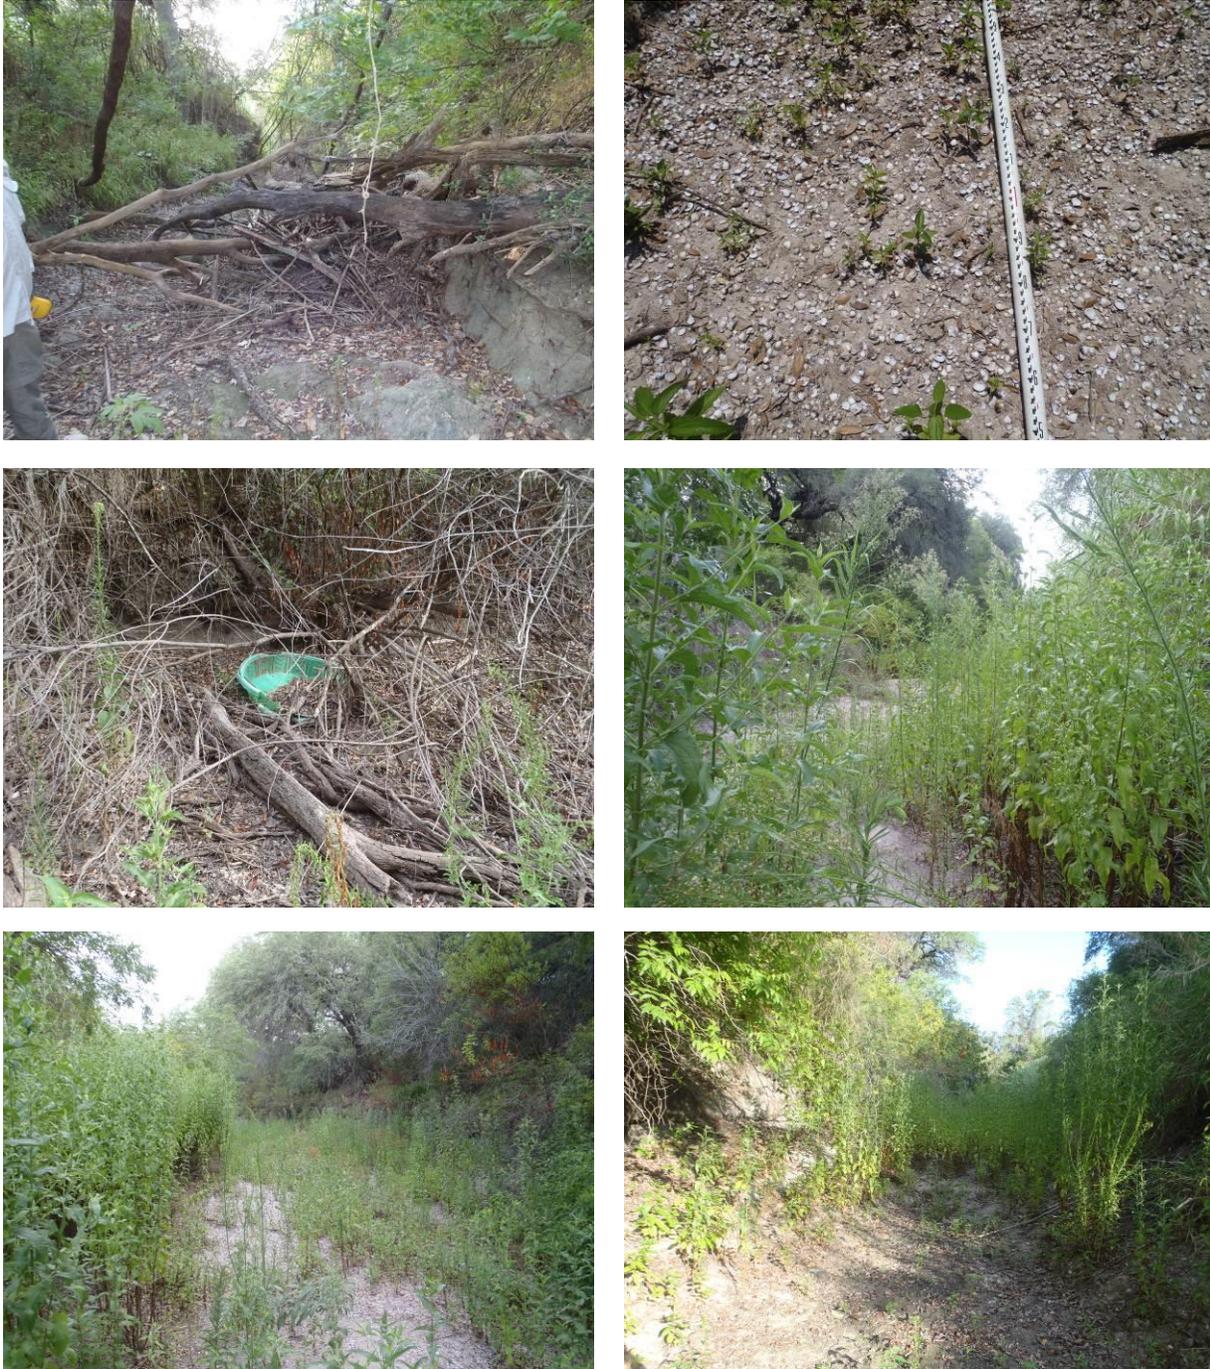
Photogroup 6-6 Leona River Site AU03_03 depicting logjam, mussel shells, kiddie pool, and stream channel conditions. (All individuals pictured are TIAER staff.) Top Left - 260-m logjam across channel, July 2012; Top Right – mussel shells on streambed bottom, May 2012; Middle Left – 100-m transect kiddie pool within debris, July 2012; Middle Right – 0-m transect downstream view, July 2012; Bottom Left – 0-m transect upstream view, July 2012; Bottom Right – 150-m transect upstream view, July 2012.

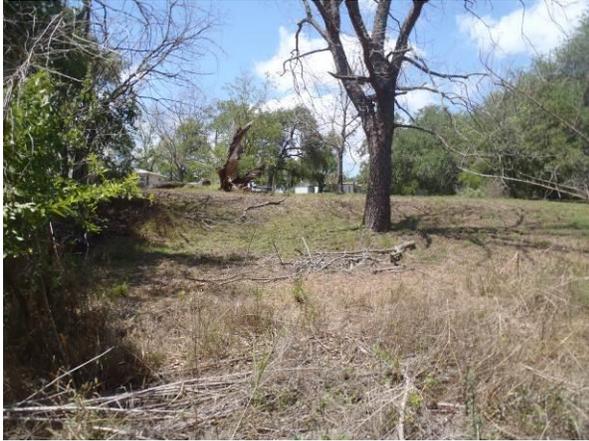
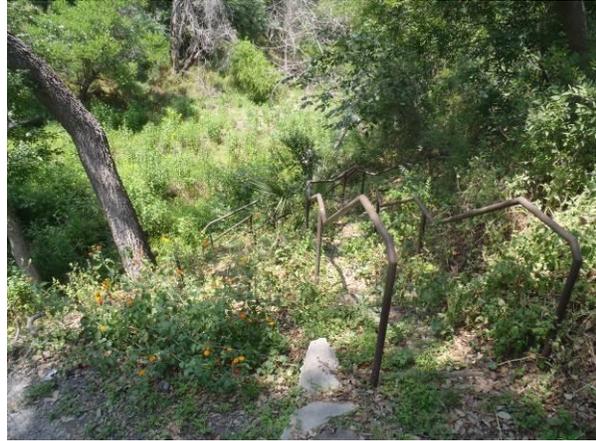
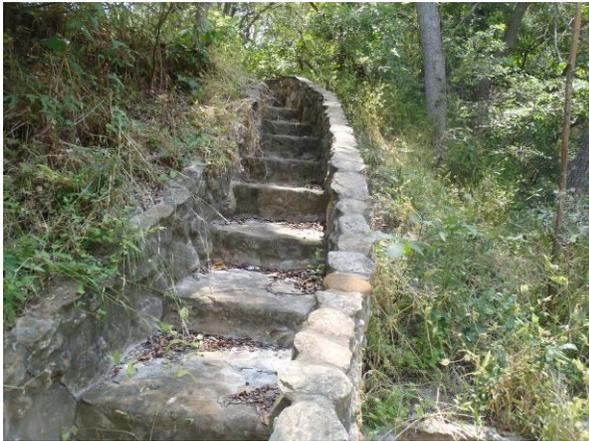
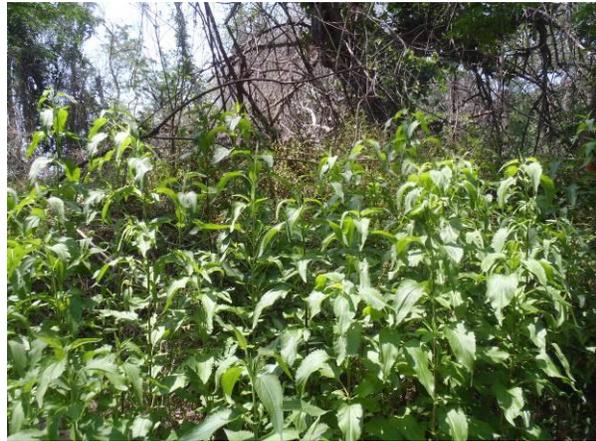
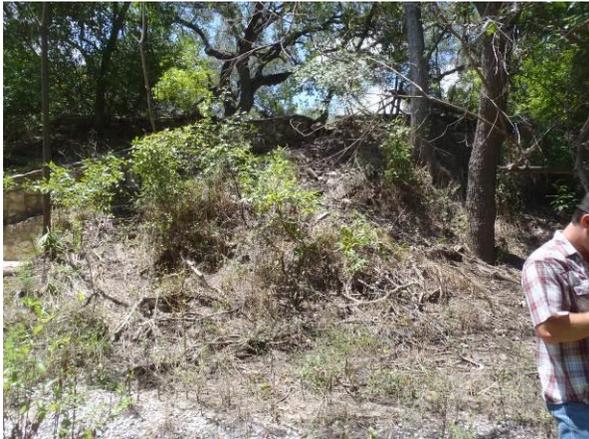
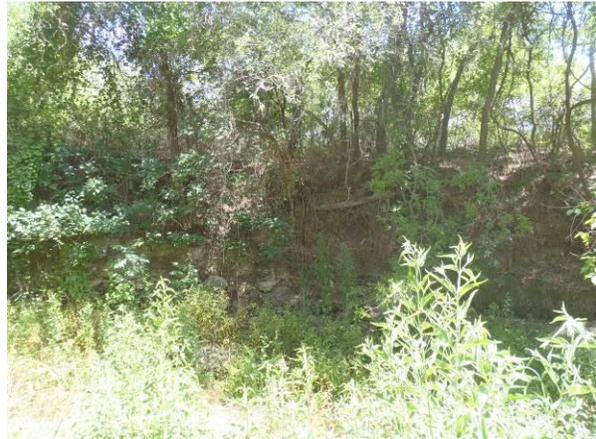
Photogroup 6-7 Leona River Site AU03_05 depicting points of entry and the general appearance of the stream. (All individuals pictured are TIAER staff.) Top Left - 150-m transect right bank view, July 2012; Top Right – pipe walkway, May 2012; Middle Left – rock walkway, May 2012; Middle Right – 0-m transect left bank view, May 2012; Bottom Left – 300-m transect right bank view, July 2012; Bottom Right – 300-m transect left bank view, July 2012.

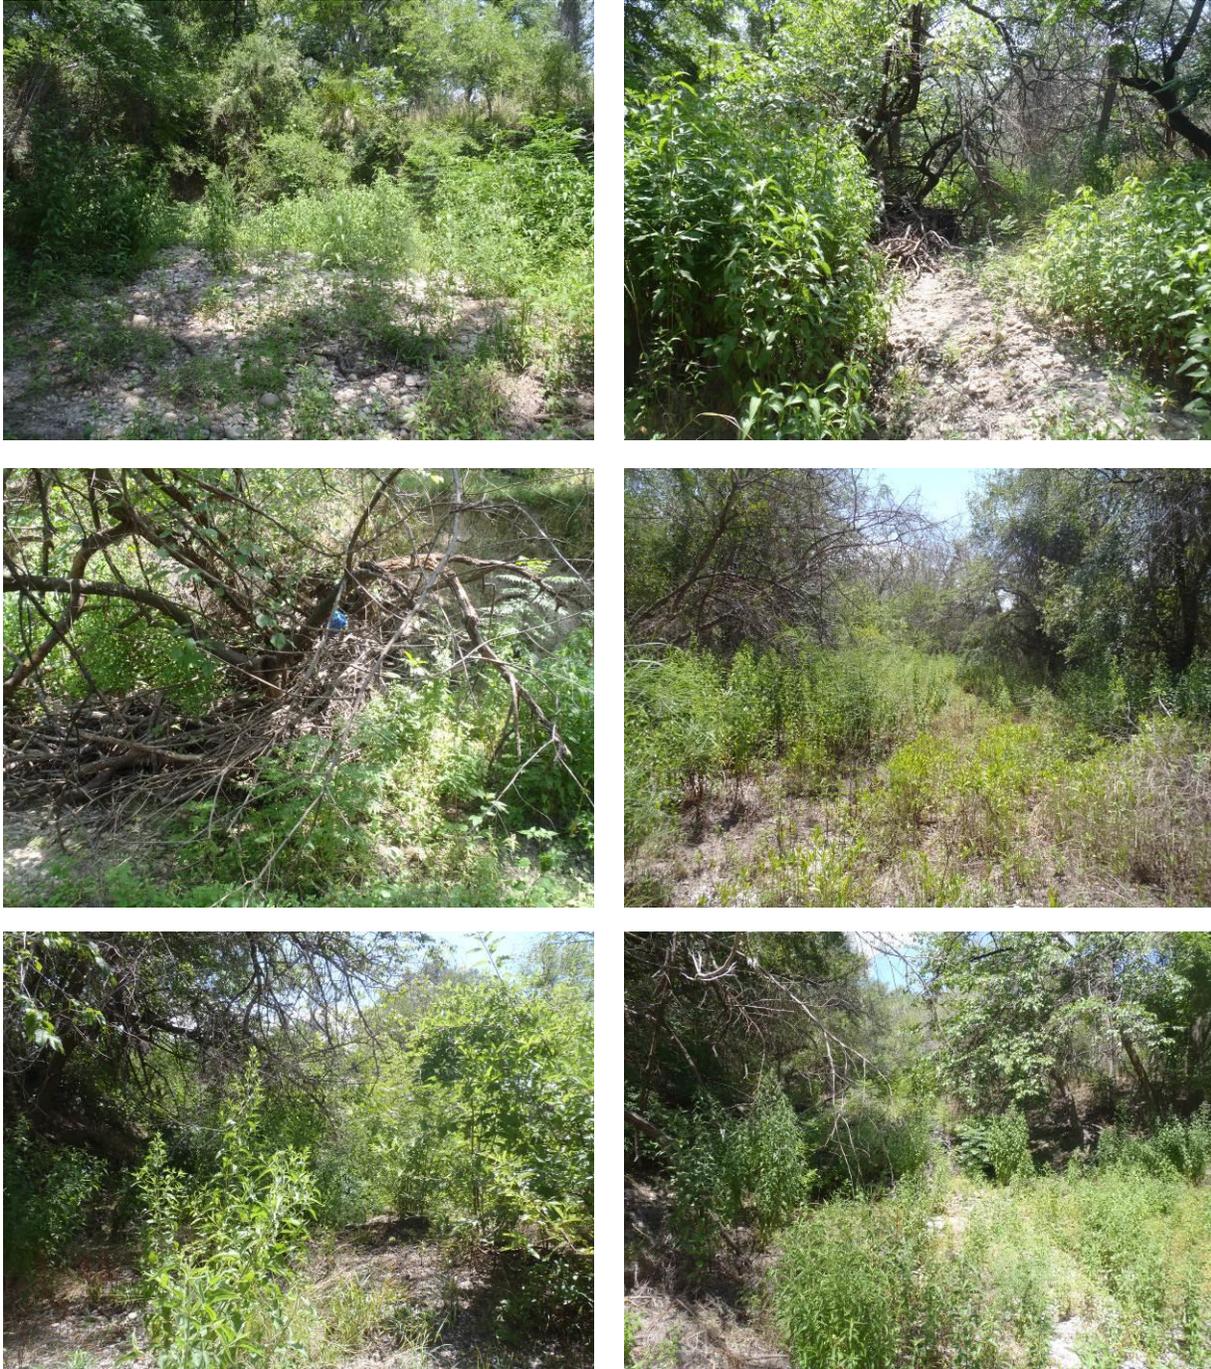
Photogroup 6-8 Leona River Site AU03_05 depicting cobble bottom, streambed vegetation, obstruction, and general stream appearance. Top Left - 0-m transect downstream view, May 2012; Top Right - 0-m transect upstream view, May 2012; Middle Left – obstruction, May 2012; Middle Right – 150-m transect downstream view, May 2012; Bottom Left – 300-m transect downstream view, May 2012; Bottom Right – 300-m transect upstream view, May 2012.

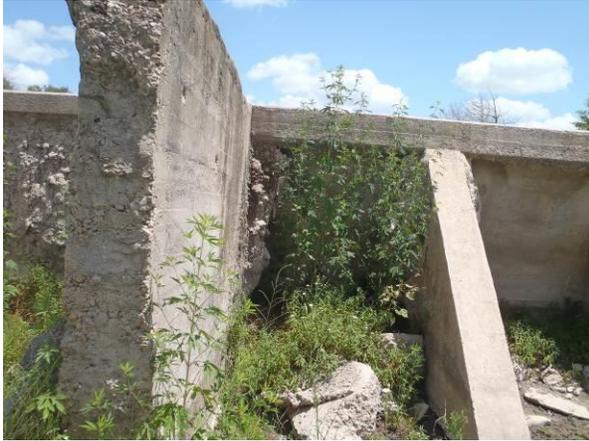
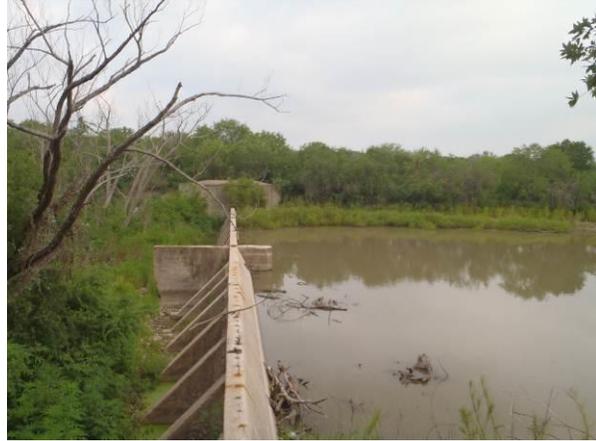
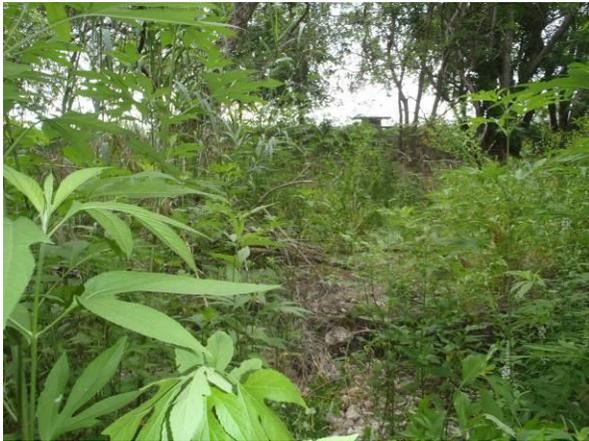
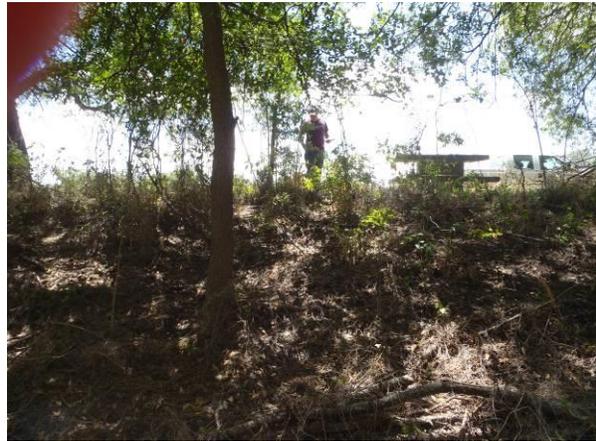
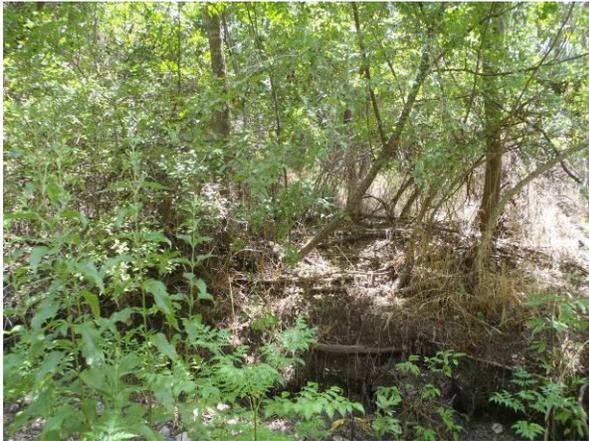
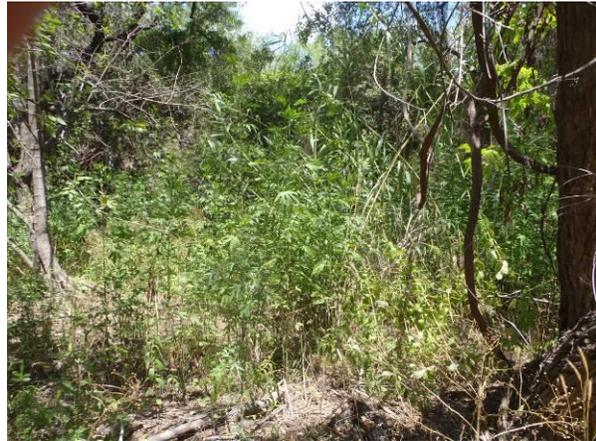
Photogroup 6-9 Leona River Site AU03_06 depicting Hoag’s Dam, the stream banks with picnic tables, and channel banks. (All individuals pictured are TIAER staff.) Top Left - 300-m transect upstream view, July 2012; Top Right - 300-m transect view of Hoag’s Dam, May 2012; Middle Left – 150-m transect left bank view, July 2012; Middle Right – 150-m transect left bank view, July 2012; Bottom Left – 0-m transect left bank view, July 2012; Bottom Right – 150-m transect right bank view, July 2012.

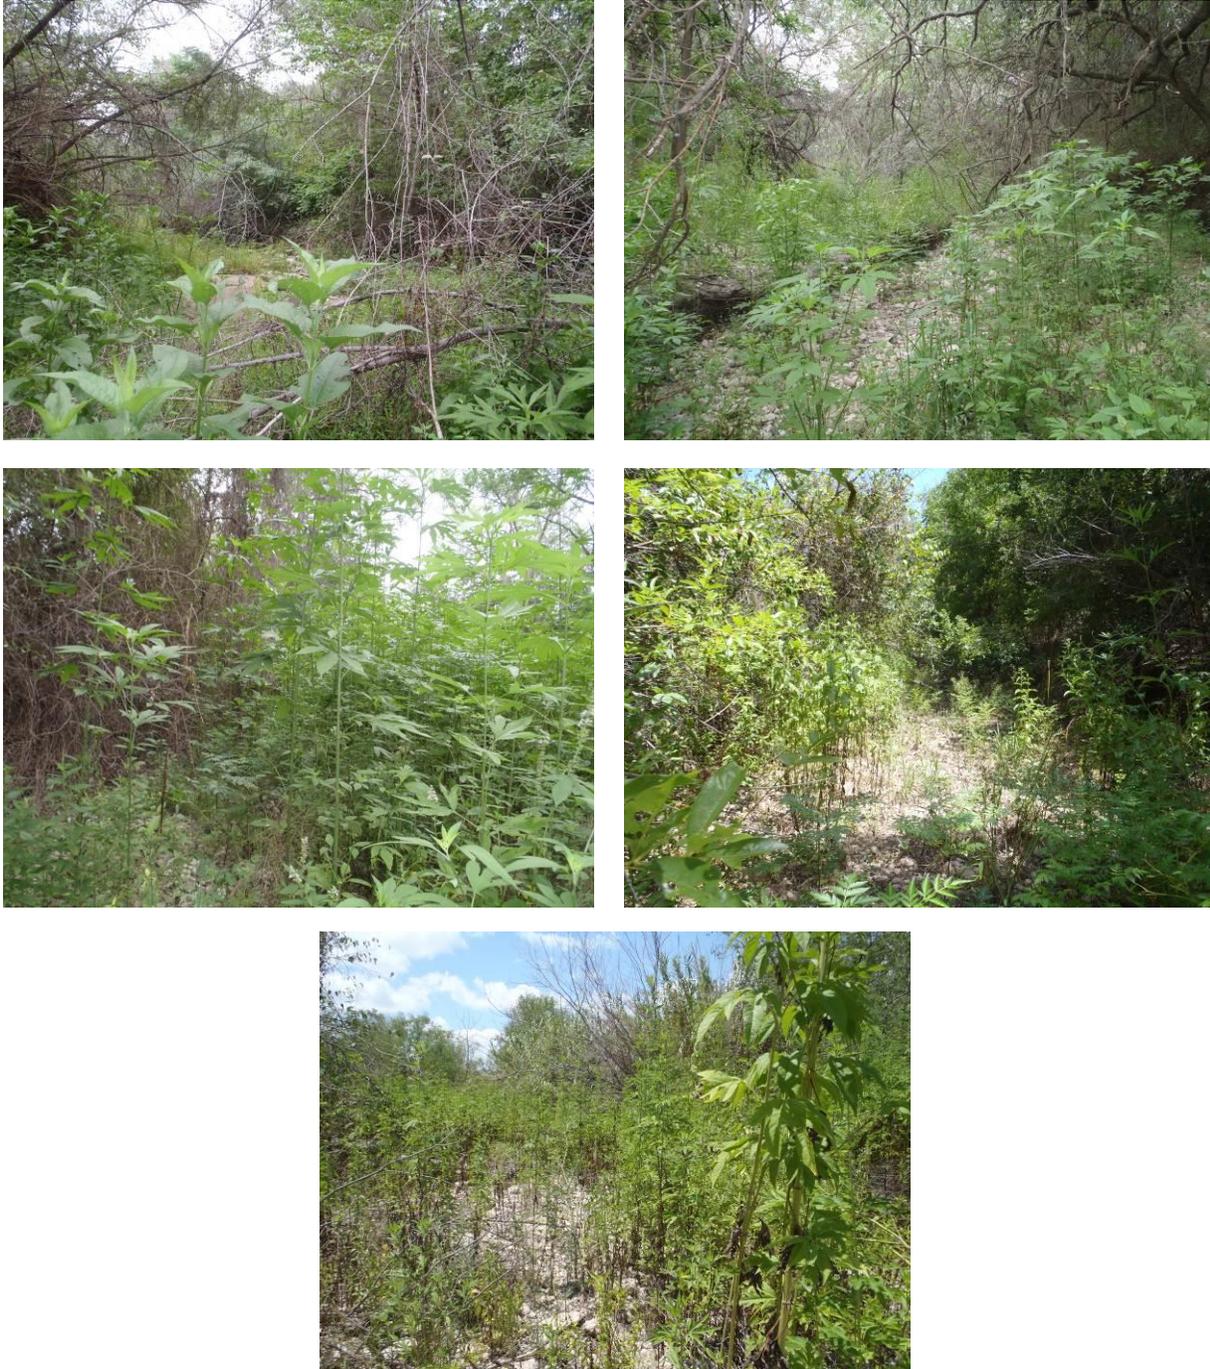
Photogroup 6-10 Leona River Site AU03_06 depicting the general appearance of the stream. Top Left - 0-m transect downstream view, May 2012; Top Right - 150-m transect downstream view, May 2012; Middle Left – 150-m transect upstream view, May 2012; Middle Right – 0-m transect upstream view, July 2012; Bottom – 300-m transect, upstream view, July 2012.
