**Leona River
Recreational Use Attainability Analysis**

**Texas State Soil and Water Conservation Board
Project 11-50**

**Texas Institute for Applied Environmental Research
Tarleton State University
Stephenville, Texas**

June 2013

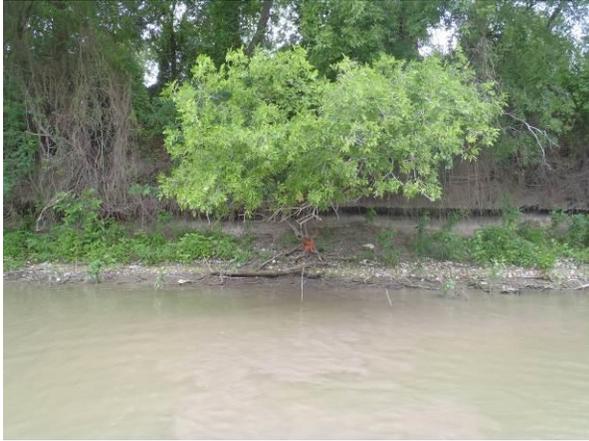
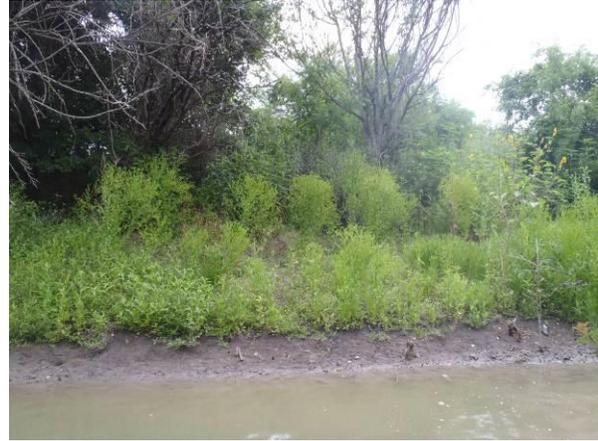
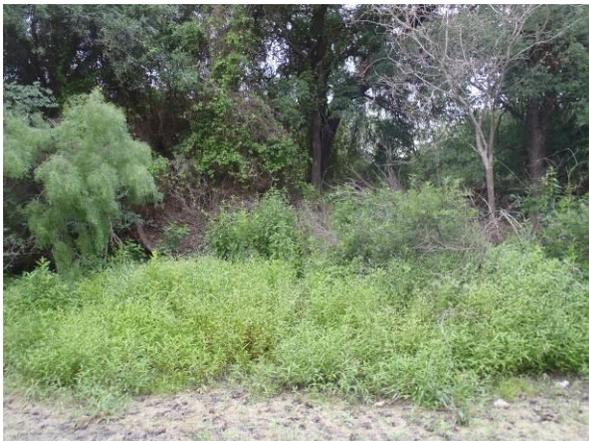
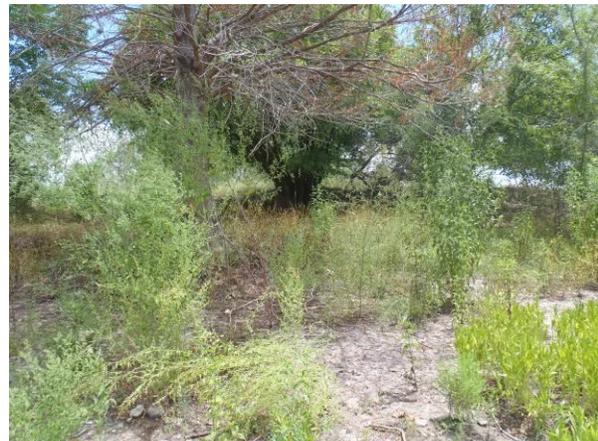
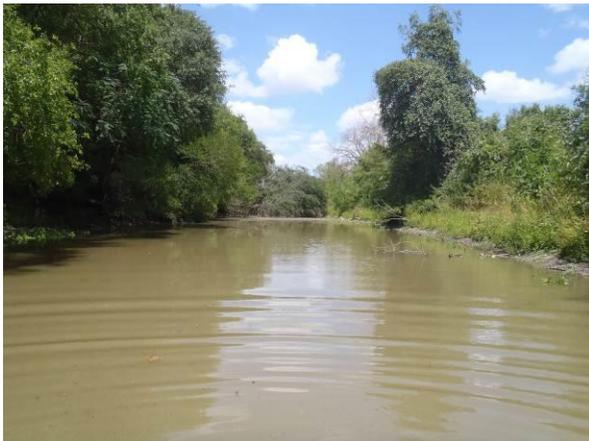
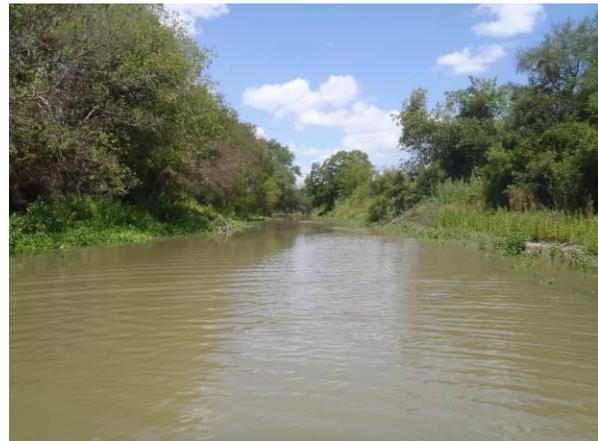
Photogroup 6-11 Leona River Site AU03_07 depicting banks and the general appearance of the stream. Top Left - 0-m transect right bank view, May 2012; Top Right - 150-m transect left bank view, May 2012; Middle Left – 300-m transect right bank view, May 2012; Middle Right – 300-m transect left bank view, July 2012; Bottom Left – 150-m transect upstream view, July 2012; Bottom Right – 0-m transect upstream view, July 2012.

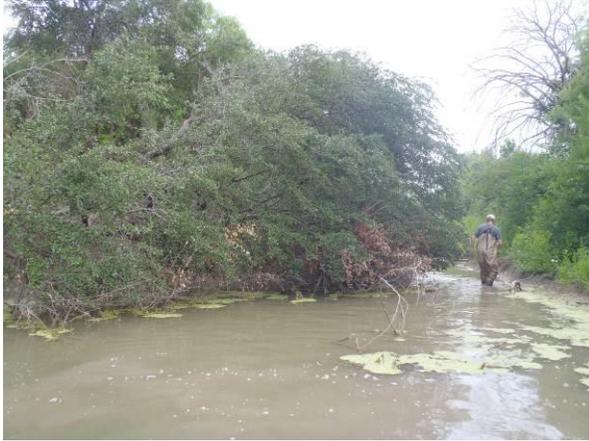
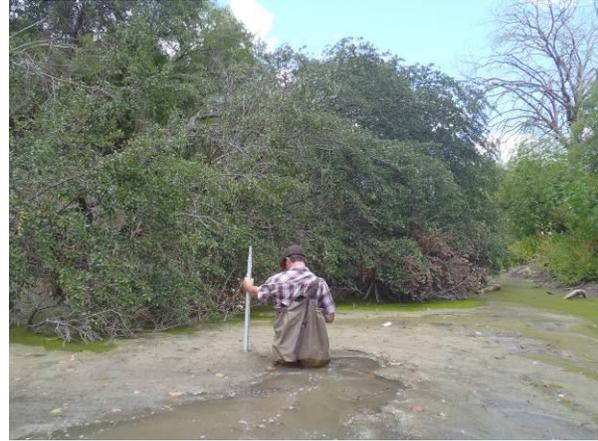
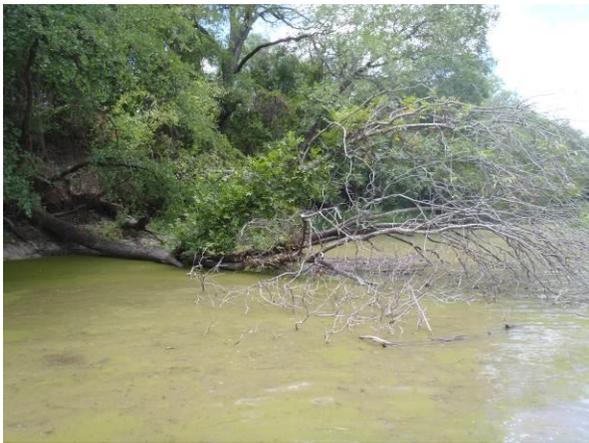
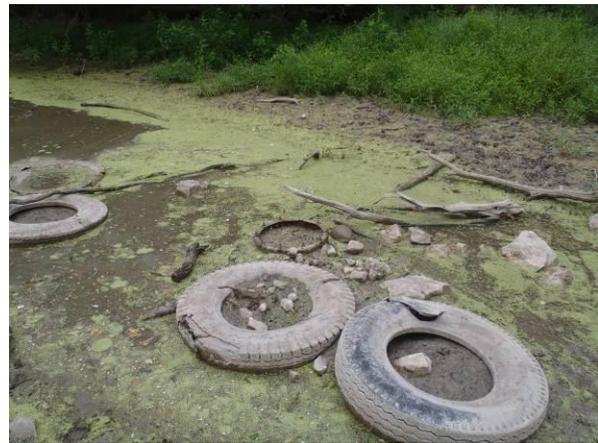
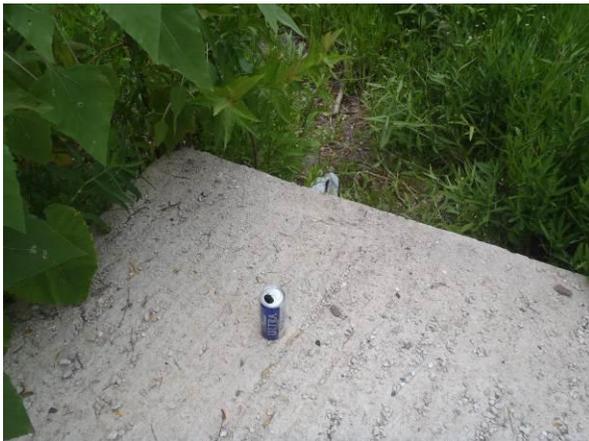
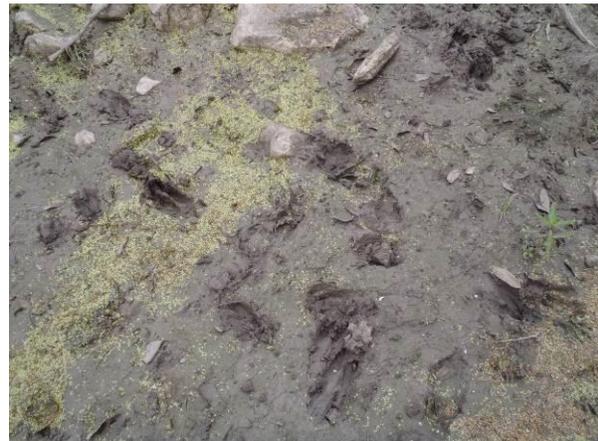
Photogroup 6-12 Leona River Site AU03_07 depicting obstructions, trash, and wildlife tracks. (All individuals pictured are TIAER staff.) Top Left - obstruction, May 2012; Top Right - 210-m obstruction, July 2012; Middle Left – 240 obstruction, July 2012; Middle Right – tires in streambed view, May 2012; Bottom Left – beer can on concrete ledge, May 2012; Bottom Right – wildlife tracks, May 2012.

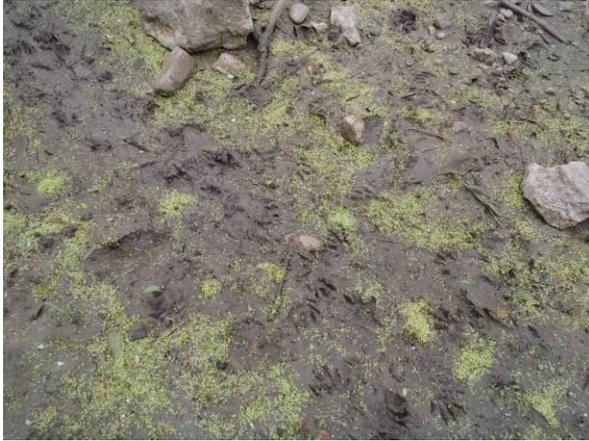
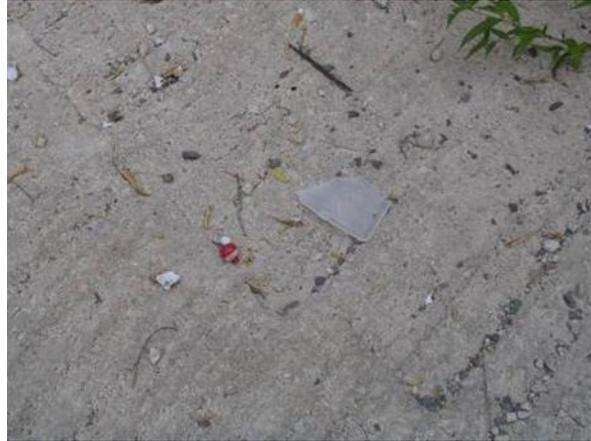
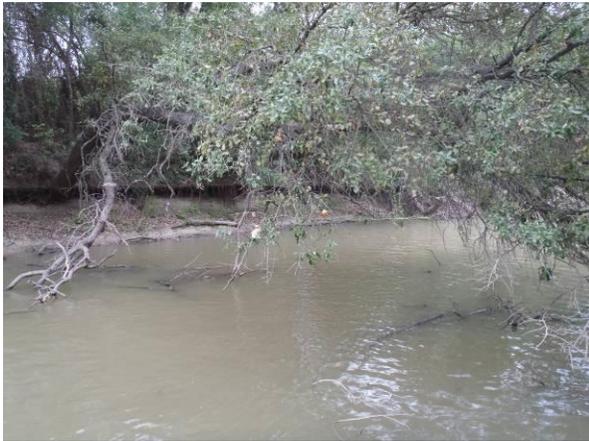
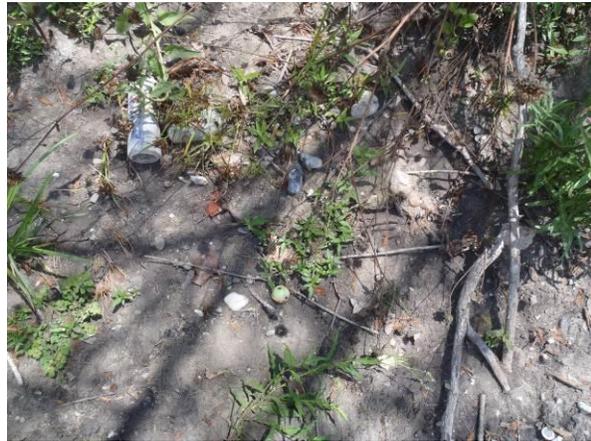
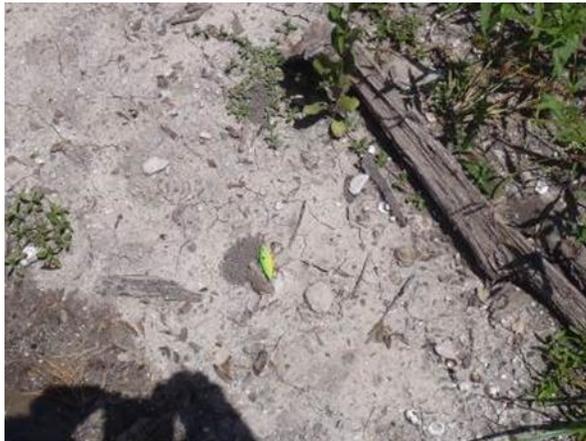
Photogroup 6-13 Leona River Site AU03_07 depicting wildlife tracks and signs of potential recreation. (All individuals pictured are TIAER staff.) Top Left – animal tracks, May 2012; Top Right - bobber, May 2012; Middle Left – bobber hanging in tree, May 2012; Middle Right – bobber on bank with trash, July 2012; Bottom – fishing line and lure, July 2012.

Evidence of potential contact recreation was observed at some sites in the segment. A canoe and flat bottom boat were observed lying next to a fence at Site AU03_03. According to the landowner, the boats were used in the past to boat in the river. Fishing bobbers, lures and a broken fishing pole were observed at Site AU03_07, at Fort Inge.

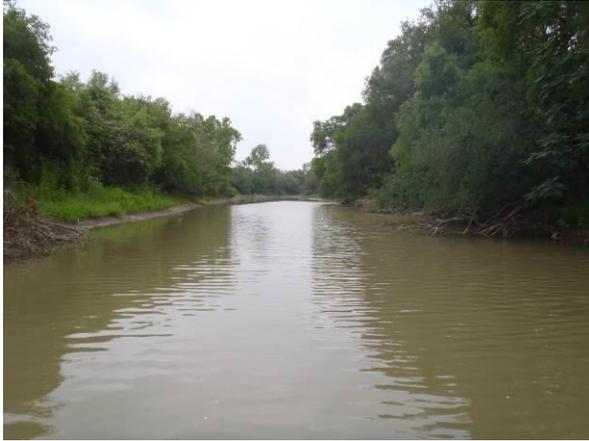
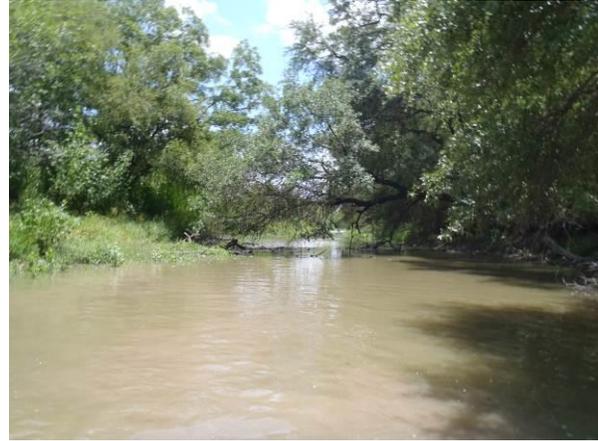
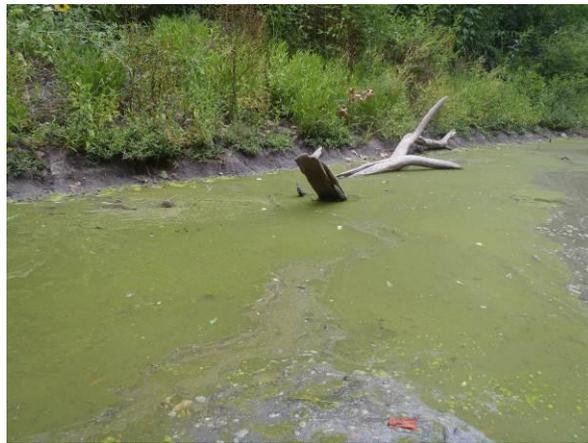
Photogroup 6-14 Leona River Site AU03_07 depicting water color and clarity. Top Left - 0-m transect downstream view, May 2012; Top Right - 150-m transect downstream view, July 2012; Middle – algal scum on water, July 2012.

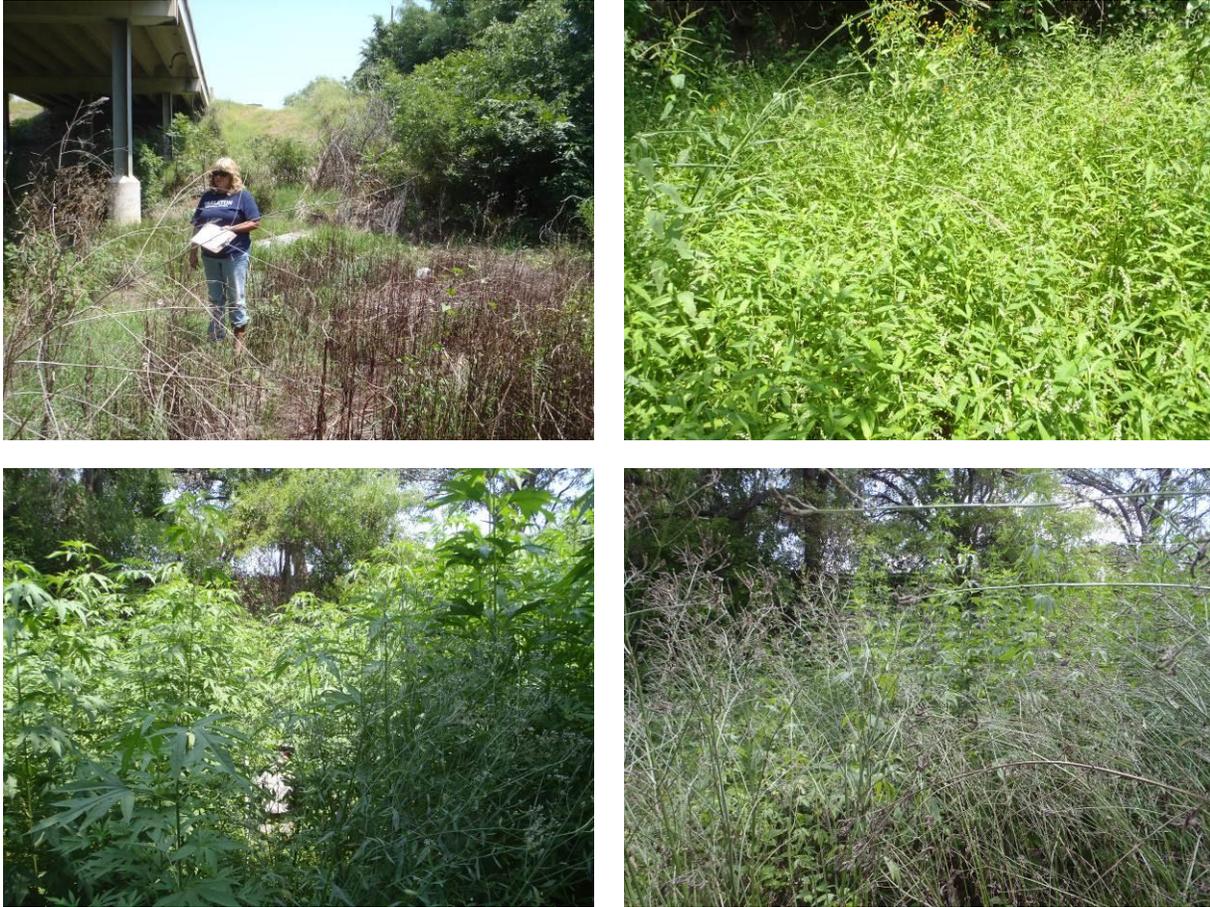
Photogroup 6-15 Leona River Site AU03_08 depicting access and the general bank appearance. (All individuals pictured are TIAER staff.) Top Left - 0-m transect left bank view, May 2012; Top Right - 150-m transect left bank view, May 2012; Bottom Left – 300-m transect left bank view, May 2012; Bottom Right – 300-m transect left bank view, July 2012.

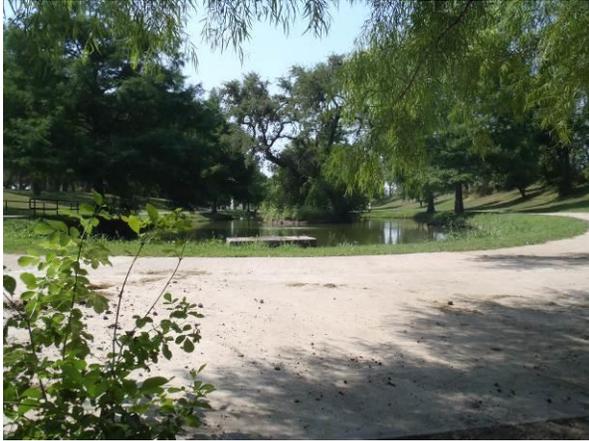
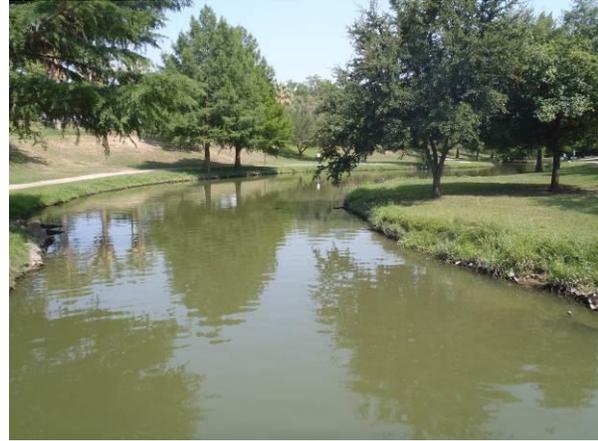
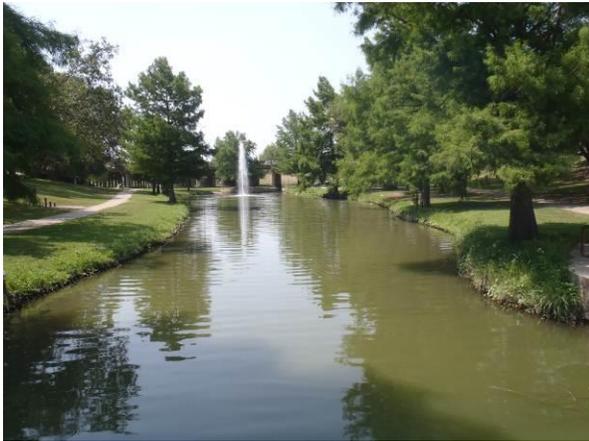
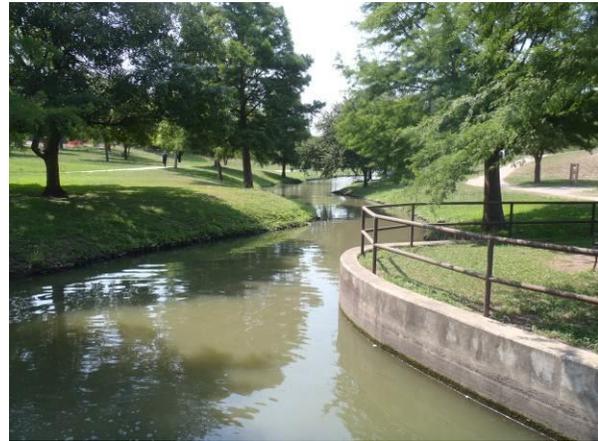
Photogroup 6-16 Leona River Site AU03_08 depicting dam and streambed conditions. Top Left – concrete dam, May 2012; Top Right - 300-m transect downstream view, May 2012; Middle Left – 0-m transect upstream view, May 2012; Middle Right – 300-m transect upstream view, May 2012; Bottom Left – 150-m transect downstream view, July 2012; Bottom Right – 150-m transect upstream view, July 2012.

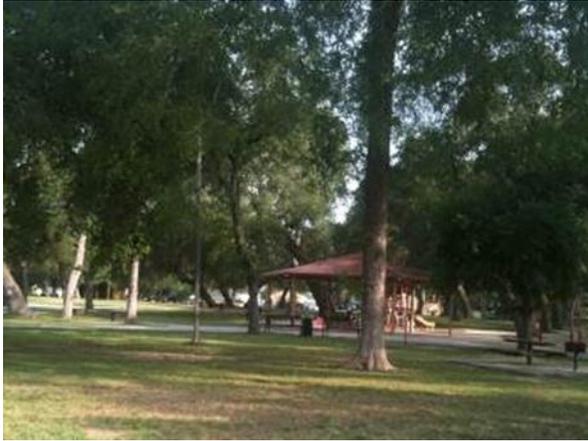
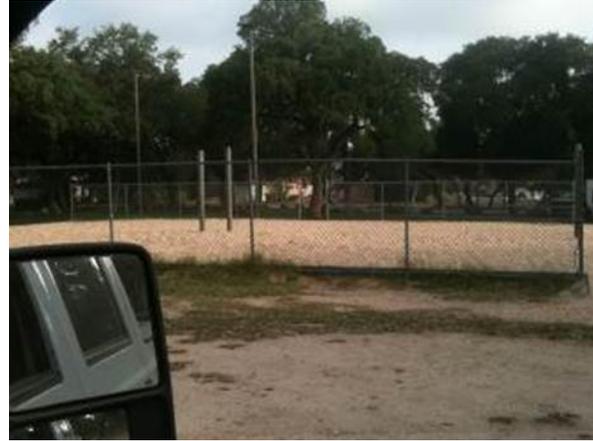
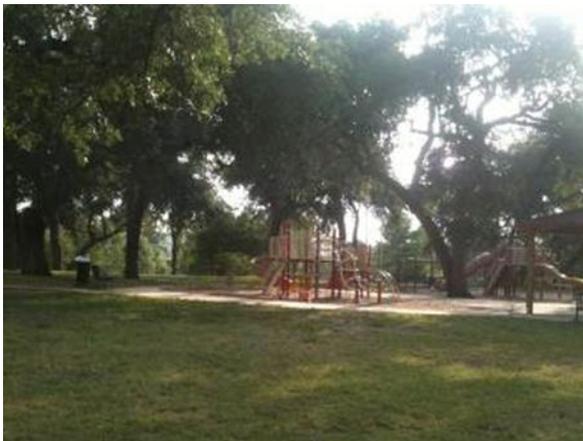
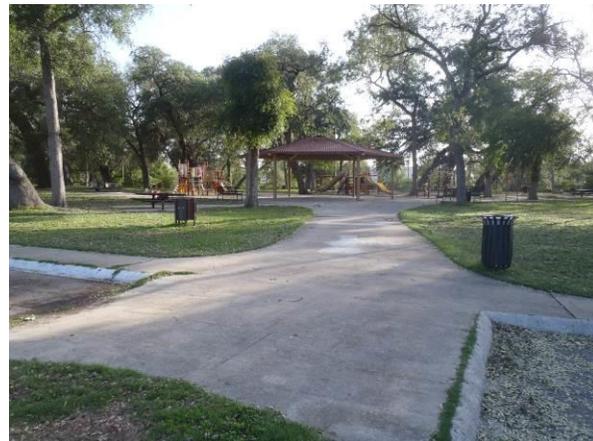
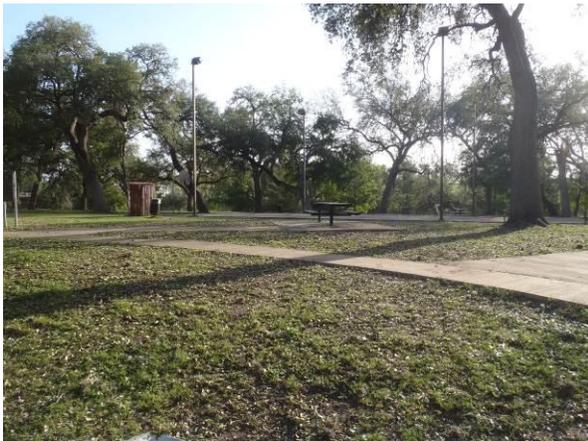
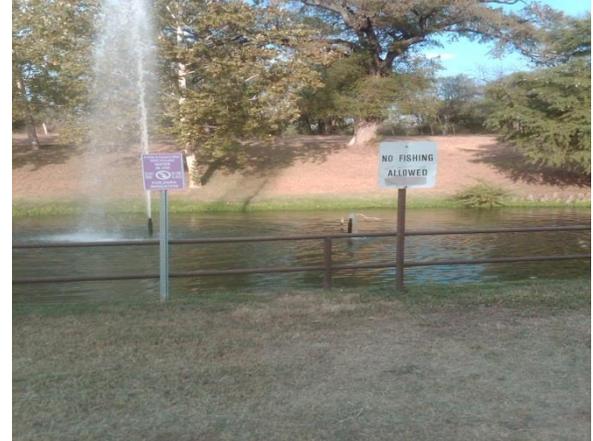
Photogroup 6-17 Leona River Site AU03_09 depicting access and the general appearance of the stream within the Uvalde City Park. Top Left - 0-m transect upstream view towards water impoundment within Uvalde City Park, May 2012; Top Right - 150-m transect downstream view, May 2012; Bottom Left – 150-m transect upstream view, May 2012; Bottom Right – 300-m transect upstream view, May 2012.

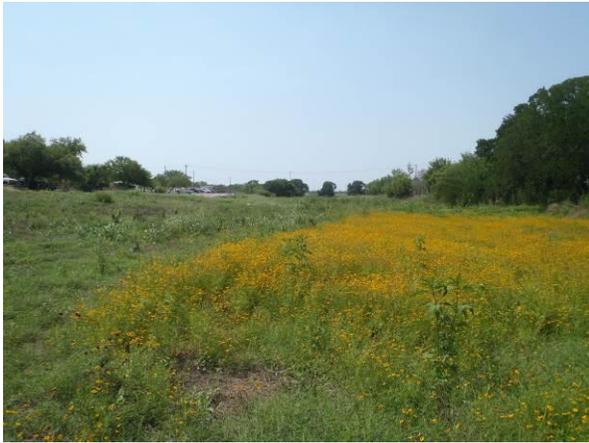
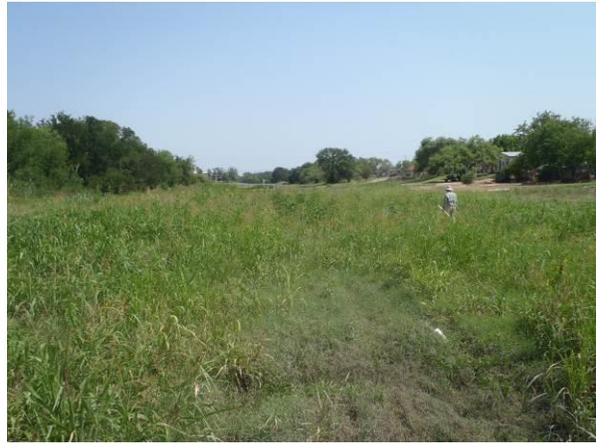
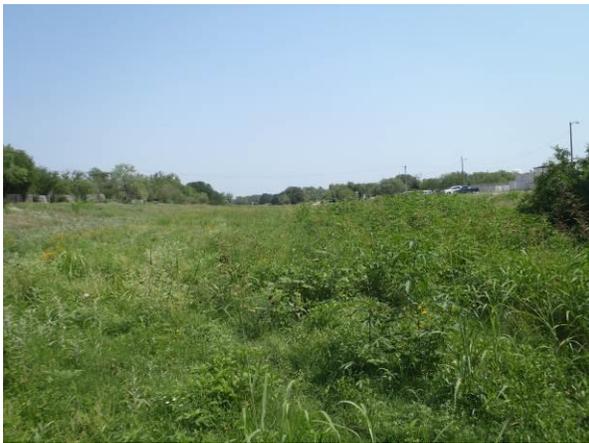
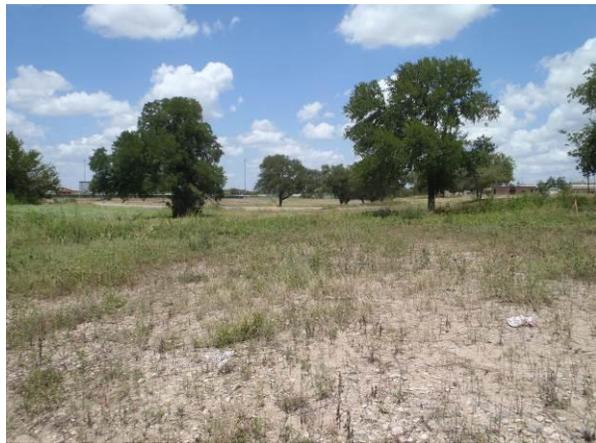
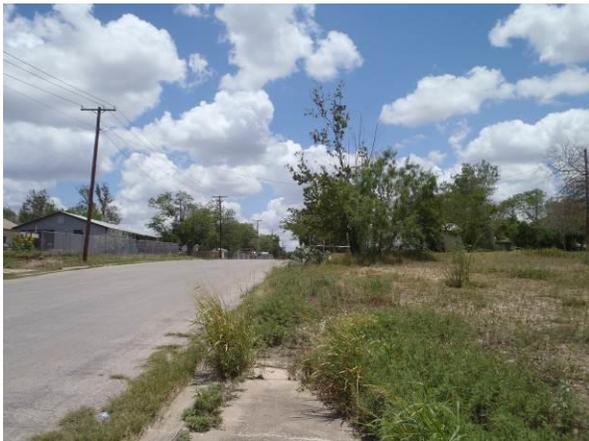
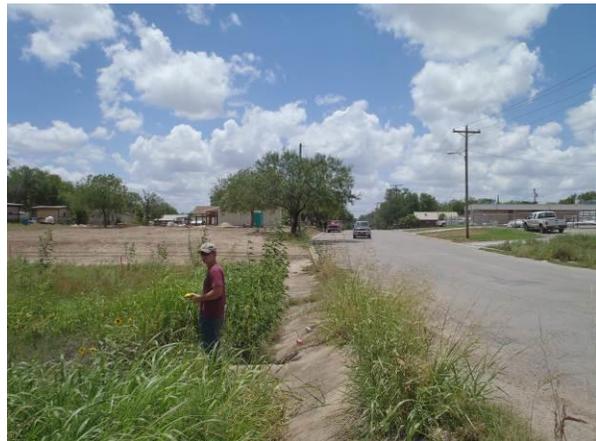
Photogroup 6-19 Leona River Site AU03_09 depicting general appearance of the stream and access. Top Left - 0-m transect downstream view, May 2012; Top Right - 0-m transect left bank view with footpath, May 2012; Bottom Left – 150-m transect downstream view, July 2012; Bottom Right – 0-m transect upstream view, July 2012.

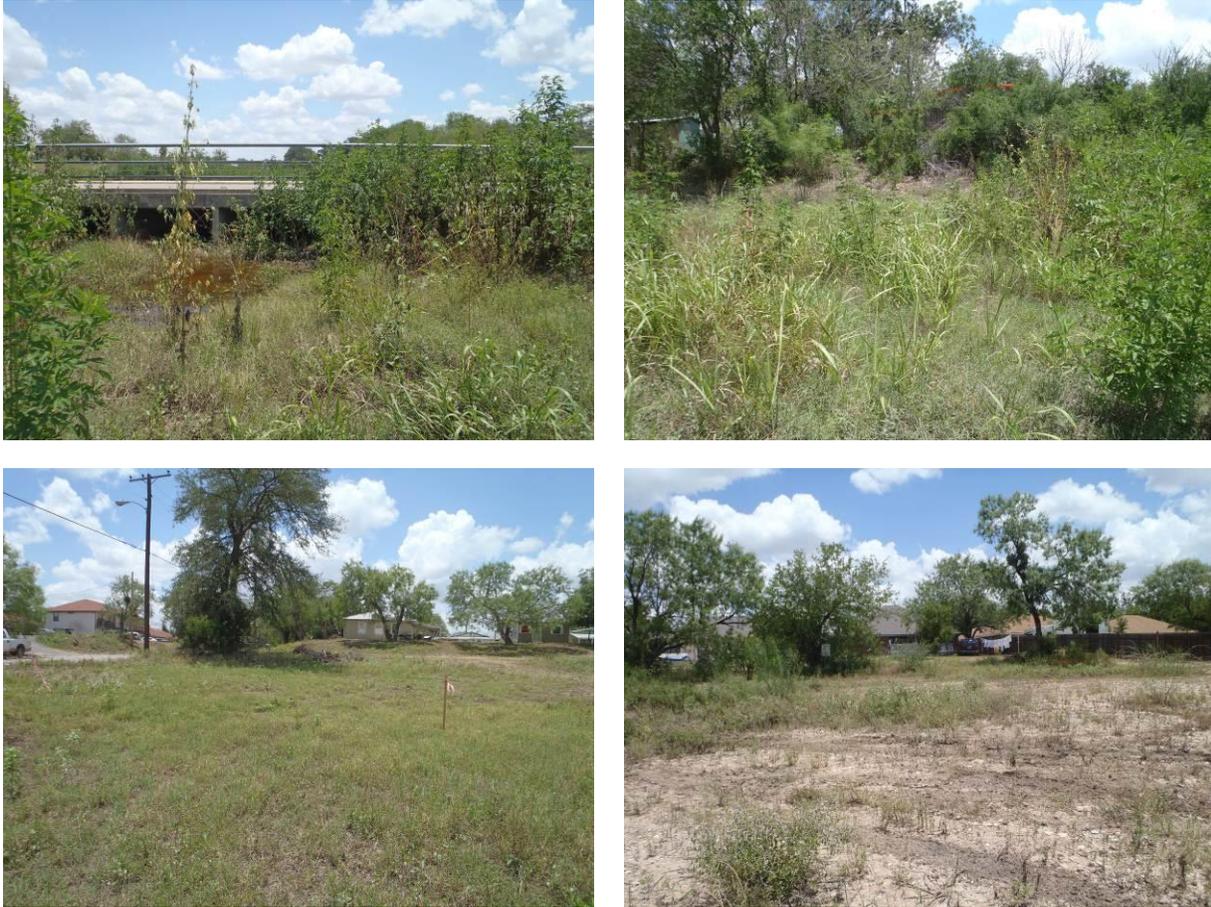
Photogroup 6-20 Leona River Site AU03_10 depicting access and the general appearance of the stream. (All individuals pictured are TIAER staff.) Top Left - 0-m transect upstream view, May 2012; Top Right - 150-m transect downstream view, May 2012; Middle Left – 300-m transect downstream view, May 2012; Middle Right – 300-m transect upstream view, July 2012; Bottom Left – 150-m transect left bank view, July 2012; Bottom Right – 150-m transect right bank view, July 2012.

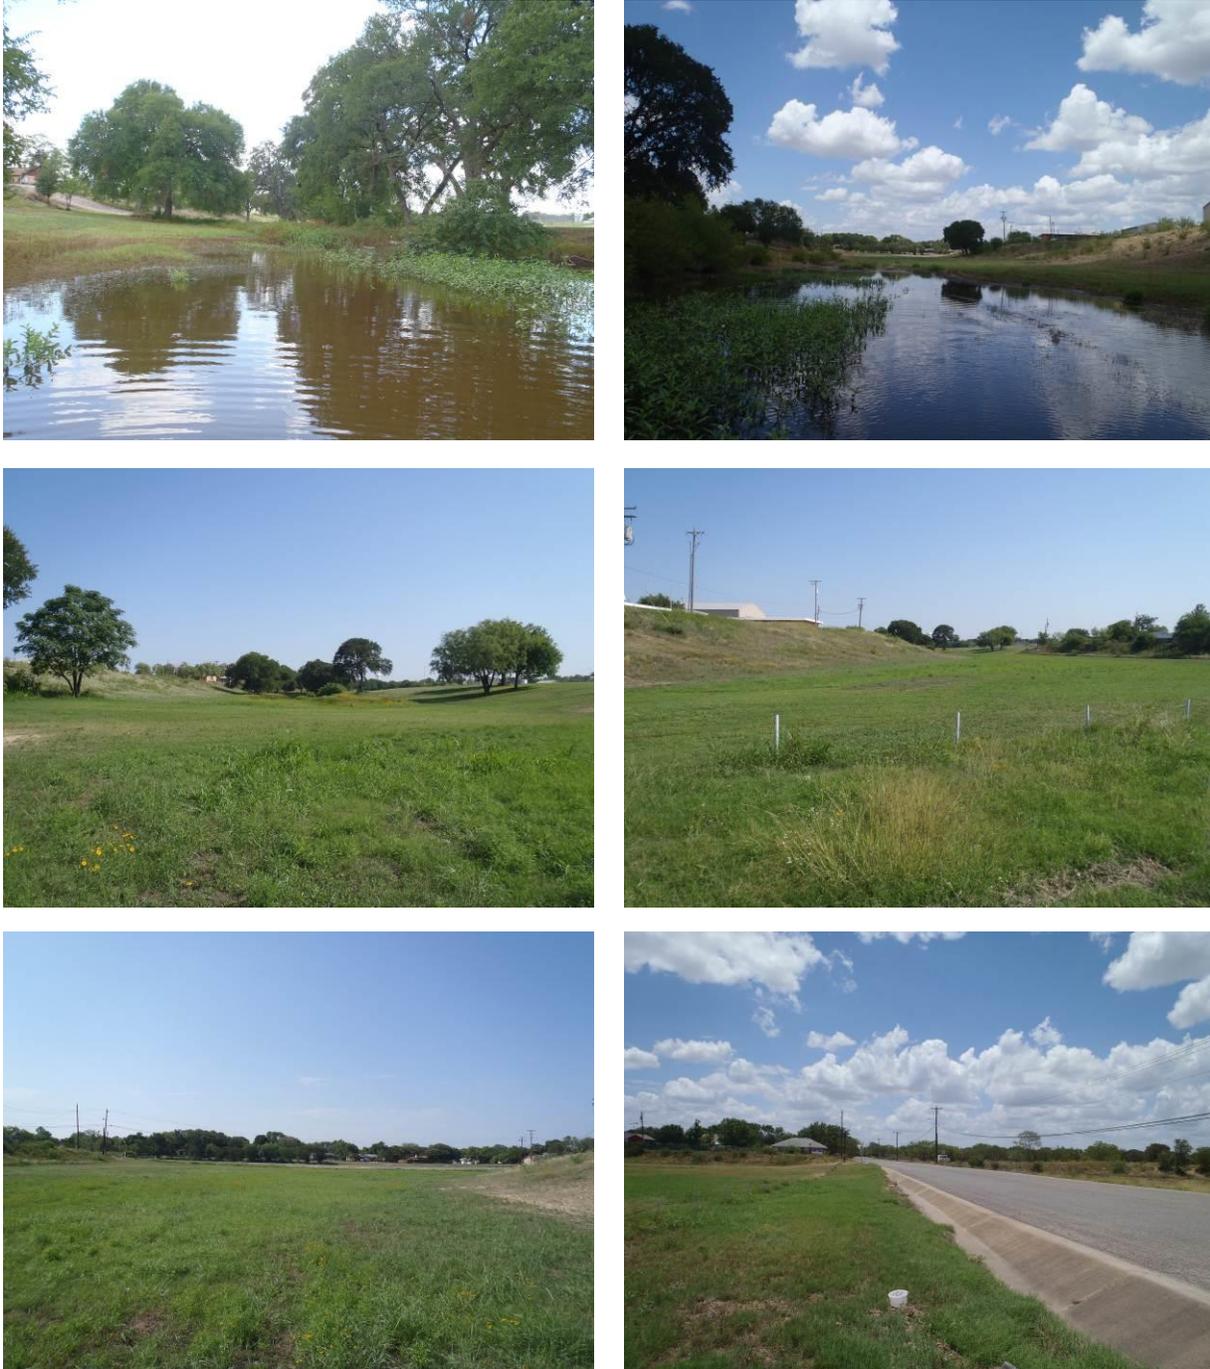
Photogroup 6-21 Leona River Site AU03_10 depicting puddle encountered in July, bank vegetation, and nearby residences. Top Left - 0-m transect downstream view, July 2012; Top Right - 0-m transect left bank view, July 2012; Bottom Left – 0-m transect right bank view, July 2012; Bottom Right – 300-m transect left bank view, July 2012.

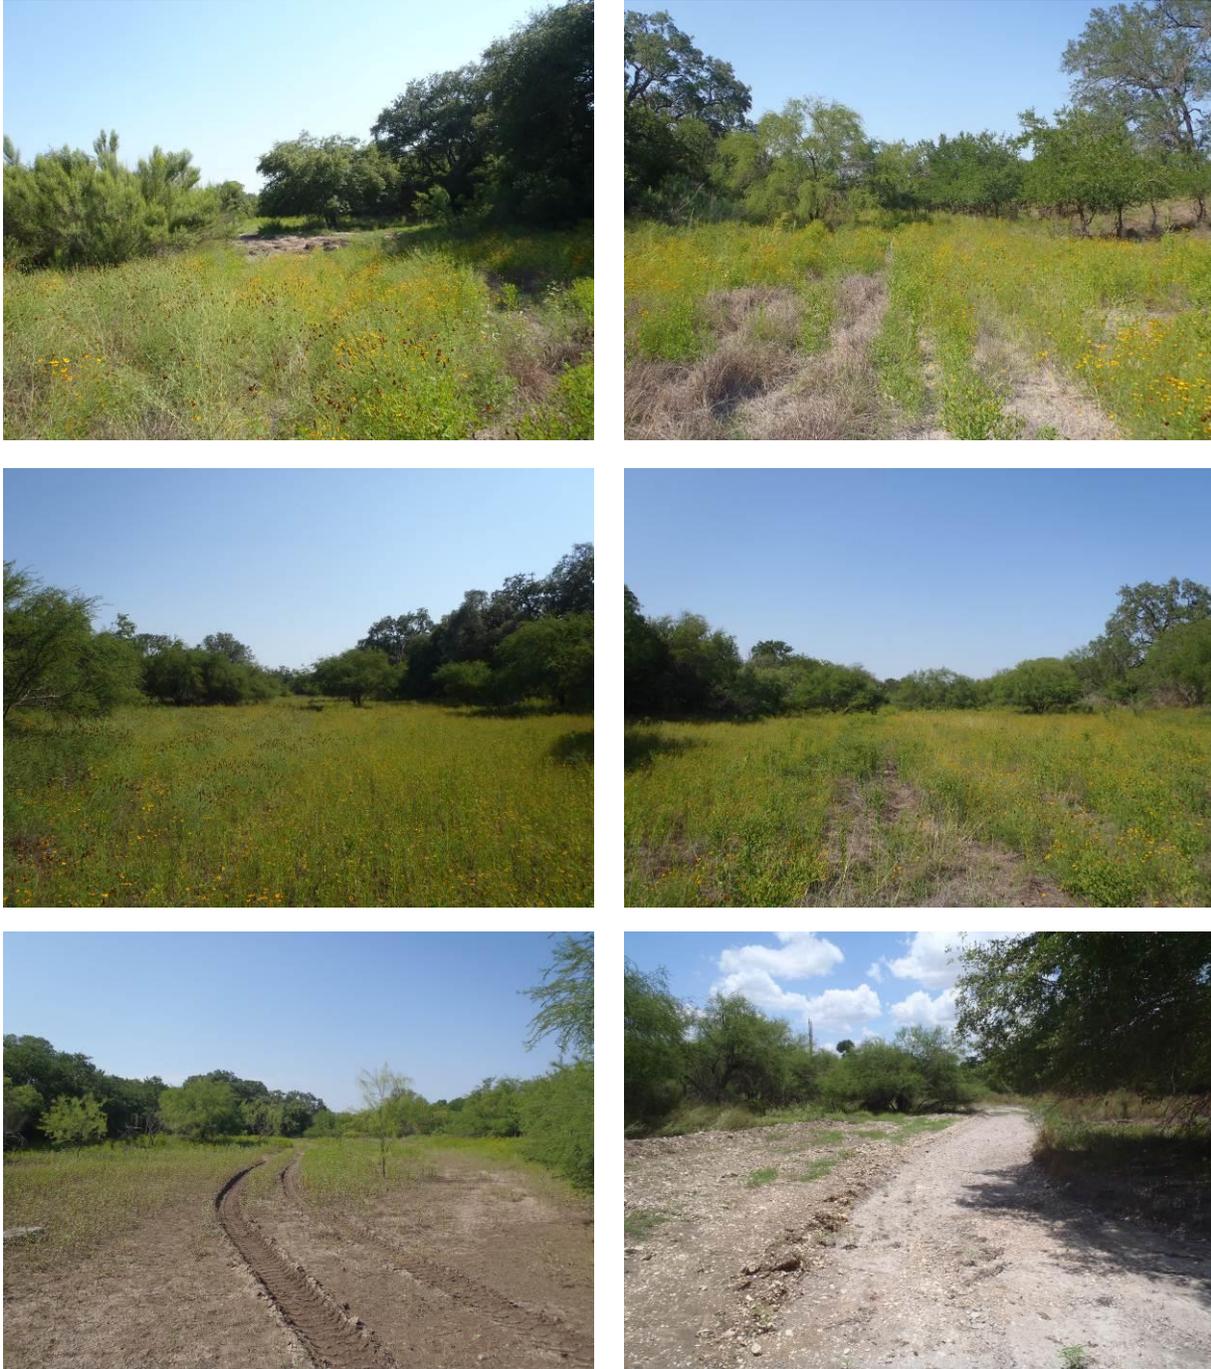
Photogroup 6-22 Leona River Site AU03_11 depicting the pool encountered and the general appearance of the stream. Top Left - 0-m transect downstream view, July 2012; Top Right - 0-m transect upstream view, July 2012; Middle Left – 150-m transect downstream view, May 2012; Middle Right – 300-m transect downstream view, May 2012; Bottom Left – 150-m transect upstream view, May 2012; Bottom Right – 300-m transect right bank view, July 2012.

surveys. Access into the stream was easy as there were no banks to speak of along the stream at this location. The grassy corridor appeared to be mowed and maintained more frequently than the corridor at Site AU03_10. In order to capture the pool of water within the reach, TIAER established the Studer Street road crossing as the 300-m transect and worked downstream, encompassing the land behind the schools. This would also increase the possibility of catching someone recreating while leaving the school property. Table 6-2 lists the stream channel and riparian zone qualities observed at this site. Photogroup 6-22 depicts the pool and general appearance of the stream, including the cable fence/barrier at Site AU03_11.

The surveyed reach at Site AU03_11 was wadeable for its entire 300 meter length. Other than the pool at the 0-m transect, no water was encountered during the two field surveys. There were no obstructions encountered and only fecal droppings were observed within the reach.

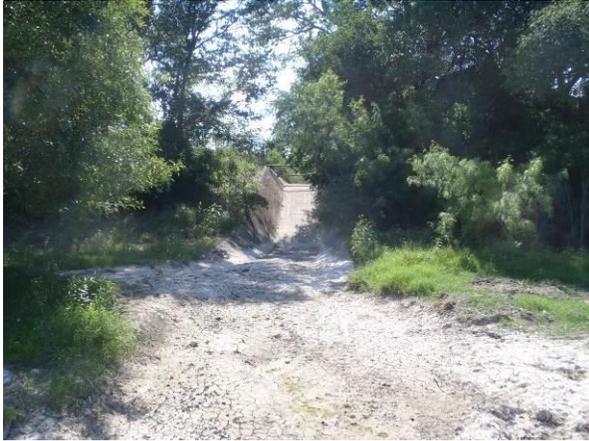
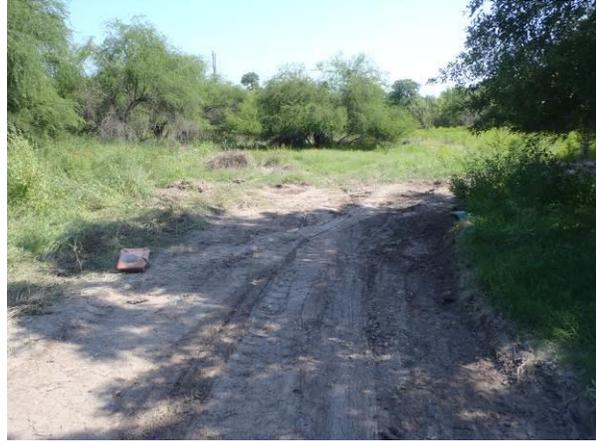
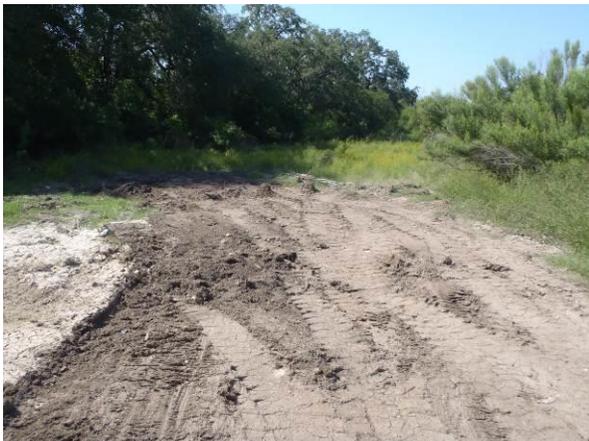
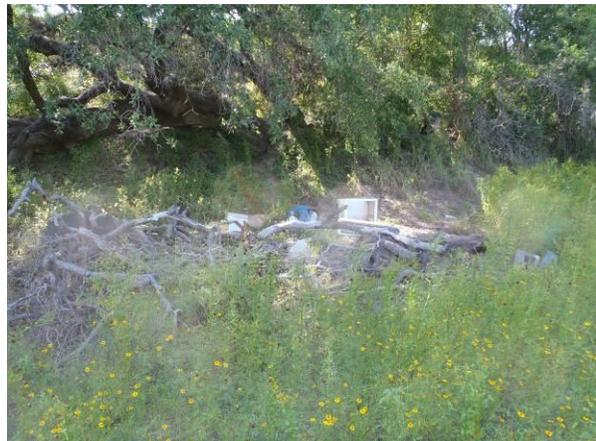
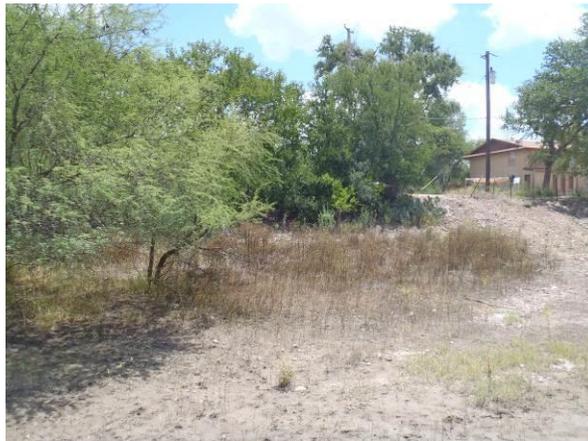
Photogroup 6-23 Leona River Site AU03_12 depicting access and the general appearance of the stream and tractor tracks in May and gravel road in July. Top Left - 150-m transect downstream view, May 2012; Top Right - 150-m transect upstream view, May 2012; Middle Left – 300-m transect downstream view, May 2012; Middle Right – 300-m transect upstream view, May 2012; Bottom Left – tractor tracks in streambed, May 2012; Bottom Right – gravel path in streambed, July 2012.

The surveyed reach at Site AU03_12 was easily wadeable for its entire length due to the lack of water. No obstructions were encountered that impeded the survey within the boundaries of the property. The dried mud/clay bottom made for easy walking. Some form of drainage channel was observed at the 120-m transect and some dirt work in the stream channel was encountered in the same area. A trash pile was encountered at the 180-m transect, but otherwise, trash was rarely encountered. Because this site was in a residential area, the lack of trash observed in the stream channel was surprising. Deer were observed during both of the surveys and tracks were also seen, but no fecal

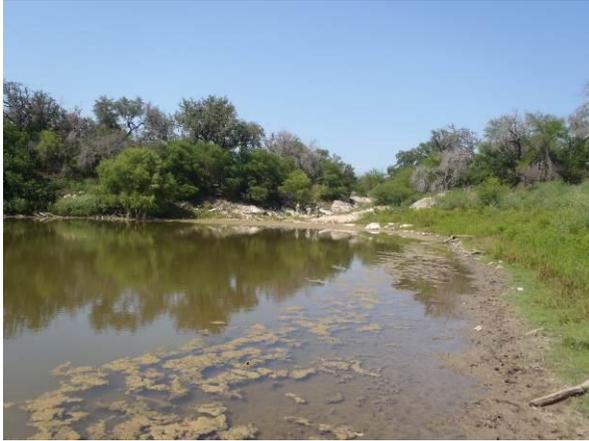
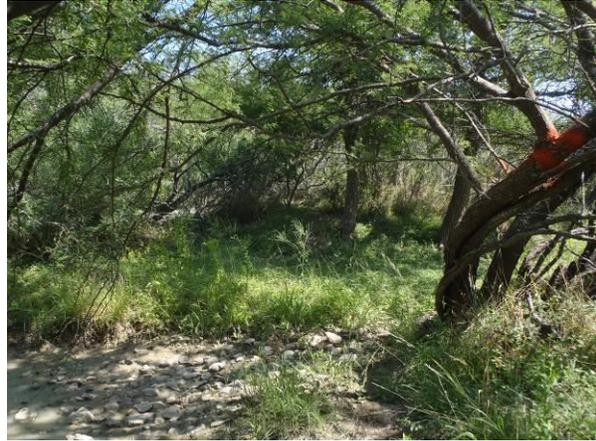
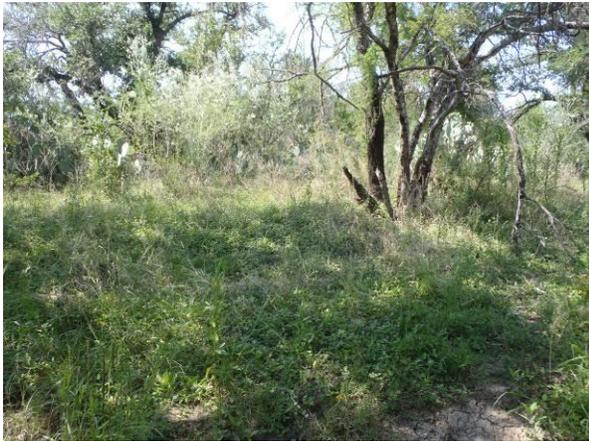
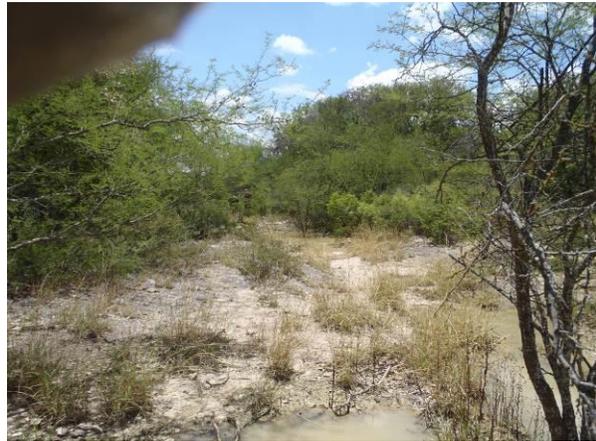
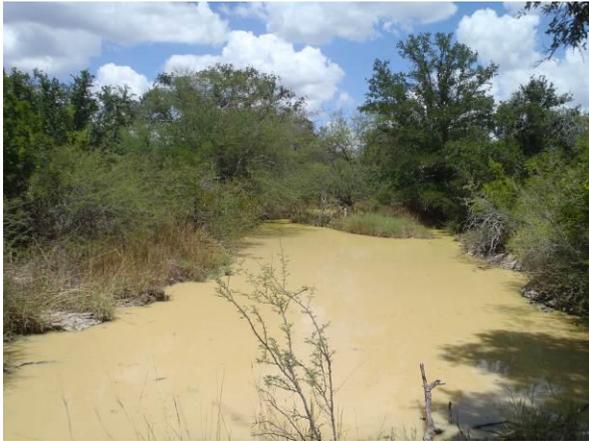
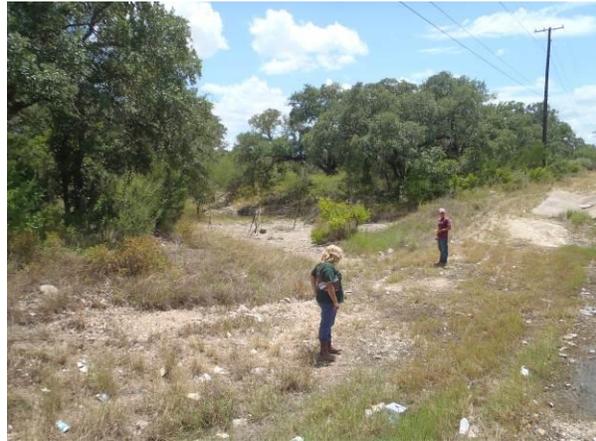
Photogroup 6-24 Leona River Site AU03_12 depicting dirt work, trash, and nearby residence. Top Left - 120-m drainage culvert, May 2012; Top Right - 120-m view of dirt work, May 2012; Middle Left – 120-m second view of dirt work, May 2012; Middle Right – 180-m trash pile, May 2012; Bottom – 0-m left bank view, July 2012.

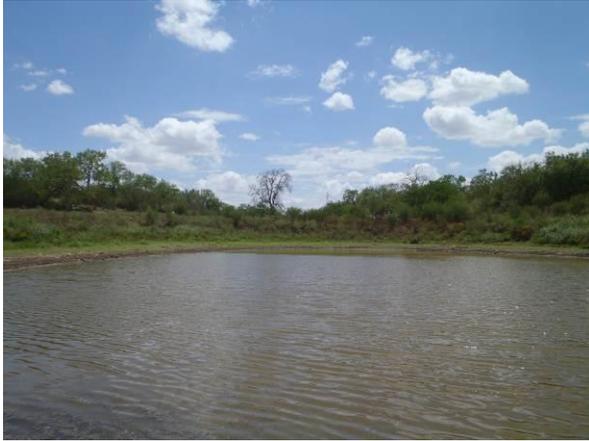
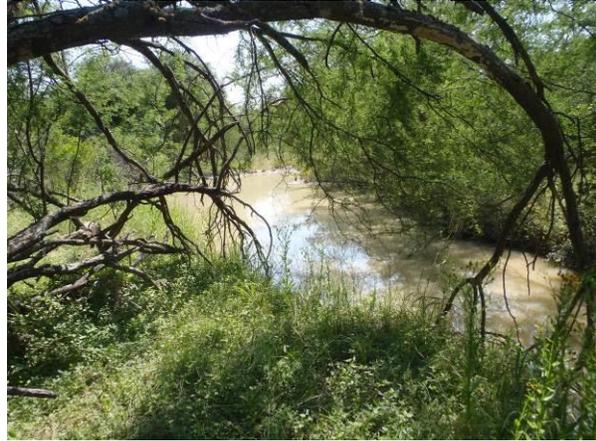
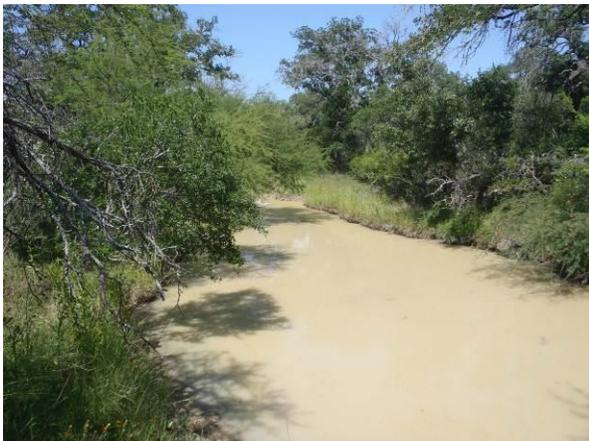
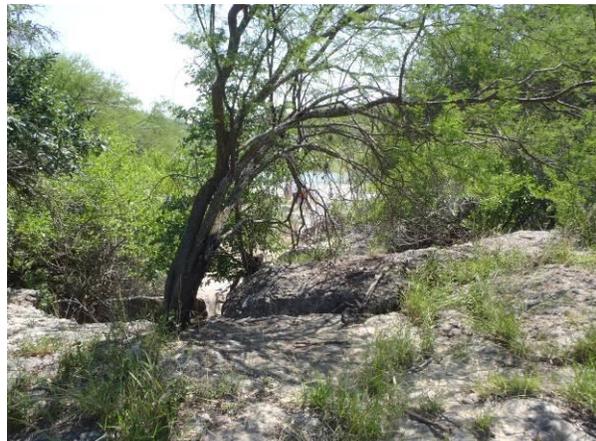
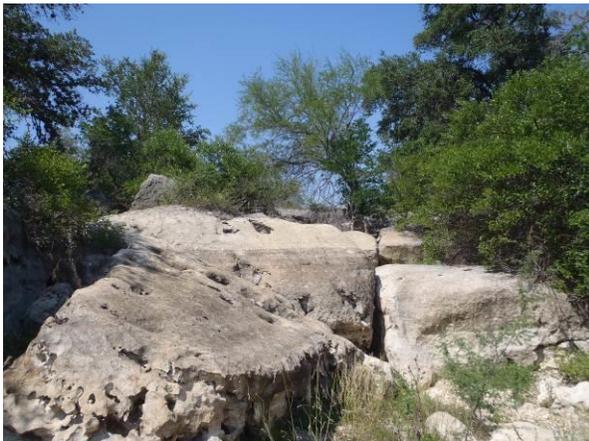
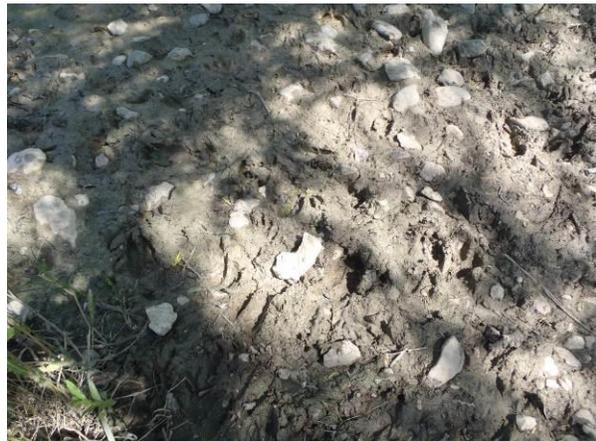
Photogroup 6-26 Leona River Site AU03_13 depicting pools, boulders, and wildlife tracks. Top Left - 0-m transect downstream view, July 2012; Top Right - 150-m transect downstream view, May 2012; Middle Left – 150-m transect upstream view, May 2012; Middle Right – rocks as obstruction, May 2012; Bottom Left – more rocks as obstruction, May 2012; Bottom Right – wildlife tracks, May 2012.

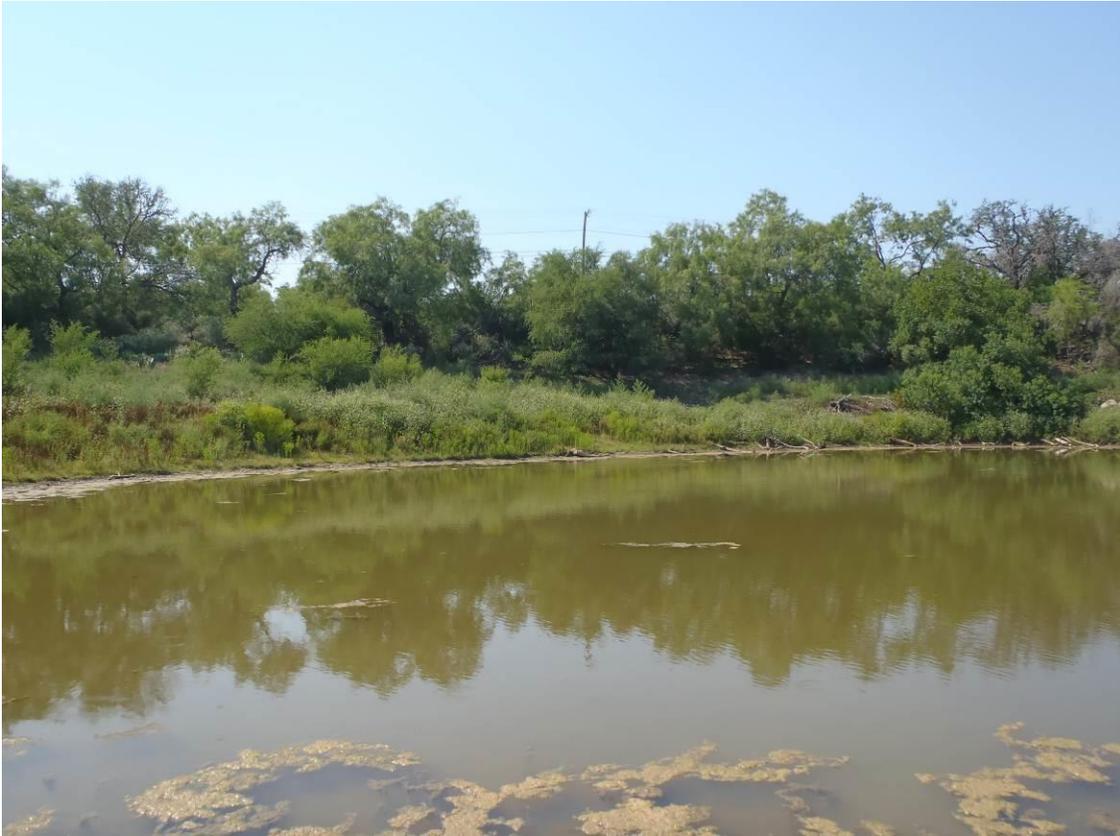
Photogroup 6-27 Leona River Site AU03_13 depicting water color and surface clarity. 0-m transect right bank view, May 2012.
