**Leona River
Recreational Use Attainability Analysis**

**Texas State Soil and Water Conservation Board
Project 11-50**

**Texas Institute for Applied Environmental Research
Tarleton State University
Stephenville, Texas**

June 2013

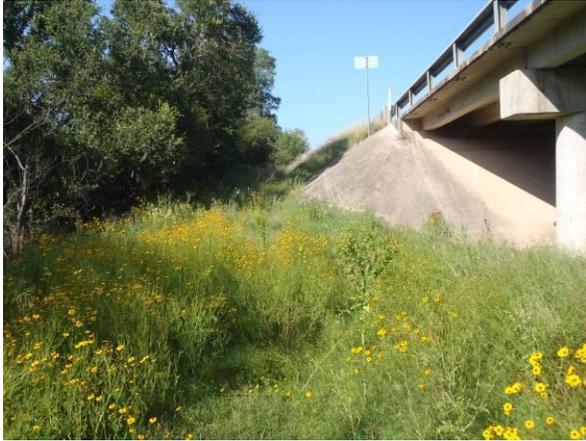
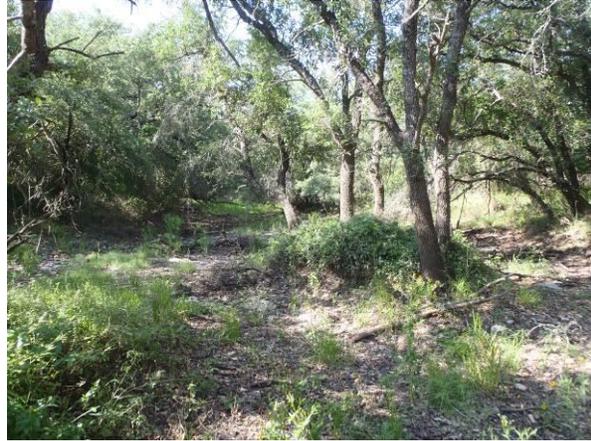
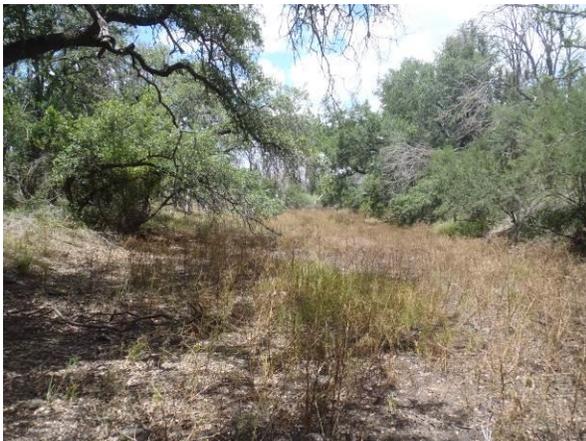
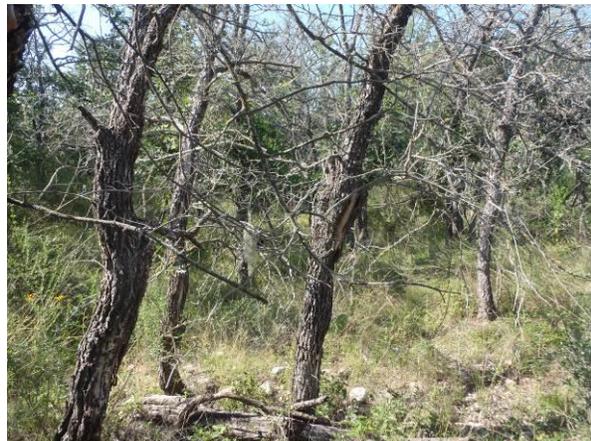
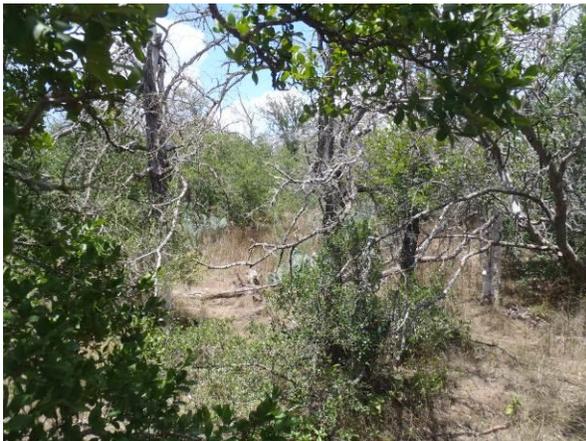
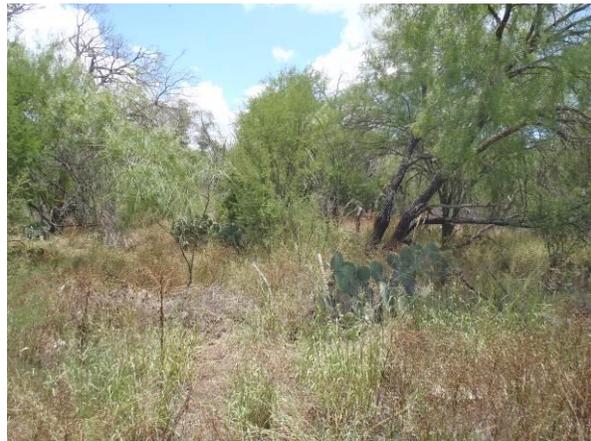
Photogroup 6-28 Leona River Site AU03_14 depicting access and the general appearance of the stream. Top Left - 300-m transect right bank view, May 2012; Top Right - 0-m transect downstream view, May 2012; Middle Left – 0-m transect upstream view, July 2012; Middle Right – 150-m transect downstream view, May 2012; Bottom Left – 150-m transect upstream view, July 2012; Bottom Right – 300-m transect downstream view, July 2012.

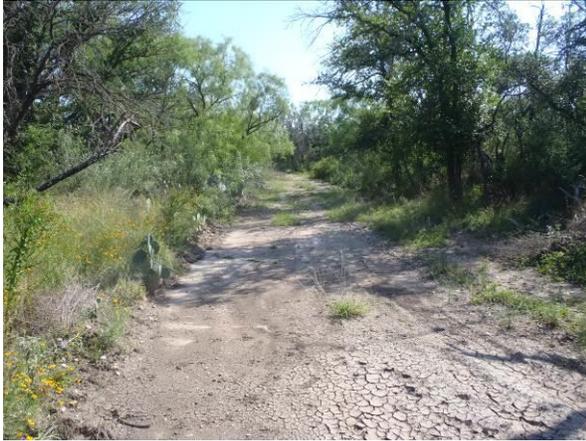
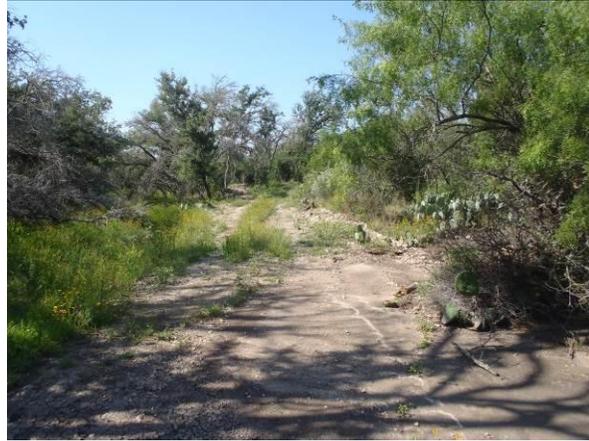
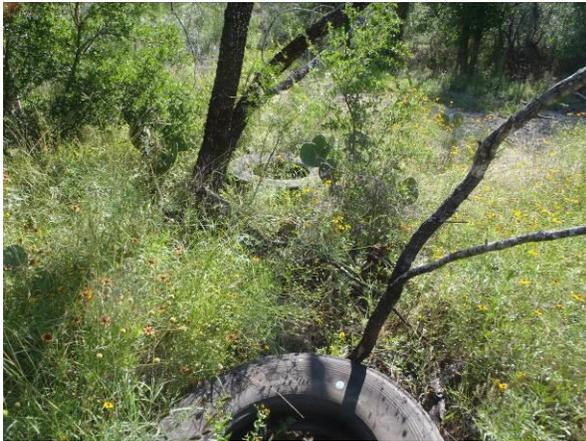
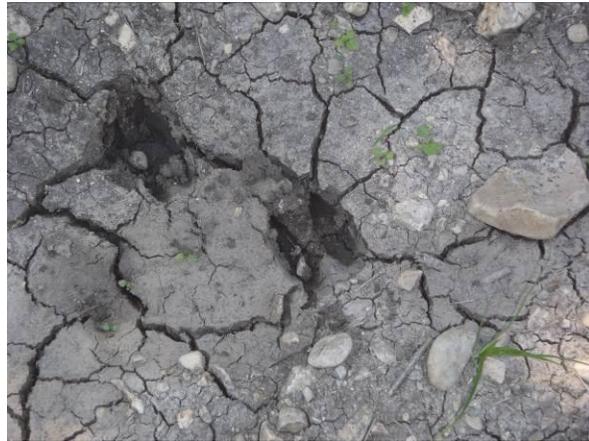
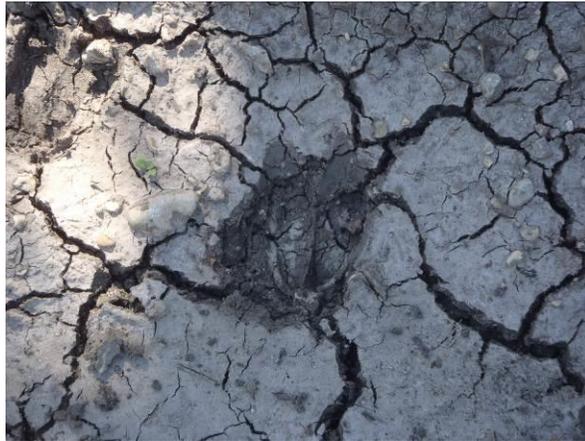
Photogroup 6-29 Leona River Site AU03_14 depicting road across creek, tire, and wildlife tracks. Top Left - 270-m road view north, May 2012; Top Right - 270-m road view south, May 2012; Middle Left – tires along stream, May 2012; Middle Right – wildlife tracks, May 2012; Bottom – more wildlife tracks, May 2012.
